Taroona Landslide Area

"The History, Current Understanding of Risks and Proposed Management of the School Creek Landslide and Surrounds"

September 2014

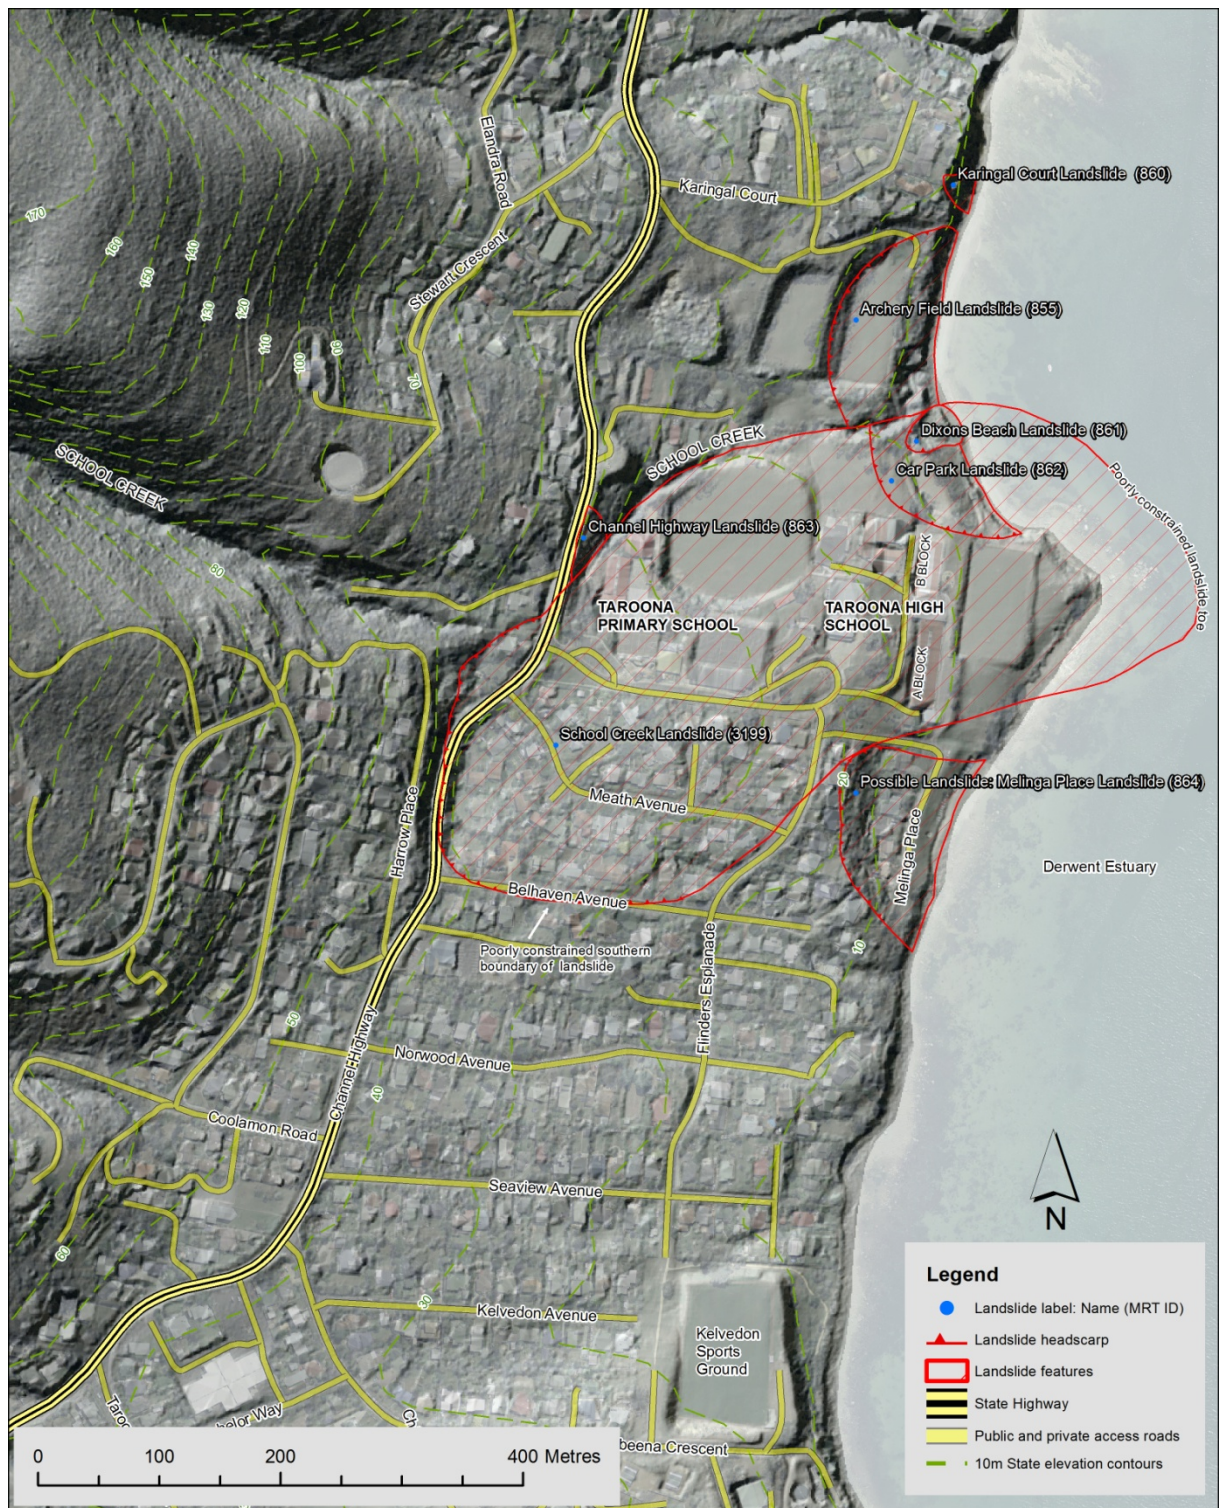
Figure 1 General plan of the landslides at Taroona

There are several relatively small active coastal landslides that have been known since the 1970's (namely the **Archery Field, Car Park and Dixons Beach Landslides**) that have a relatively clear expression on the landscape Figure 1. There are currently no buildings on these features.

Subsidence and damage along the Channel Highway, centred about 100m north of the intersection of the school driveway has been ongoing for several decades. This feature, here named the **Channel Highway Landslide** (Figure 1), is considered to be a small landslide and is probably related to failure of the embankment fill.

There is a much larger feature - the **School Creek Landslide**, in the vicinity of the two schools and south to Belhaven Avenue (Figure 1) which is an active landslide. This feature is not obvious on the landscape. It had been known for many years that buildings in the general area have required periodic structural repairs, much of it attributable to poor foundation construction on highly reactive soil. However, the continuing program of repairs to a section of the Channel Highway adjacent to the Taroona Primary School appear to have prompted more critical investigation of land instability in the mid 1970's by the then Department of Main Roads. This resulted in a large landslide hypothesis (Moon and McDowell 2002) that has been subsequently refined by various parties. In hindsight direct evidence of contemporary movement of the School Creek Landslide dates back to the beginning of aerial photography in the State (mid 1940's).

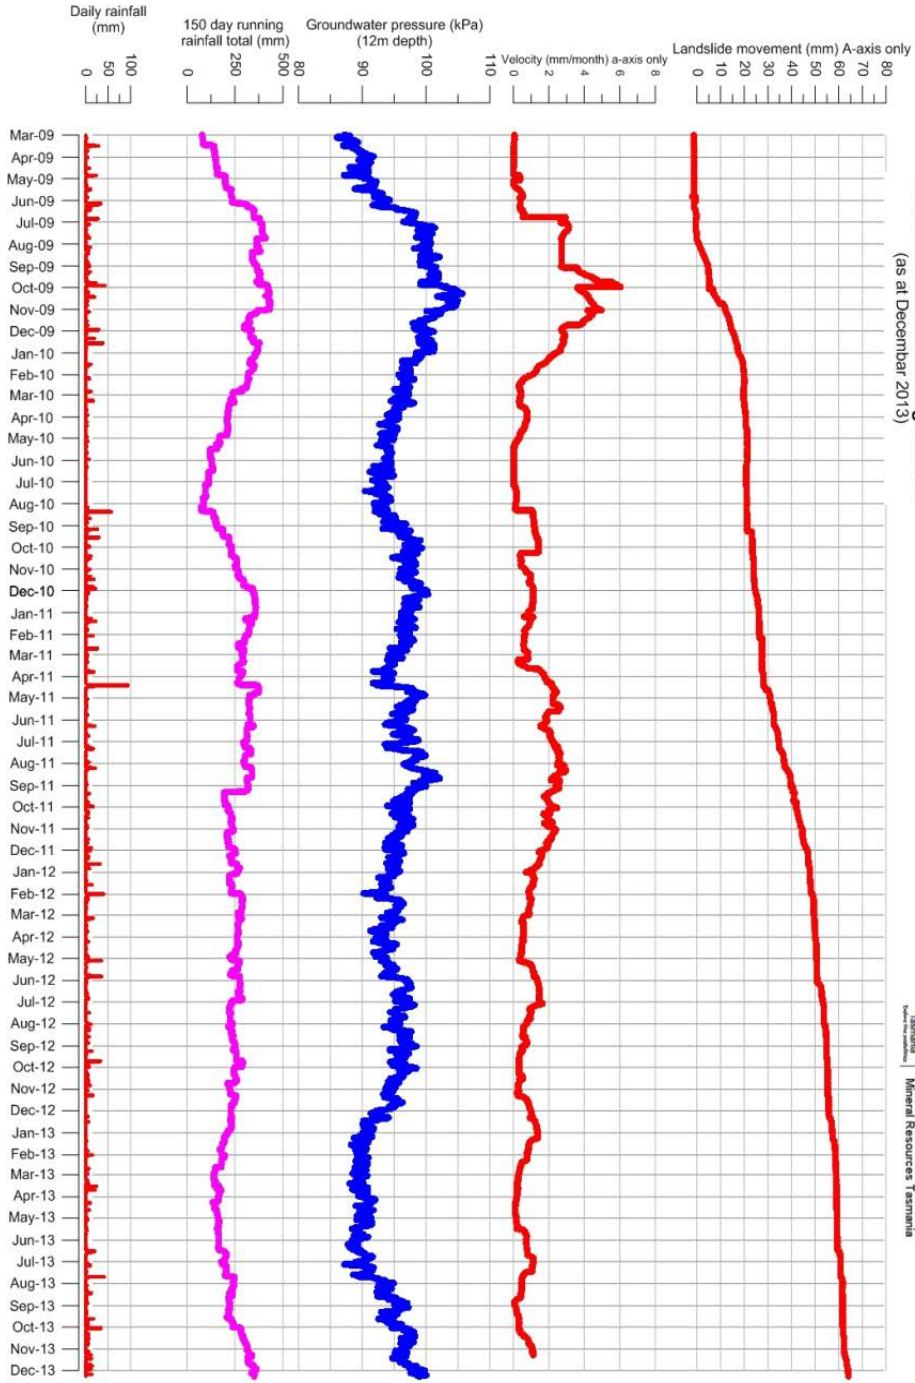
Figure 3 Time series plot of rainfall/groundwater pressure & near real time inclinometer displacement. Note that groundwater pressure and landslide movement is strongly correlated to long term rainfall

It is recommended that the near-real-time monitoring facility be supported for the length of its useful life and that additional sensors recently installed be integrated with this facility.

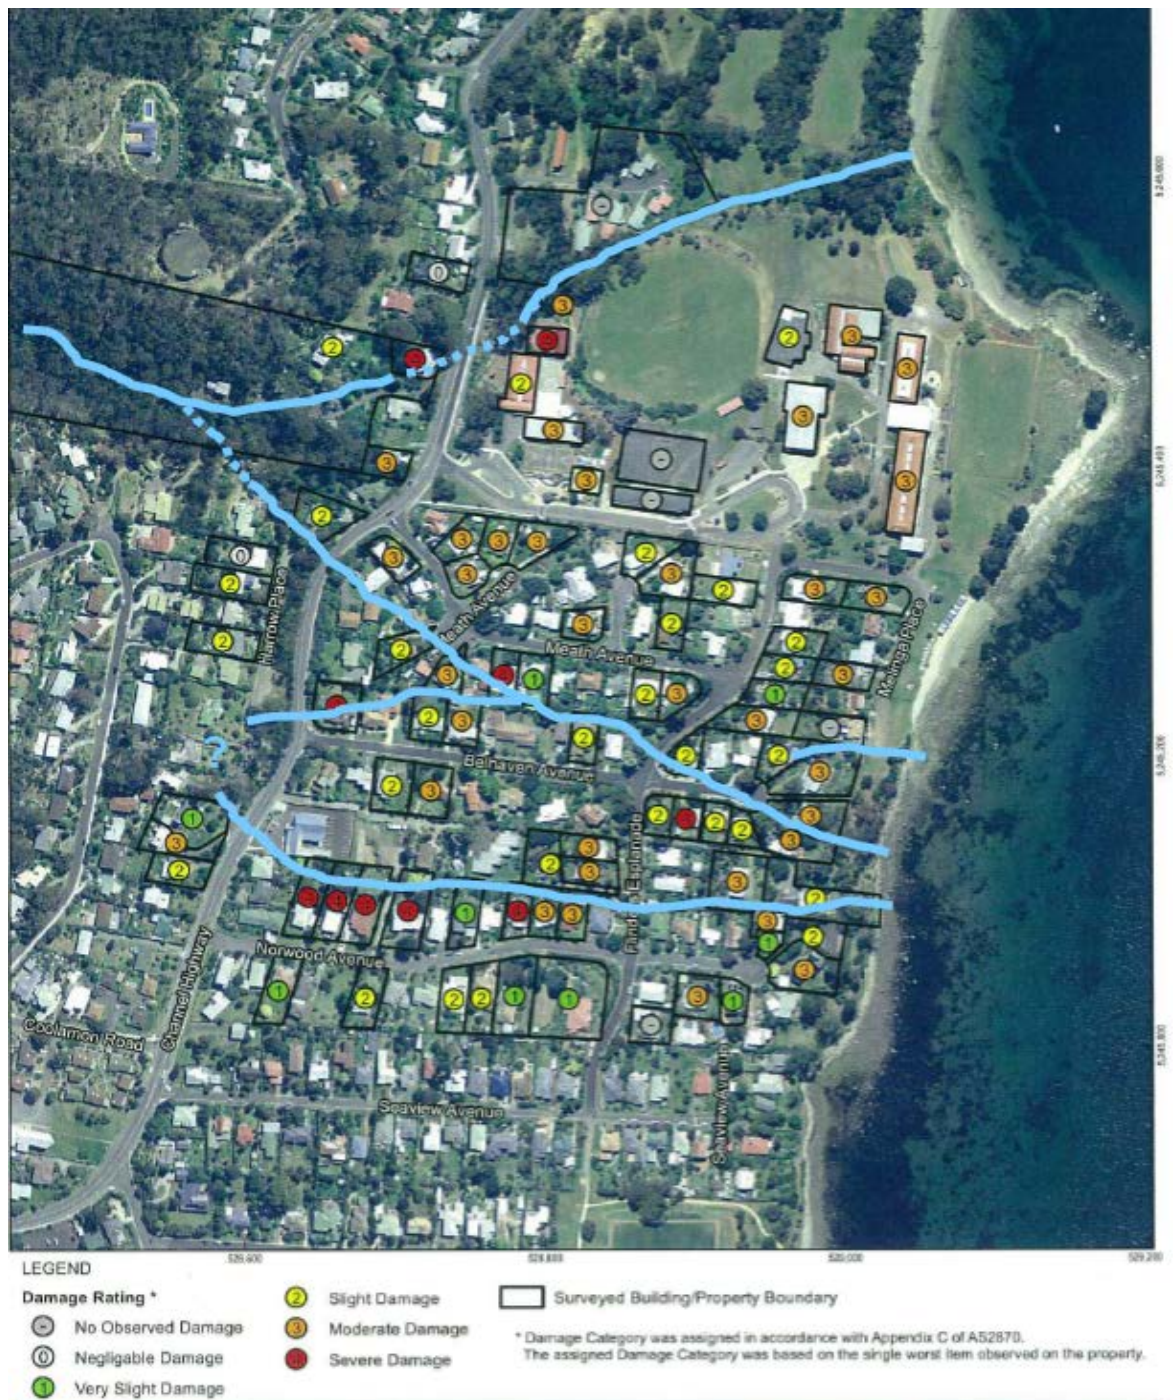
Aerial photographs from the 1940's reveal that prior to this development; several streams crossed the coastal plain below the steeper escarpment slope. In the vicinity of School Creek, these streams originated in the base of the steep gully that descends the escarpment slope immediately west of the point where School Creek crosses beneath the Channel Highway. The aerial photographic record shows that in developing the Taroona residential area some of these natural stream courses were filled in and residential streets and buildings constructed over the filled stream courses. The recent visual damage survey of buildings in the landslide area (see section 2.2.2 of this report) has assessed the damage of these buildings under five rating classes, from no damage through to severe damage. When the traces of the existing and former natural stream courses are superimposed on the plan of buildings examined, there is a strong correlation of former stream courses with buildings exhibiting severe and moderate damage. This correlation suggests that the observed building damage may in some part be due to ongoing long term settlement of poorly compacted fill within the former stream courses. Confirmation of this causal relationship would require more detailed investigation including sub-surface insitu material testing.

Figure 4 shows the location of the old stream paths overlaid onto the structural damage map.

Figure 4 Plan showing overlay of building damage survey results and infilled stream locations

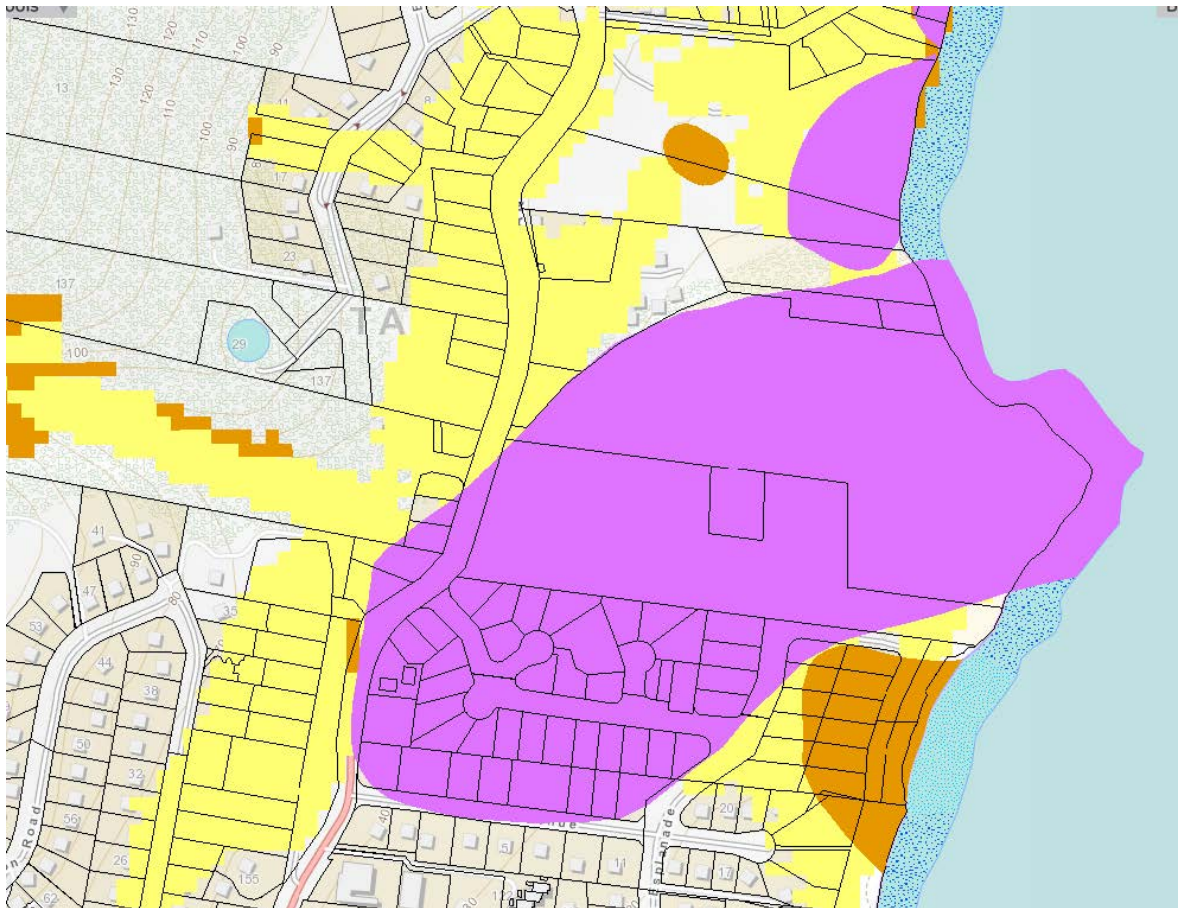
The Taroona Landslide Area is identified as being within the Medium Active Landslide Hazard Area on the planning scheme maps. Building and works within this area will generally require a landslide risk management report prepared by an suitably qualified person to demonstrate that the landslide risk associated with the buildings and works is either:

Figure 5 Landslide Hazard Bands, Kingborough Interim Planning Scheme 2014 (Source: The LIST)

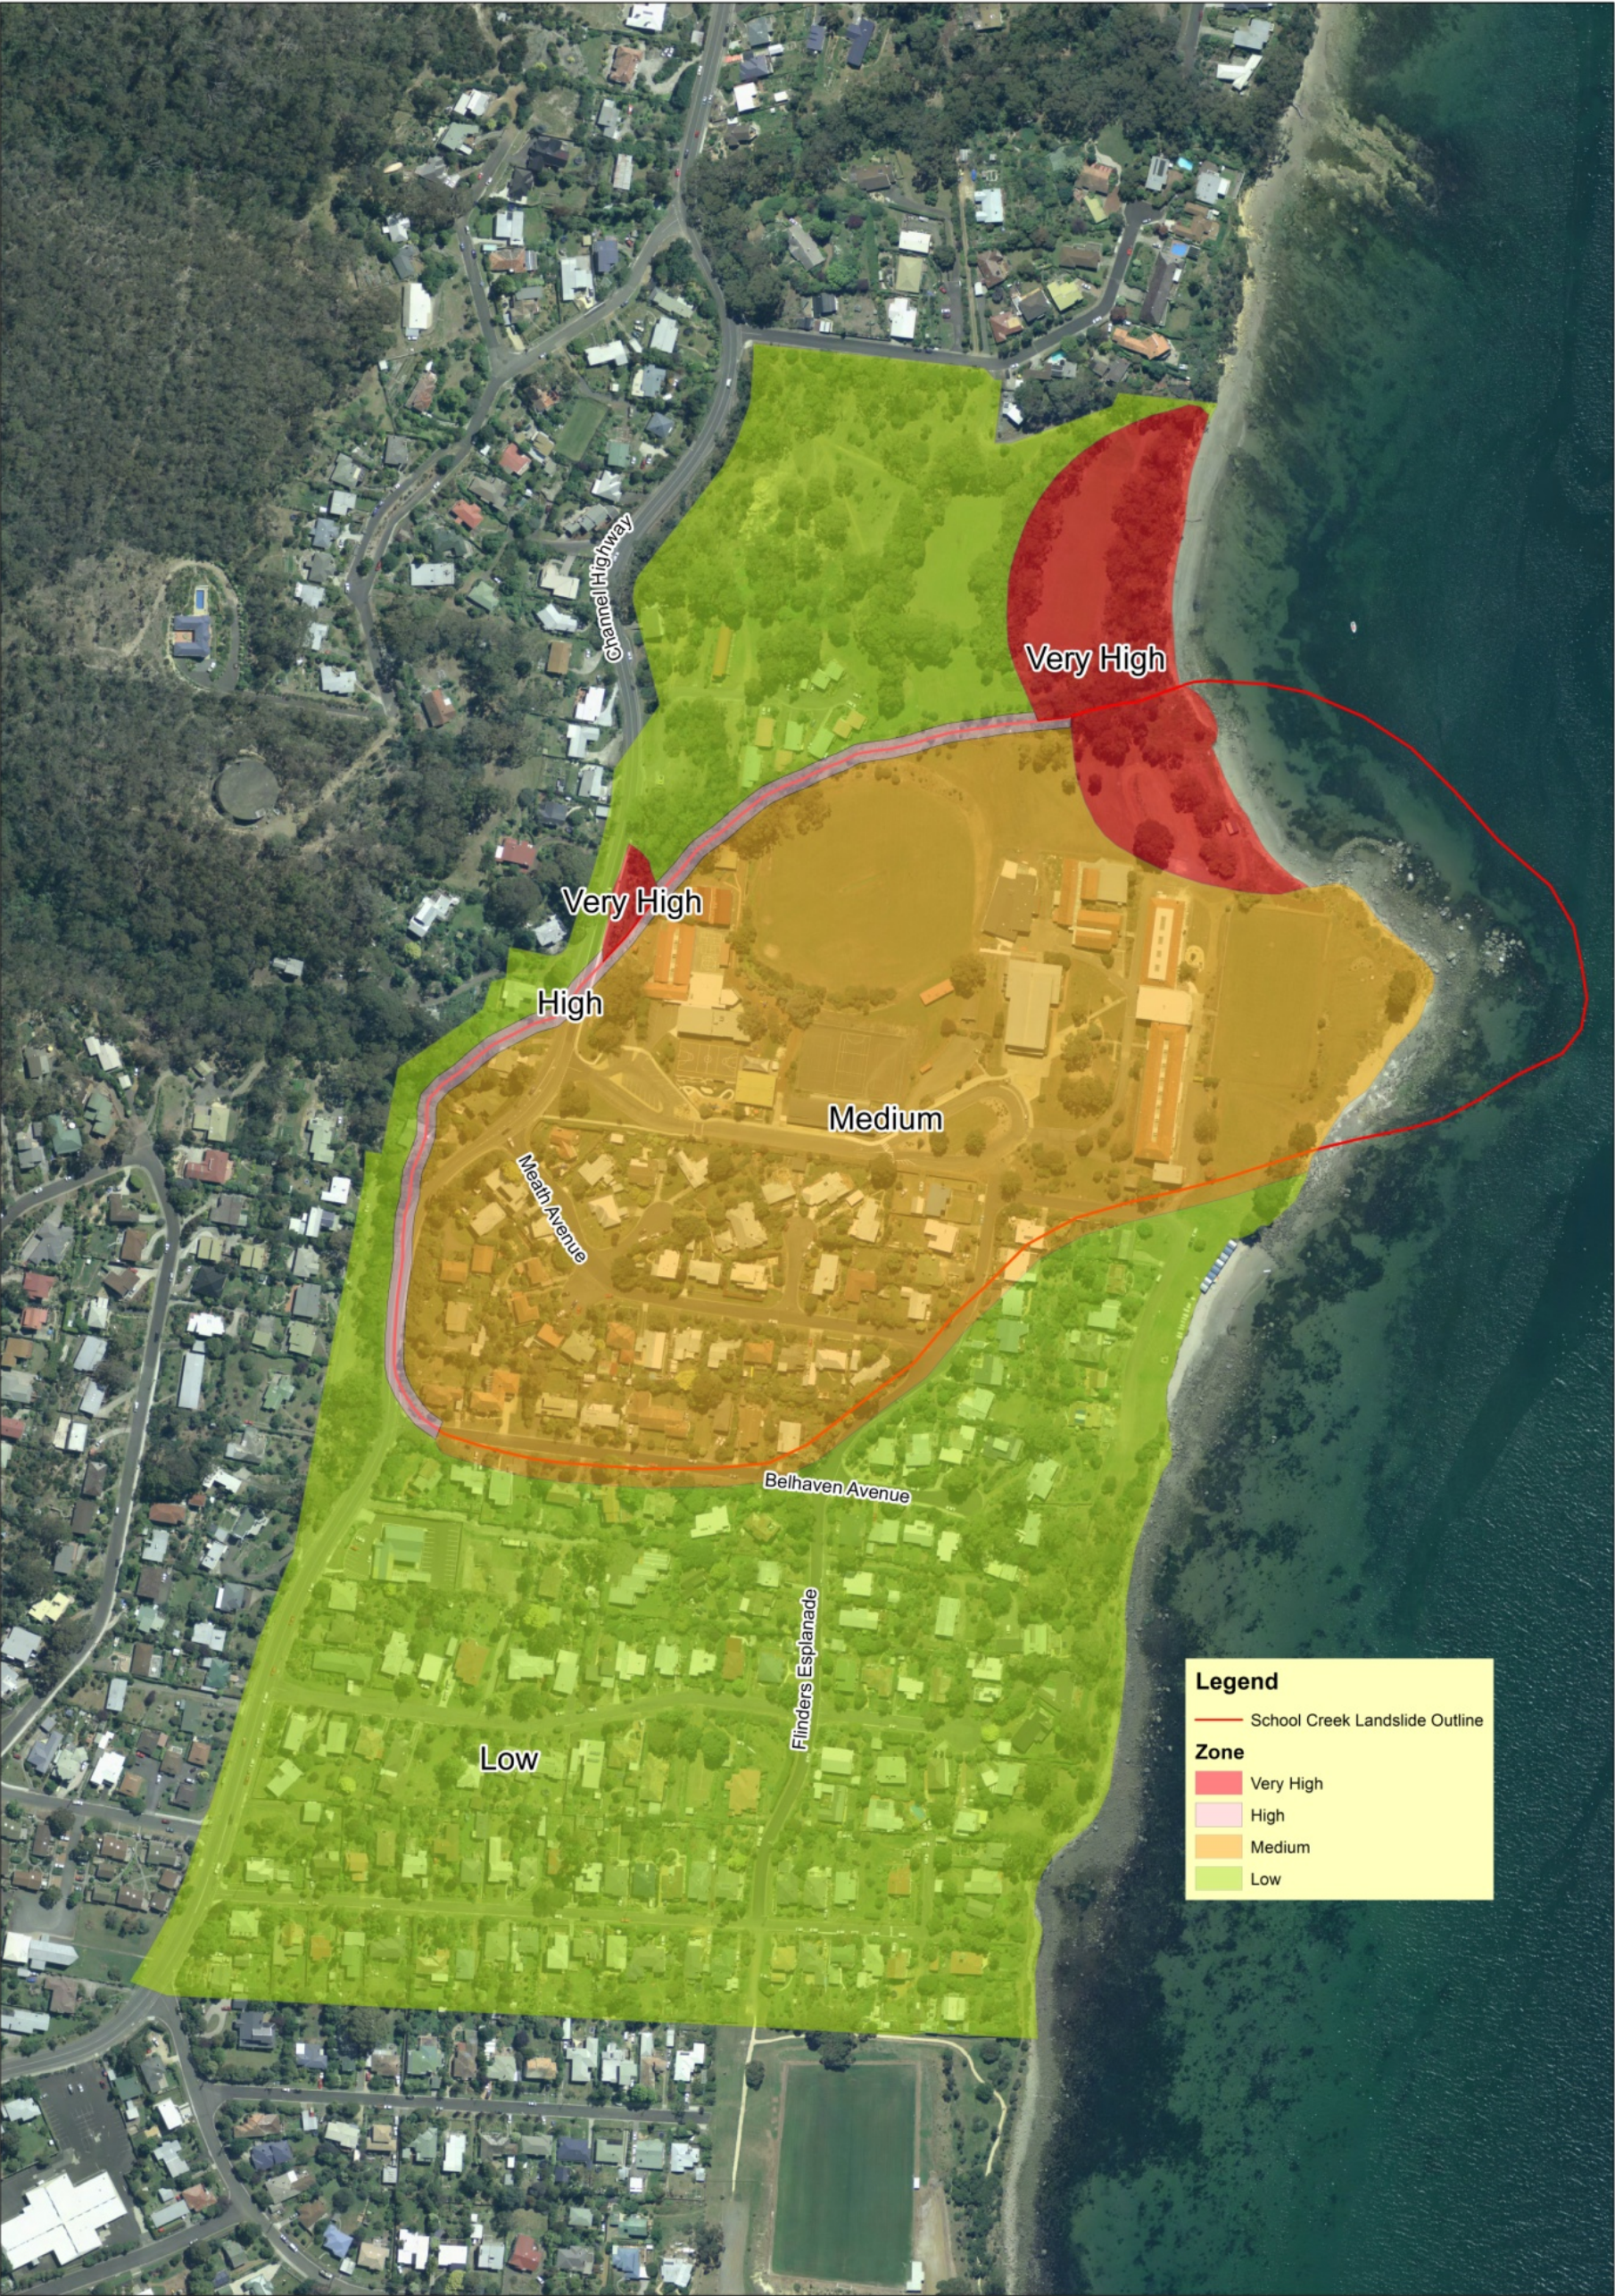
Appendix A - Site Plan showing Hazard areas

The identified hazard zone encompasses the area of the School Creek Landslide and is shown in Appendix A. It is noted that the definition of the area of the School Creek Landslide is based on sometimes widely spaced information and that some aspects of the extent of the landslide are poorly defined (e.g. the southern boundary of the landslide is not well understood).

In general, the higher hazard zones, where differential movements are most noticeable, encompass the boundary zones of the landslide, in particular the headscarp area. The headscarp area (whose boundary with the side scarps is poorly defined and conjectural) is regarded as the most hazardous, as differential movements recorded in this area are regarded as having the highest hazard. The correlation of movement in this area with rainfall, and the significant vertical component of the displacement vectors are typical of a headscarp regression of a landslide. These headscarp displacements are evidenced by the continued deformation of the Channel Highway at this location, and can be expected to continue as long term displacements accumulate.

The main body of the landslide is regarded as a medium level hazard zone where movement of the body of the landslide mass may occur, but differential movements will be less noticeable. The areas outside the main body of the landslide are regarded as forming a lower hazard area where differential movement is less likely.

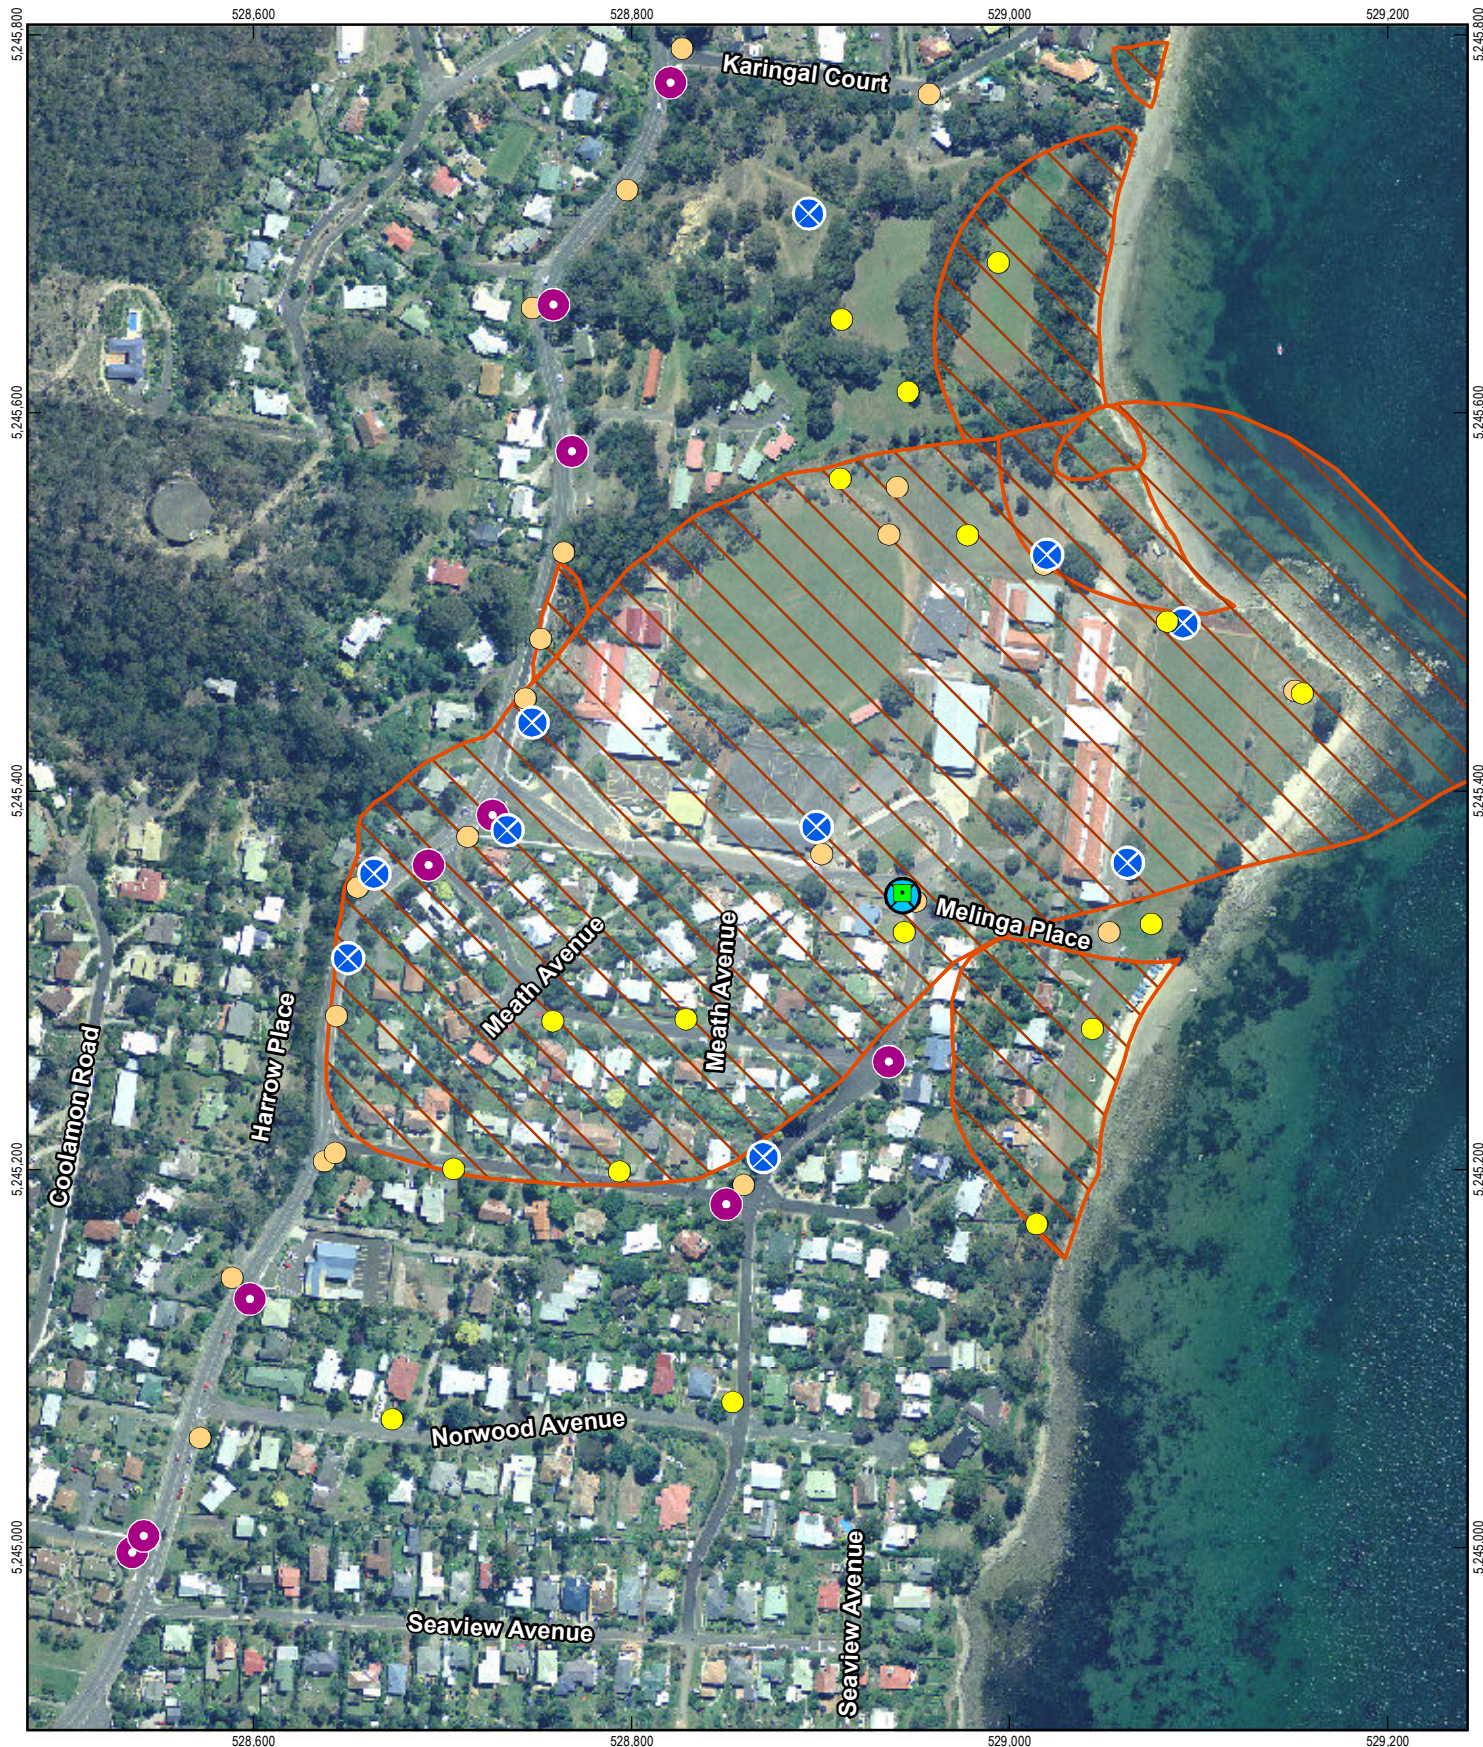
Appendix C – Site Plan - Instrumentation & Additional Survey Monitoring Points

In order to address this life-span issue, and to further our understanding of the landslide, two new boreholes were drilled near the intersection of Flinders Esplanade and Melinga Place in which an inclinometer casing and two piezometers have been placed. These are shown on Appendix C.

It is recommended that manual inclinometer readings be carried out annually.
