**KINGBOROUGH COUNCIL**

**BLACKMANS BAY BLOWHOLE AND ENVIRONS  
GEOTECHNICAL REPORT**

January 2020

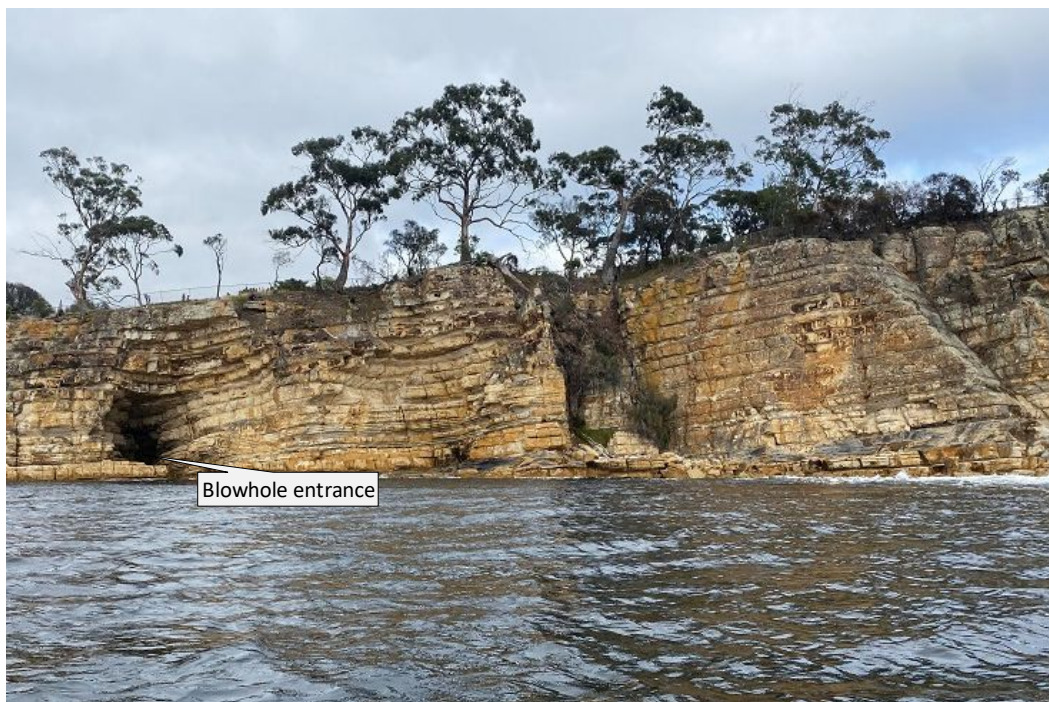
Figure 1. View west towards the southern part of the study area, showing well-bedded Permian-age siltstone, sandstone and mudstone dipping approximately 12° southwest.

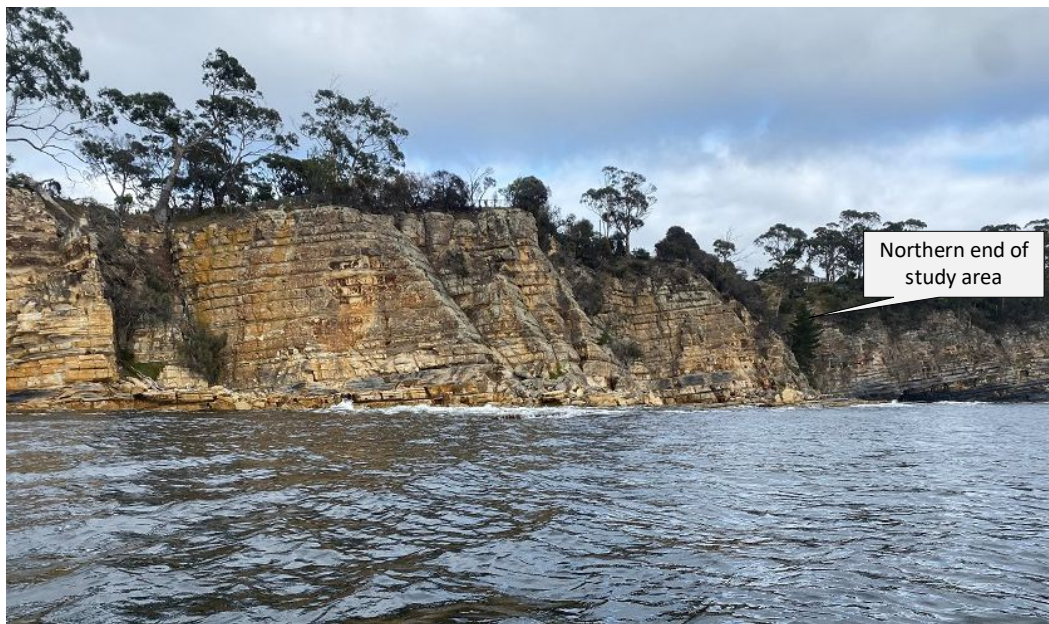
Figure 2. View northwest to the sea cliffs in the northern half of the study area, showing well-bedded Permian-age siltstone, sandstone and mudstone dipping approximately  $12^{\circ}$  southwest

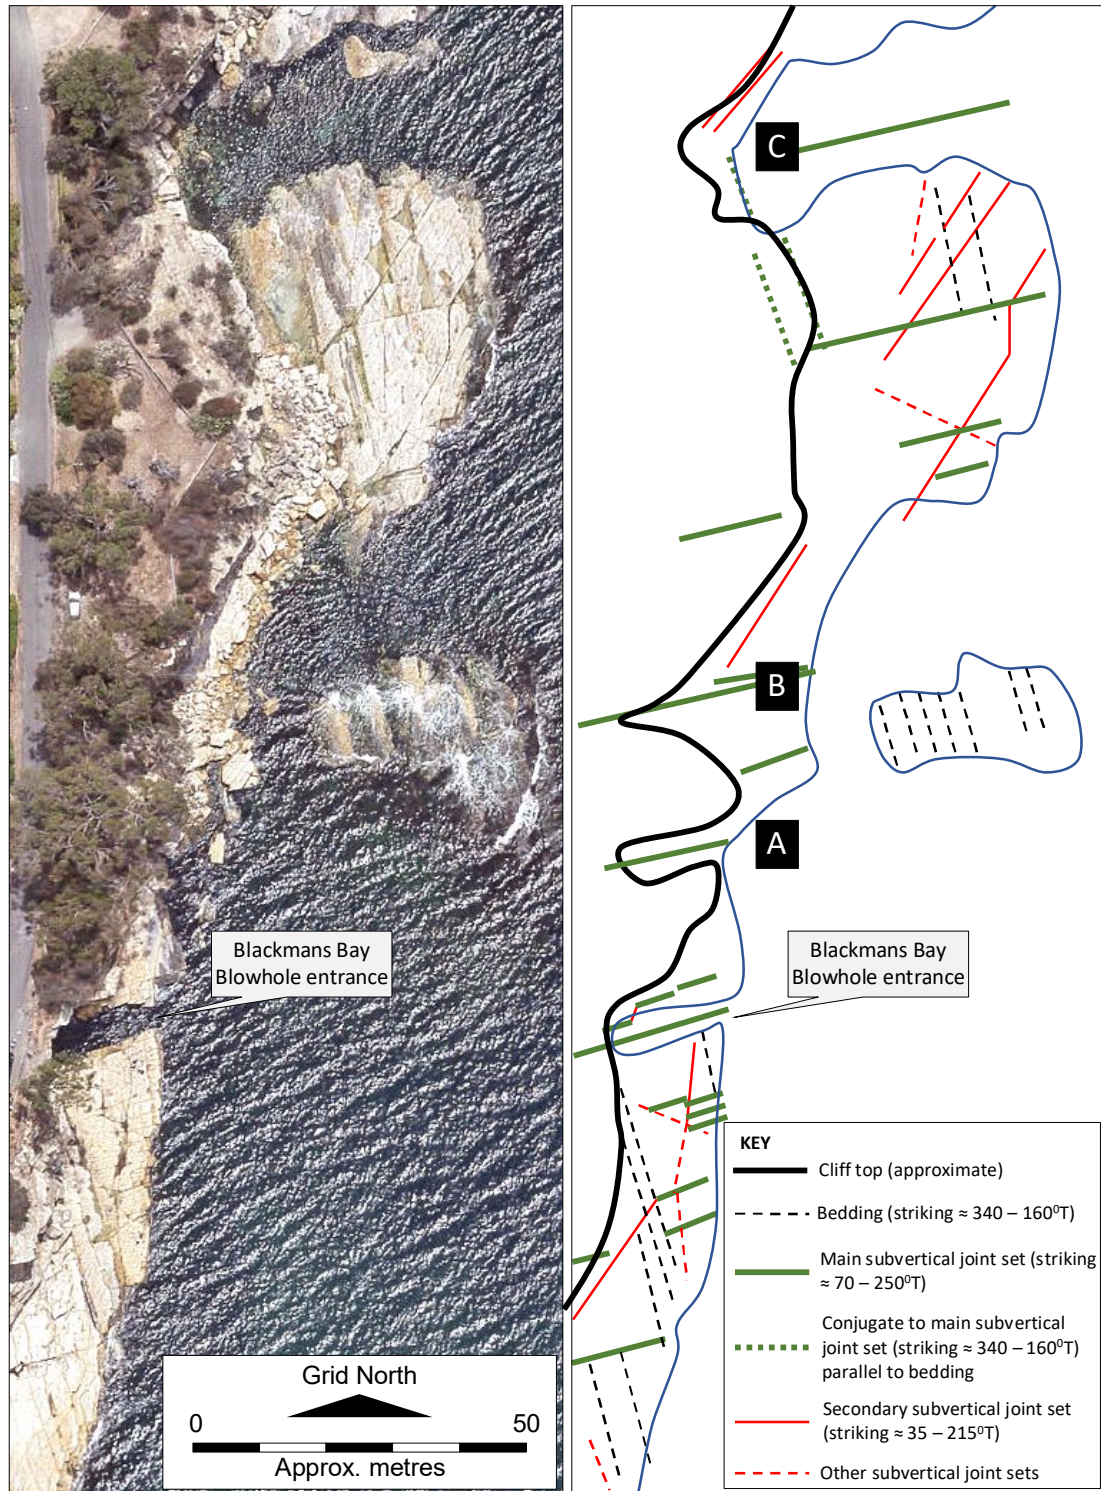
Figure 3. The dominant joint direction along the sea cliffs in the study area is approximately  $70 - 250^\circ\text{T}$ . These are subvertical, and marine erosion along some of them has produced the blowhole and its mouth, and re-entrants A, B and C shown here. See also the photographs in Attachment 3.

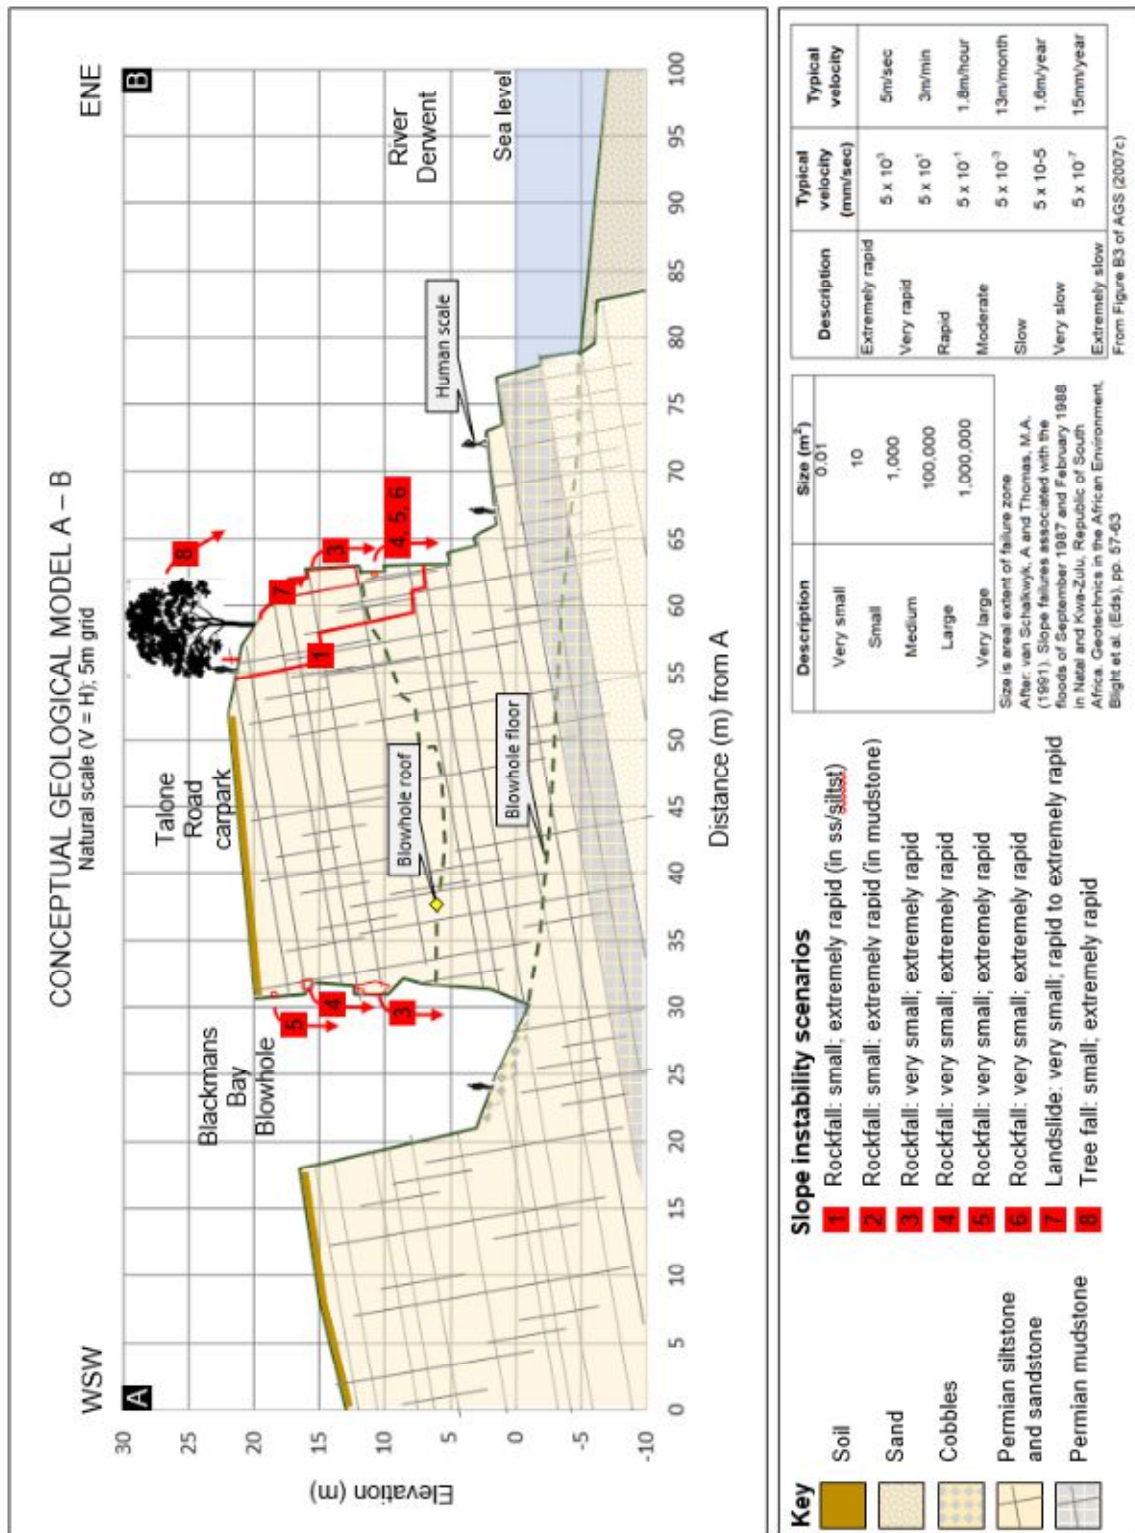
Figure 5. Conceptual geological cross section A – B through the Blackmans Bay Blowhole, showing the types, and nominal sizes and speeds, of identified geotechnical hazards. Note the human scale, which is different to that in Figure 6. See Figure 7 for the location of the cross section.

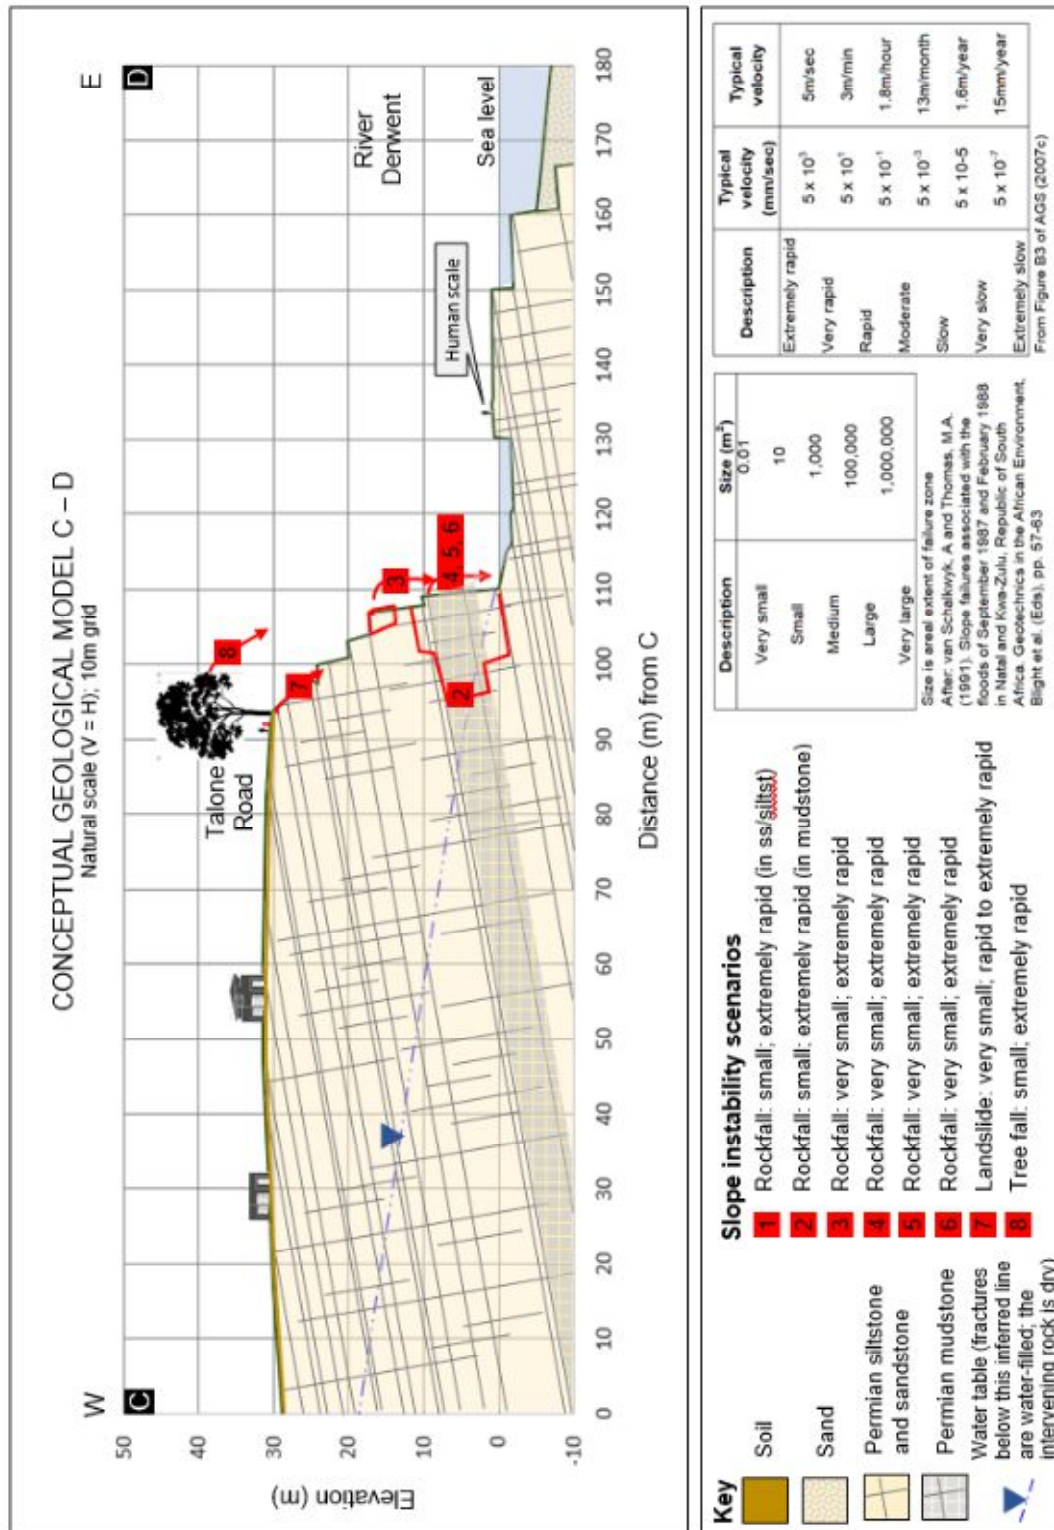
Figure 6. Conceptual geological cross section C – D roughly through the centre of the study area, showing the types, and nominal sizes and speeds, of identified geotechnical hazards. Note the human scale, which is different to that in Figure 5. See Figure 7 for the location of the cross section.

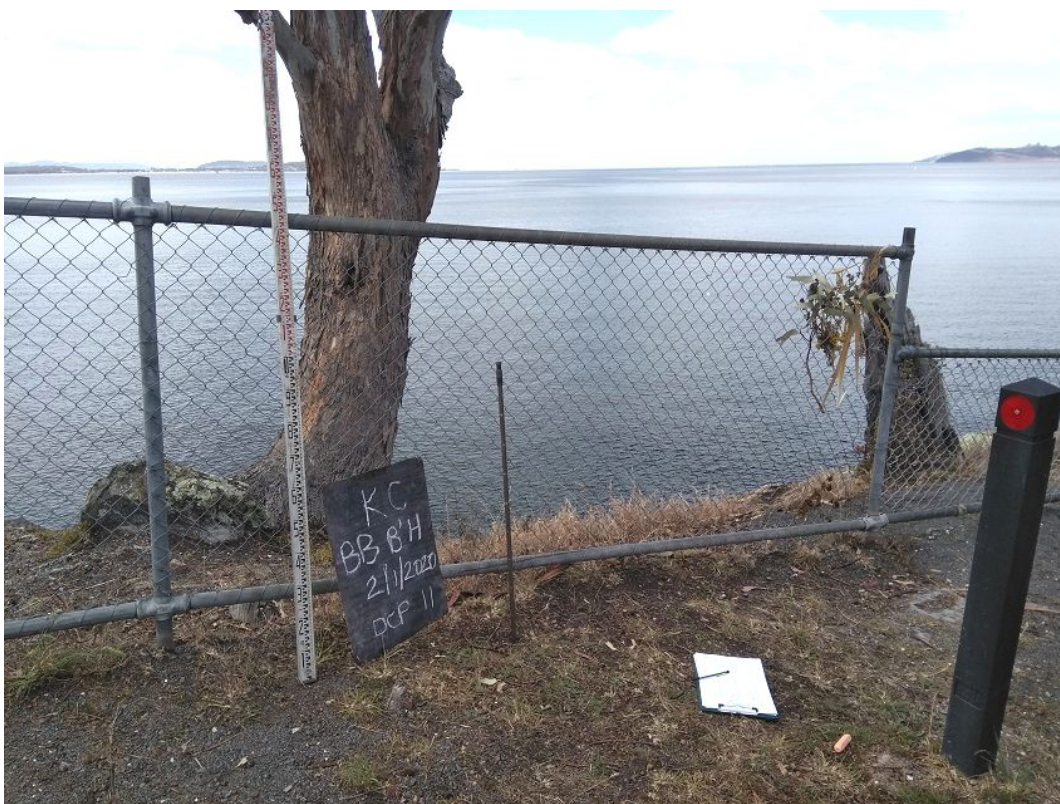
Figure 8. Different heights of the cyclone fence at the Talone Road carpark opposite the Blackmans Bay Blowhole (at DCP11). At left, the fence is 1.4m high; at right, about 0.9m. Abseilers anchor from this location. Anecdotal, an old couch was positioned at one time over the fence at left.

Local residents say the fence is several decades old. Some of the posts are slightly loose. Apart from its variable height, its condition is fair.

IPM has recommended the fence be upgraded. It is suggested here that if it is replaced, it should be of uniform height and material type. A minimum height of 1.2m is suggested as reasonable (there are likely to be objections from local residents if it any higher, and height is not a serious deterrent to people intent on scaling it).

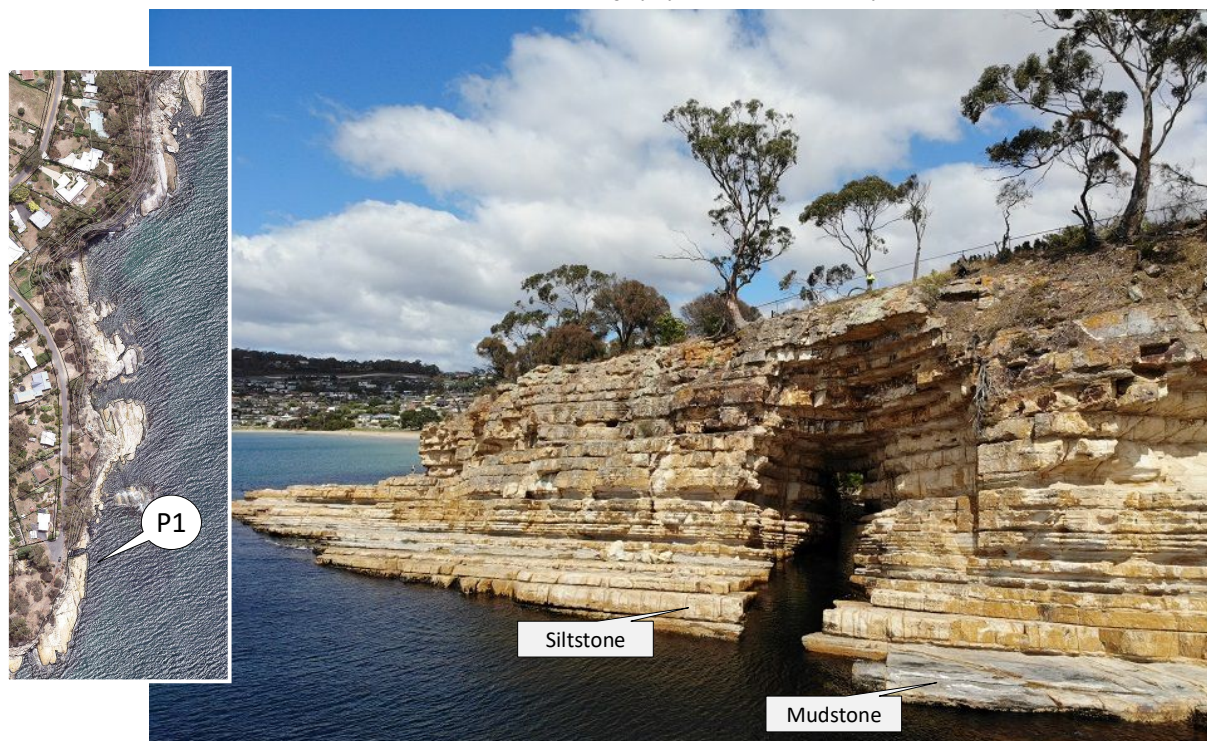
Plate 1 (above). View WSW towards the mouth of the Blackmans Bay Blowhole. The Permian sedimentary rocks dip at about  $12^{\circ}$  away from the camera. The shore platform is devoid of fallen rocks (removed by wave action).

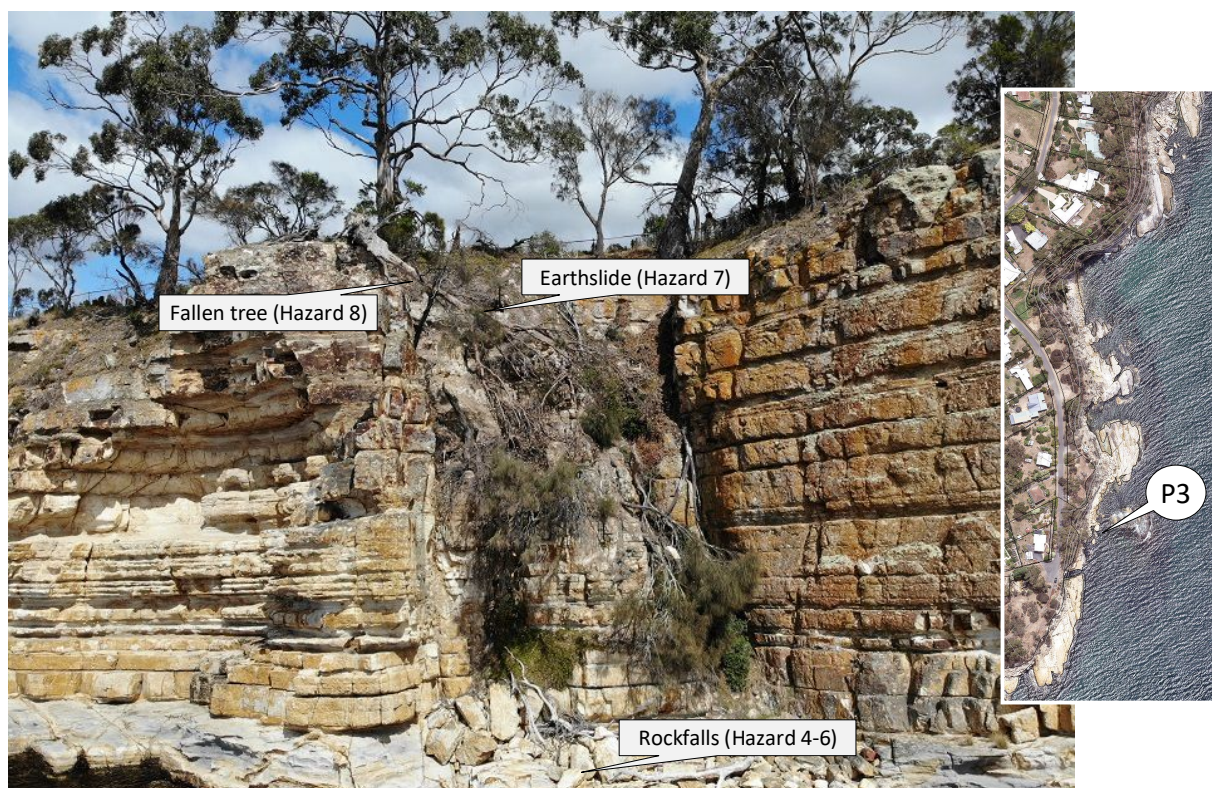
Plate 3 (above). View WSW towards a major set of subvertical joints trending in the same direction.

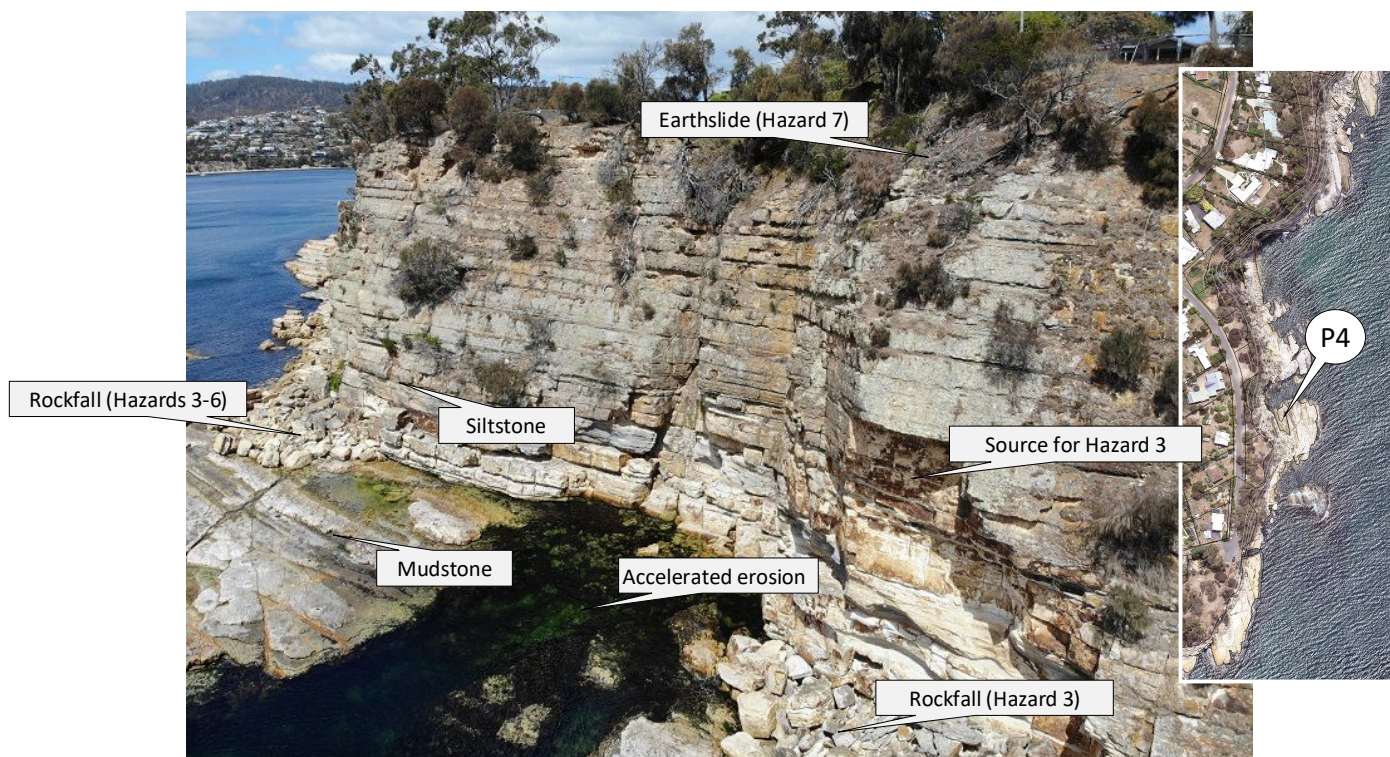
Plate 4 (below). View SSW. Note rockfalls, and accelerated marine erosion WSW along major joints

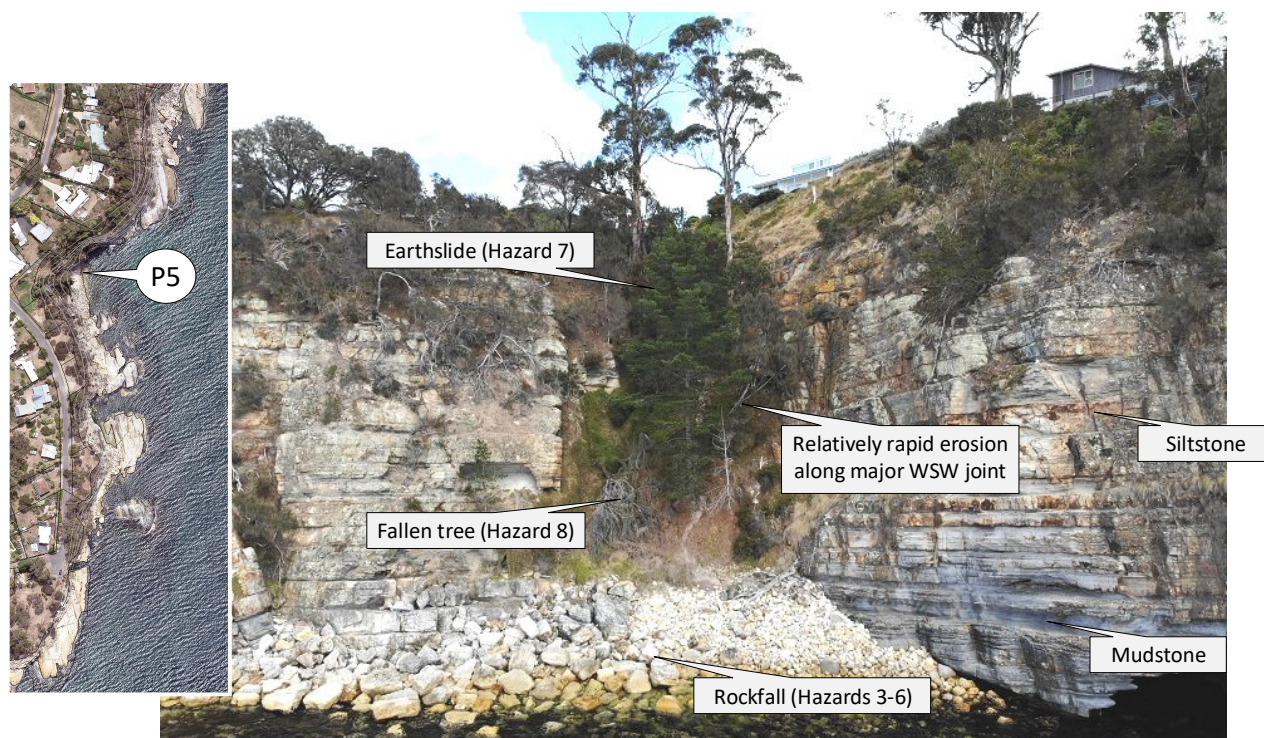
Plate 5 (above). View W towards a major set of subvertical joints trending WSW. Boulder (ie joint spacing) is smaller than elsewhere along the cliff line.

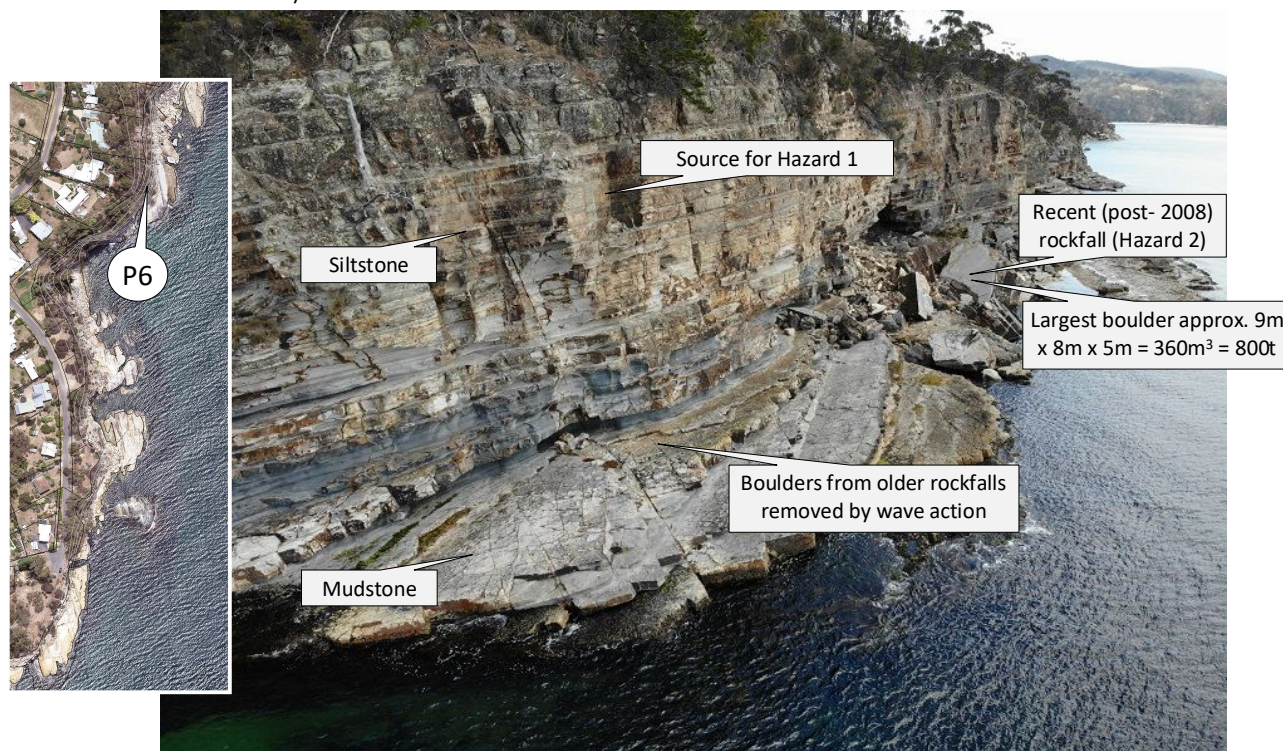
Plate 6 (below). View N. A major rock fall involving mostly mudstone occurred since March 2008 (see Attachment 4).

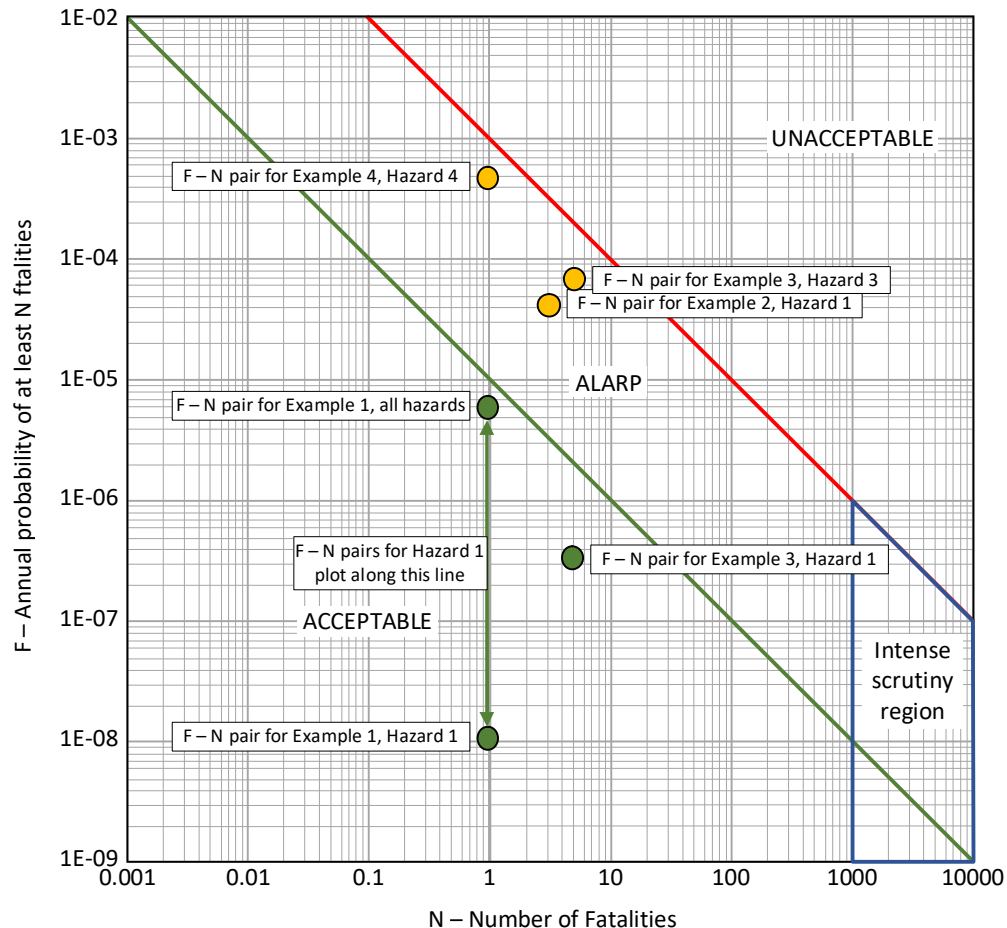
The F- N pair for hazard 4 for this individual most at risk plot on the ALARP region of the societal risk graph (Figure 6.4).

Figure 6.4 Societal risk graph for risks to life estimated for Examples 1 – 4 in the study area. The acceptability shown here of the risks is for guidance only and is based on AGS2007c Section 8 Table 1 reproduced here in Figure 6.5. Kingborough Council as regulator should assess the acceptability of the risks against its own organisational criteria.
