## Kingborough Council

### Public Safety Risk Assessment Report

### Blackmans Bay Cliff

October 2019

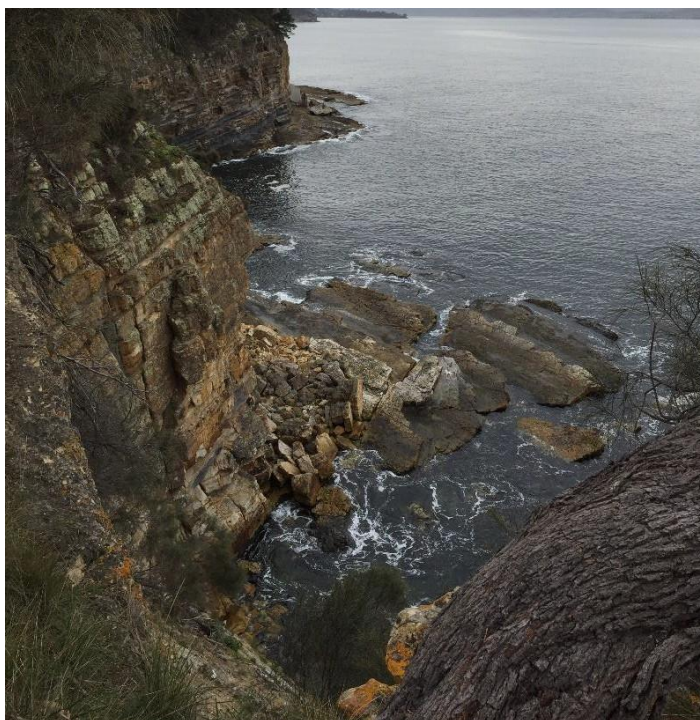
*Photo 1: Section of cliff face*

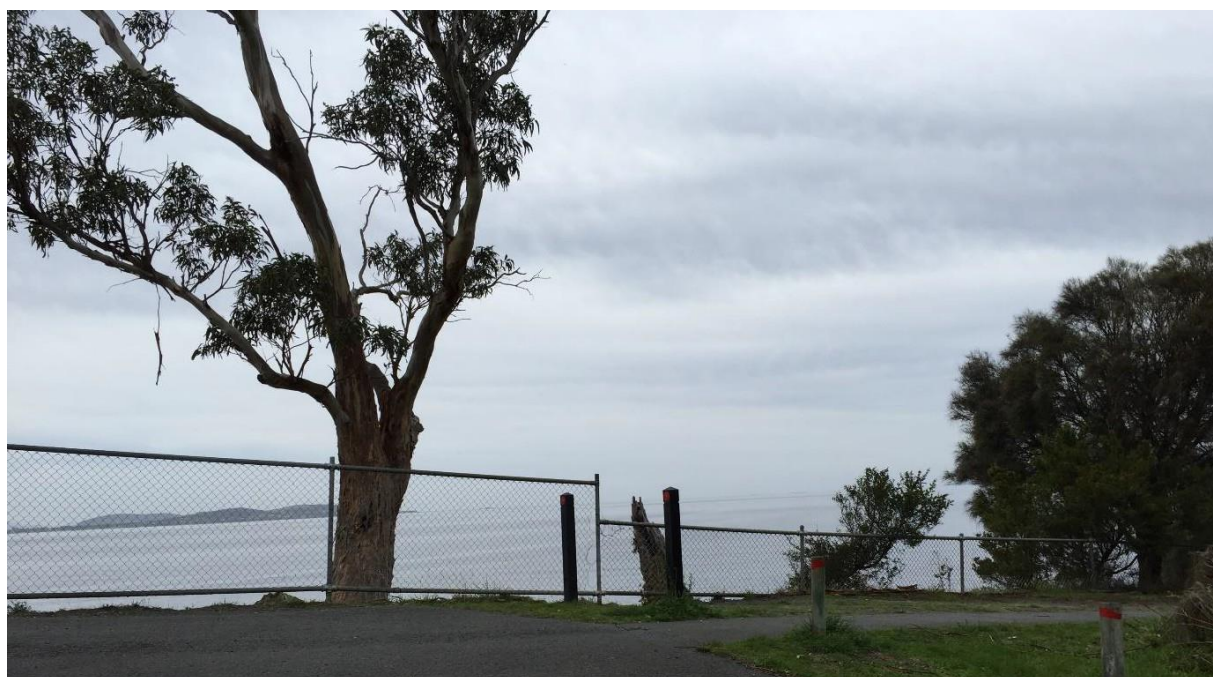
The main risk, a fall from the cliff resulting in death, was rated as a significant risk based on the historical data of incidents and the current controls that are in place; inconsistent fencing and the inadequate warning signage.

*Photo 2: Two standards of fencing*

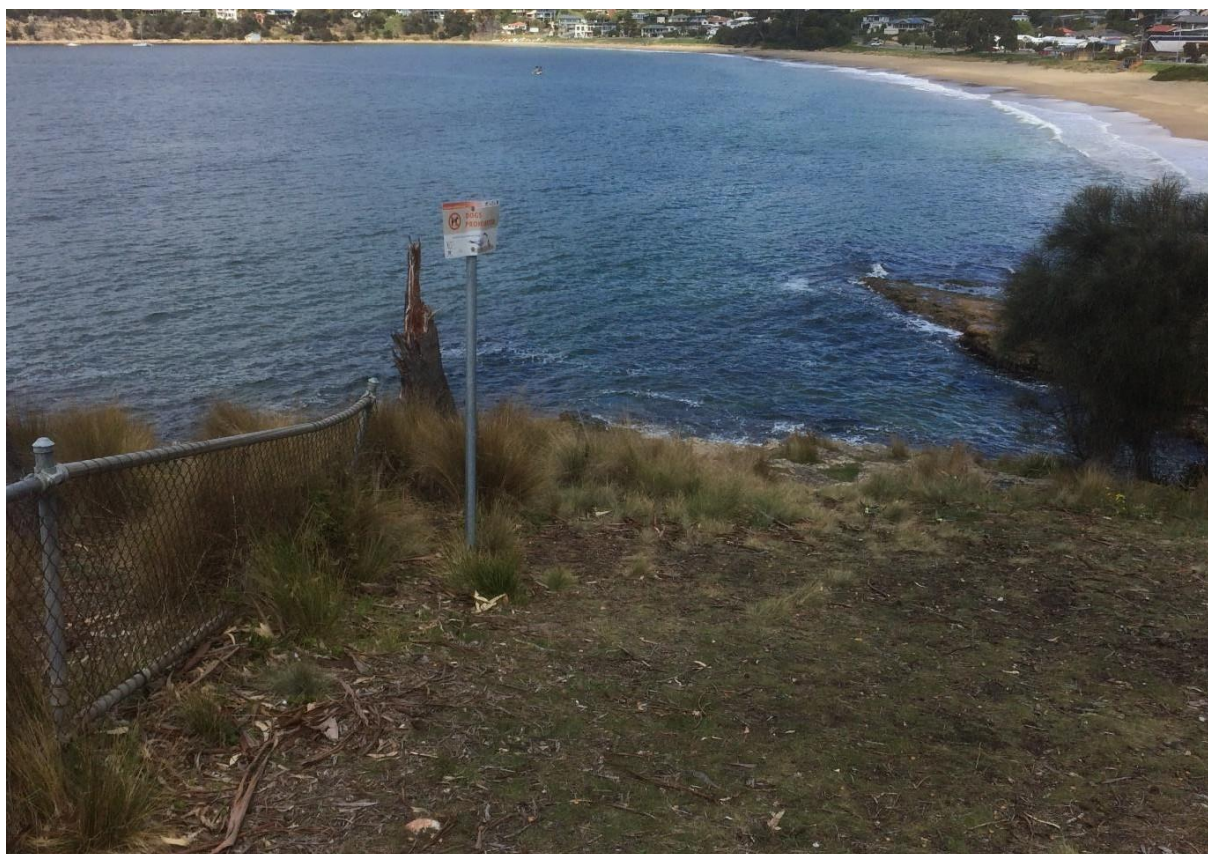
*Photo 3: Fence in Blowhole Reserve*

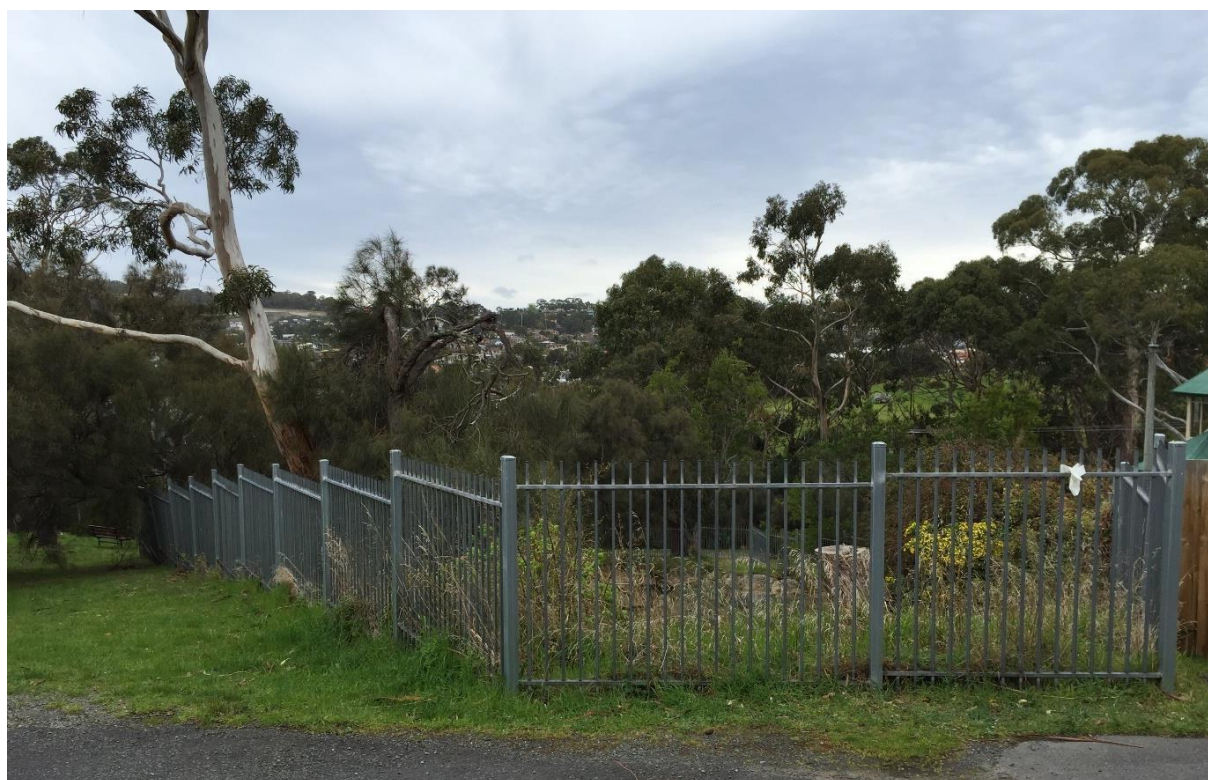
The additional risk identified was the potential to fall over the blowhole edge. This location has a larger fence (about 1.8m - see Attachment 3 – Photo 4) surrounding the blowhole and does not have the same appeal for risk-takers and is not used by abseilers therefore it was rated as a slightly lower risk and the controls were deemed adequate.

*Photo 4: Blowhole Fence*

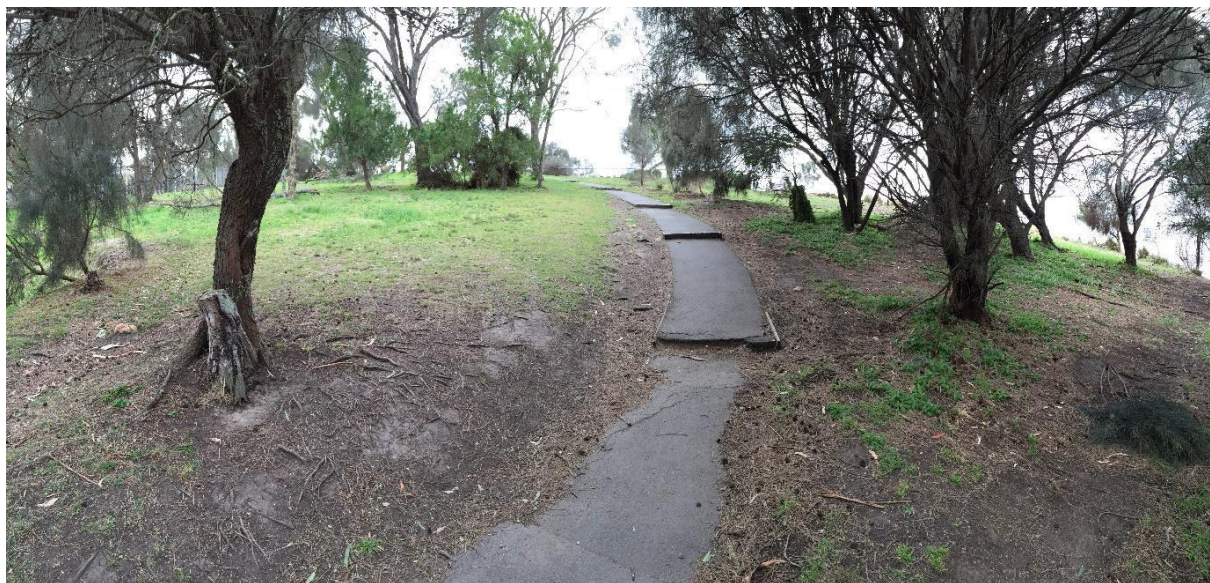
An additional control to improve the quality of the paved pathways within the park was included to reduce the risk of a trip hazard due to the uneven paths (see Attachment 3 - Photo 5)

*Photo 5: Pathway in Blowhole Reserve*

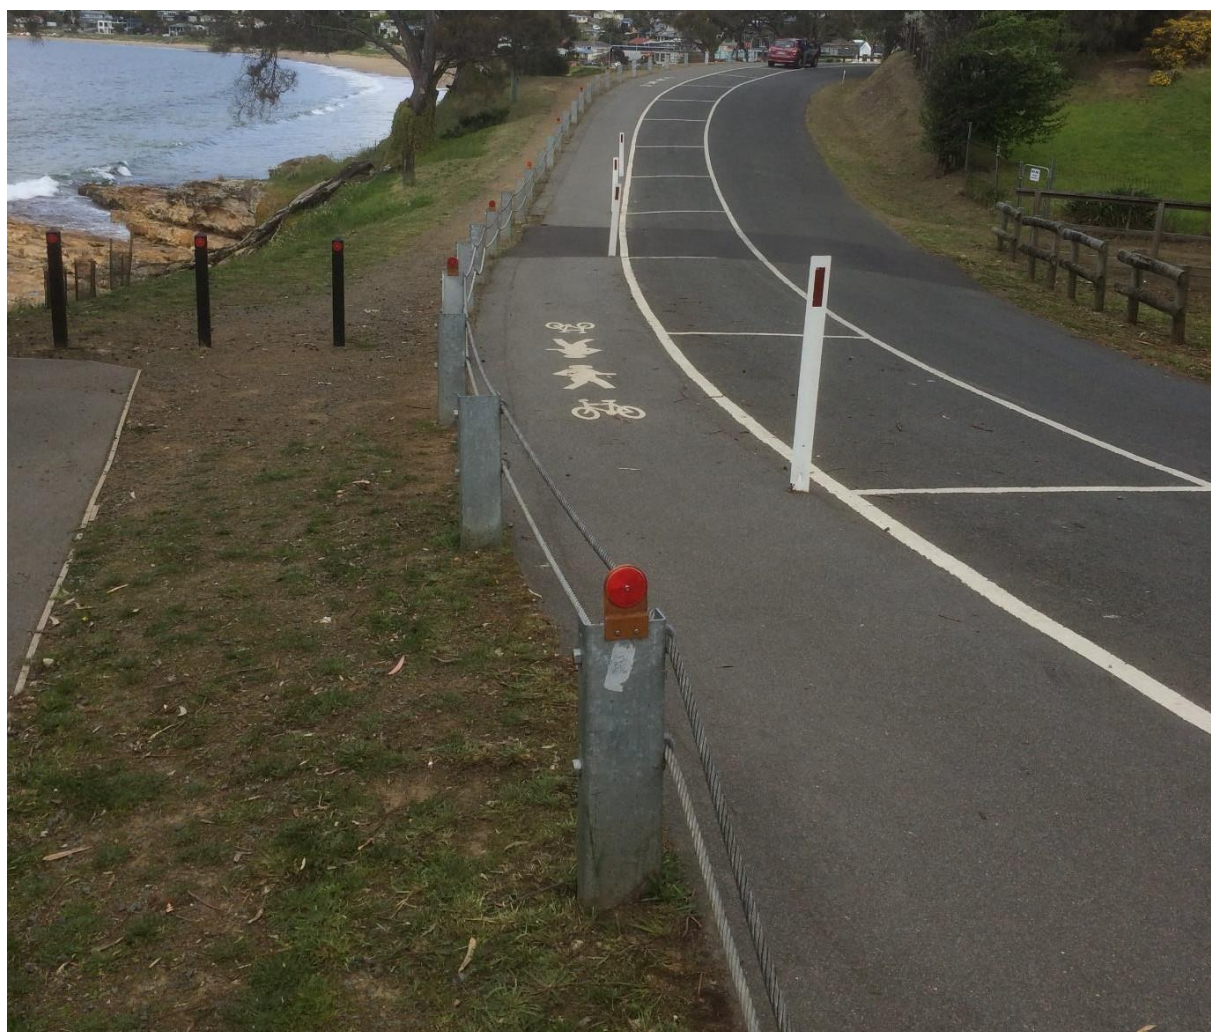
Firstly, the risk of the proximity of cars to pedestrians and cyclists (see Attachment 3 – Photo 6) which was rated moderate. It is recommended that the pedestrian and vehicular interface is redesigned to provide a physical barrier between pedestrians and vehicles.

*Photo 6: Blowhole Road – Pedestrian / vehicle interface*

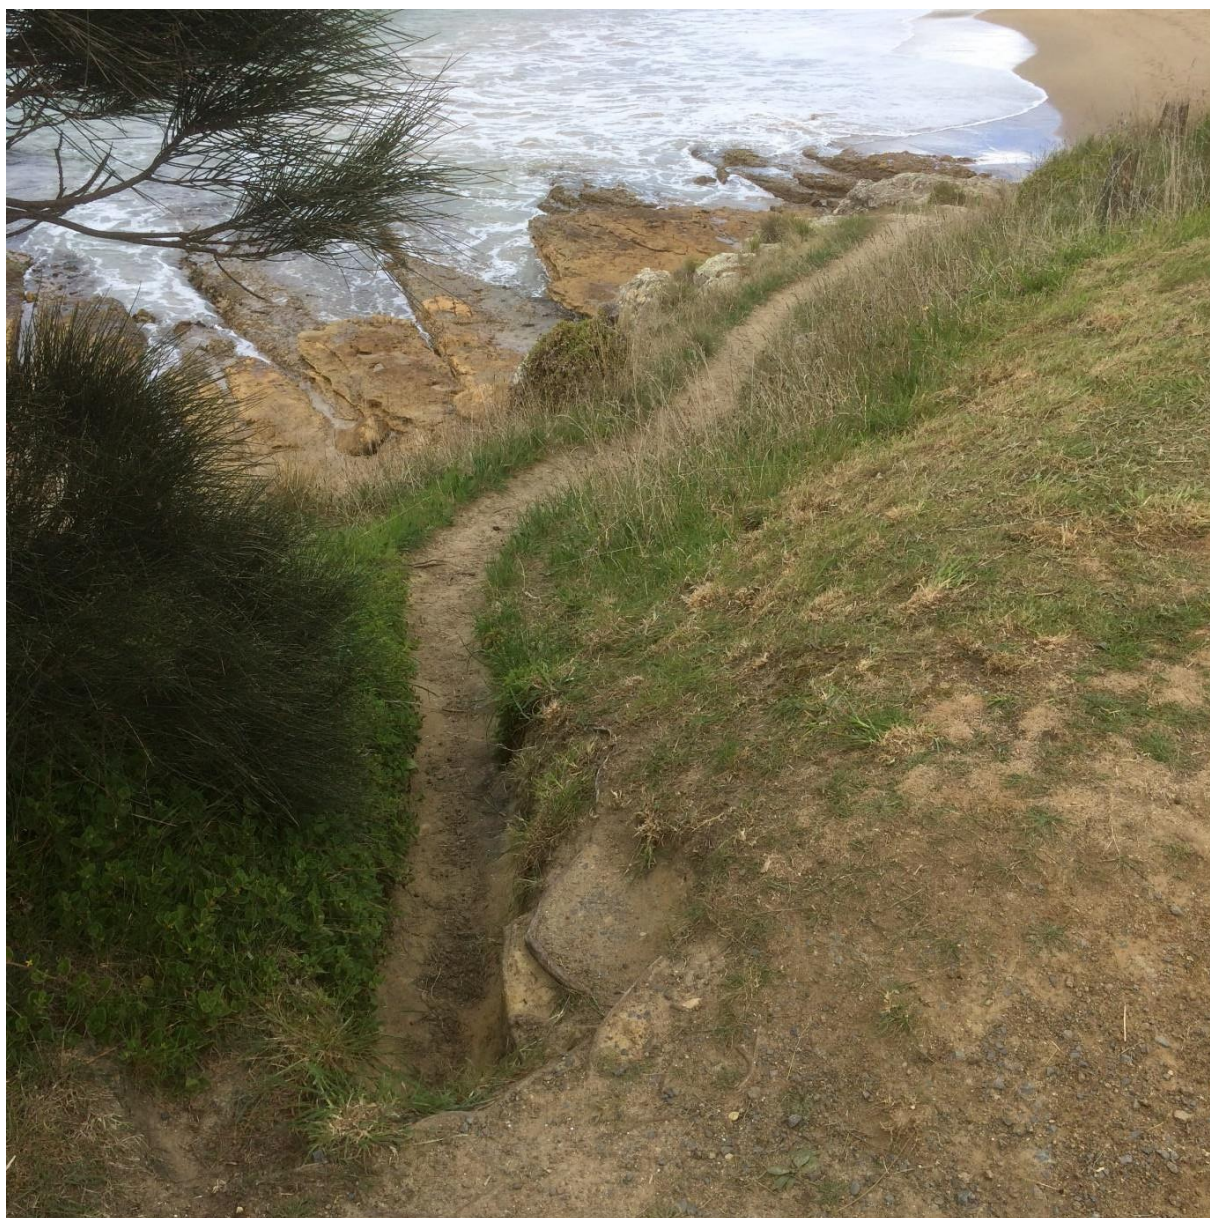
Secondly, there was a risk of slip or trip when using the unofficial path to beach (see Attachment 3 – Photo 7), this was also rated moderate. One of the causes for the use of this path was thought to be the lack of a physical barrier between vehicle and pedestrians on the current path, therefore a redesigned pedestrian and vehicular interface may go part way to alleviating this risk. Further controls identified were to install a path and stairs in this location to provide for better access or install a vegetation barrier to prevent access.

The unofficial pathway from Blowhole Road to the beach presents a slip/trip/fall hazard to the public. A staircase is recommended to provide a lower risk access for this trail. However, it is noted that the natural resource management authority, NRM South, may not allow the construction of a path and stair in this location due to concerns over penguin access.

*Photo 7: Unofficial path from Blowhole Road to beach*

If the path and stairs are not permitted, it is recommended that the alternative is the installation of a dense vegetation barrier to prevent access.
