# SUNCOAST HEADLAND TRACK BLACKMANS BAY

## GEOTECHNICAL REPORT

AUGUST 2020

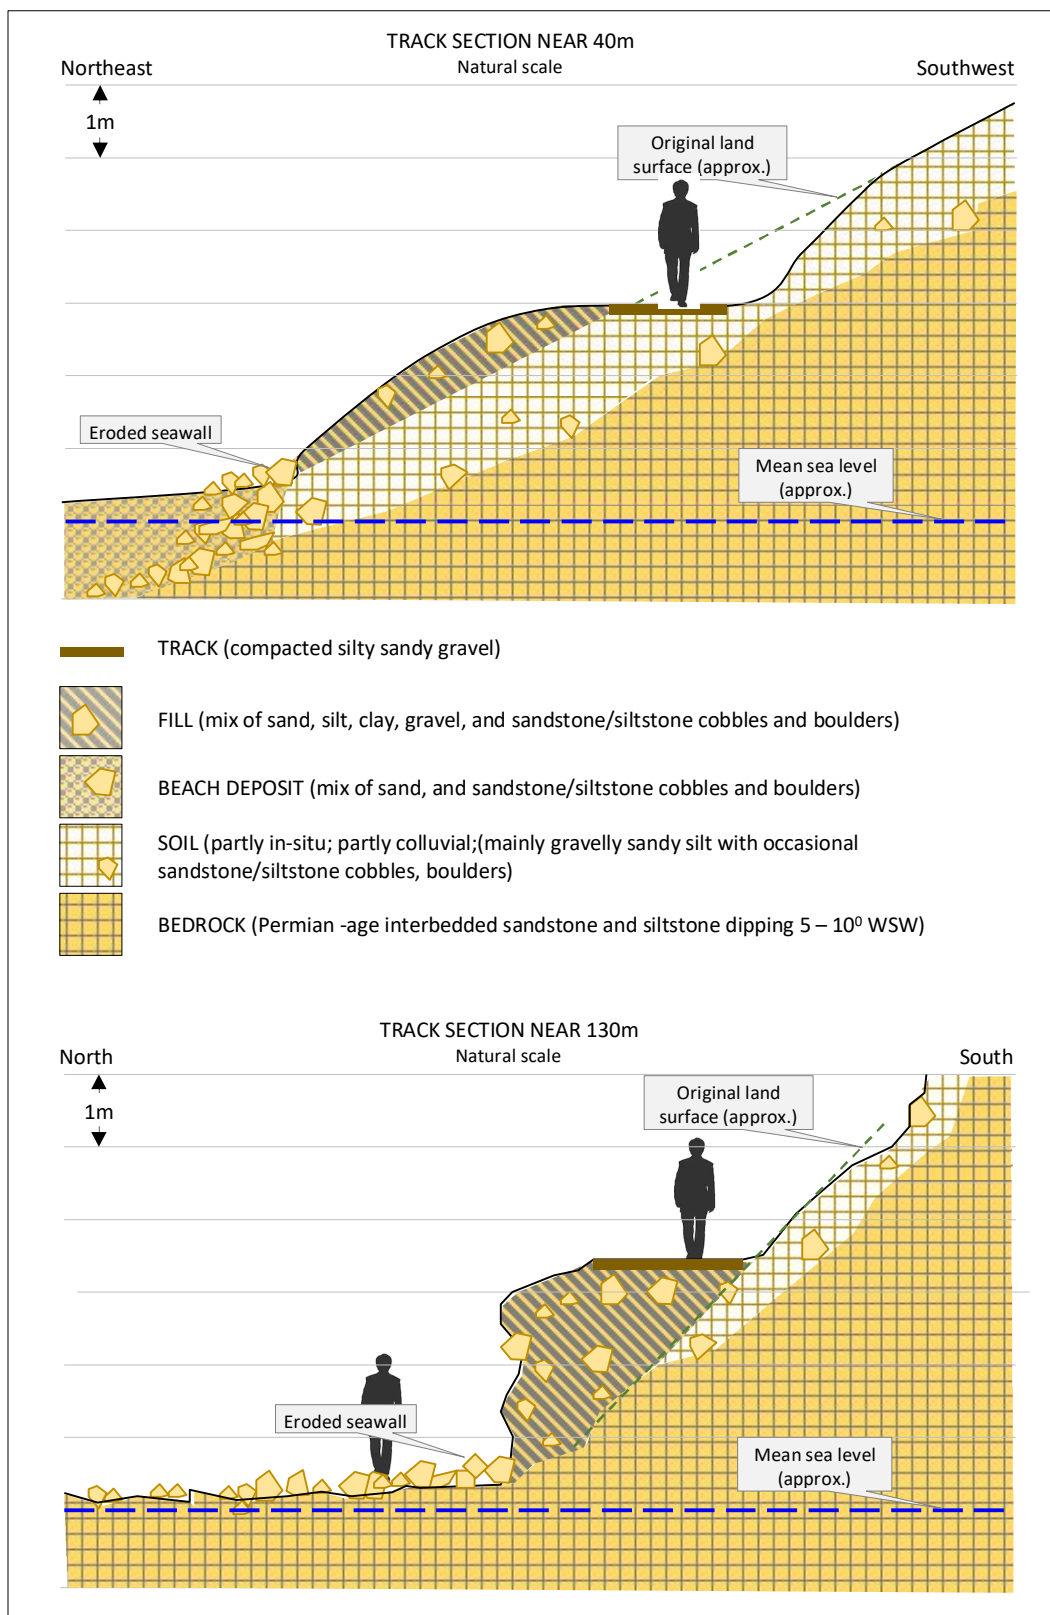
During track construction, fill was placed along the outer edge of the track along its full length (0 – 170m). To about chainage 40m or so, it is not clear whether the track has been cut in and rests on original soil and/or bedrock, but after about 40m, it is inferred that the track is built largely on fill (Figure 1).

Figure 1. Interpreted geological cross sections at natural scale through the Suncoast Headland Track near chainages 40m and 130m.

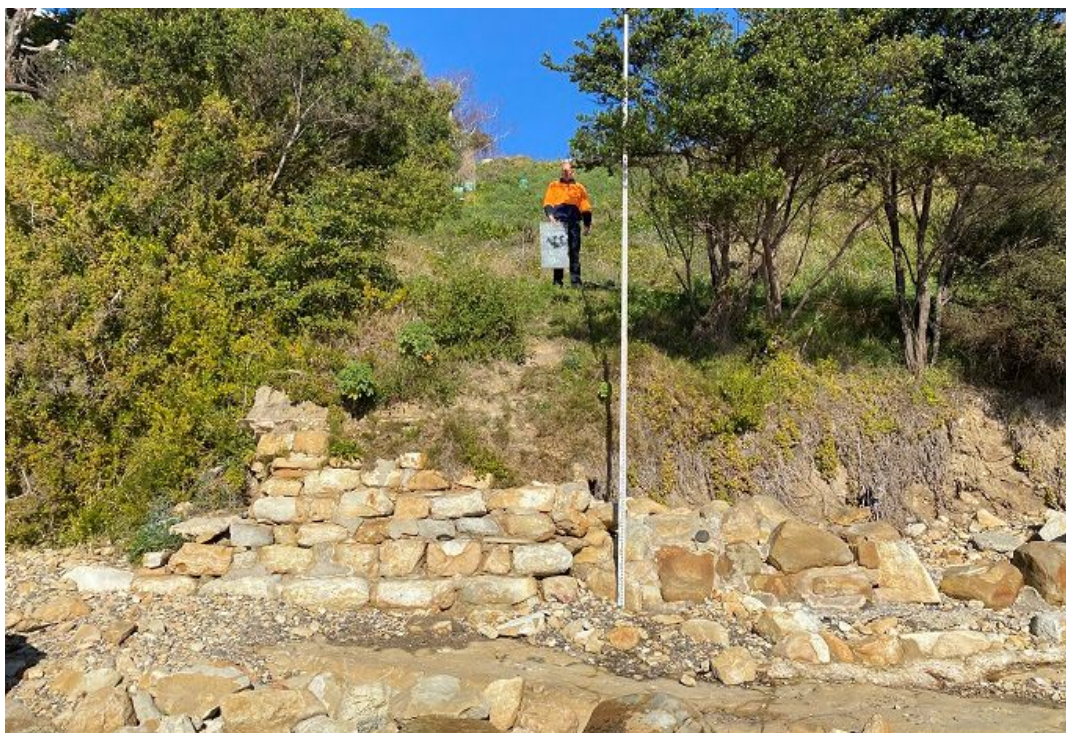
Remnants of a mortared sandstone block seawall are scattered near high water mark almost the full length of the track (Figure 2).

Figure 2. The mortared sandstone seawall originally protected almost the full 170m of track described in this report. It contains sandstone blocks ranging in length from about 0.2 – 0.6m, and about 0.25m wide and high (approx. 20 – 100kg). Wave action has destroyed almost of it. The staff is 5m high.

The gabion wall should extend from 0m to 170m, replacing the former sandstone block wall.

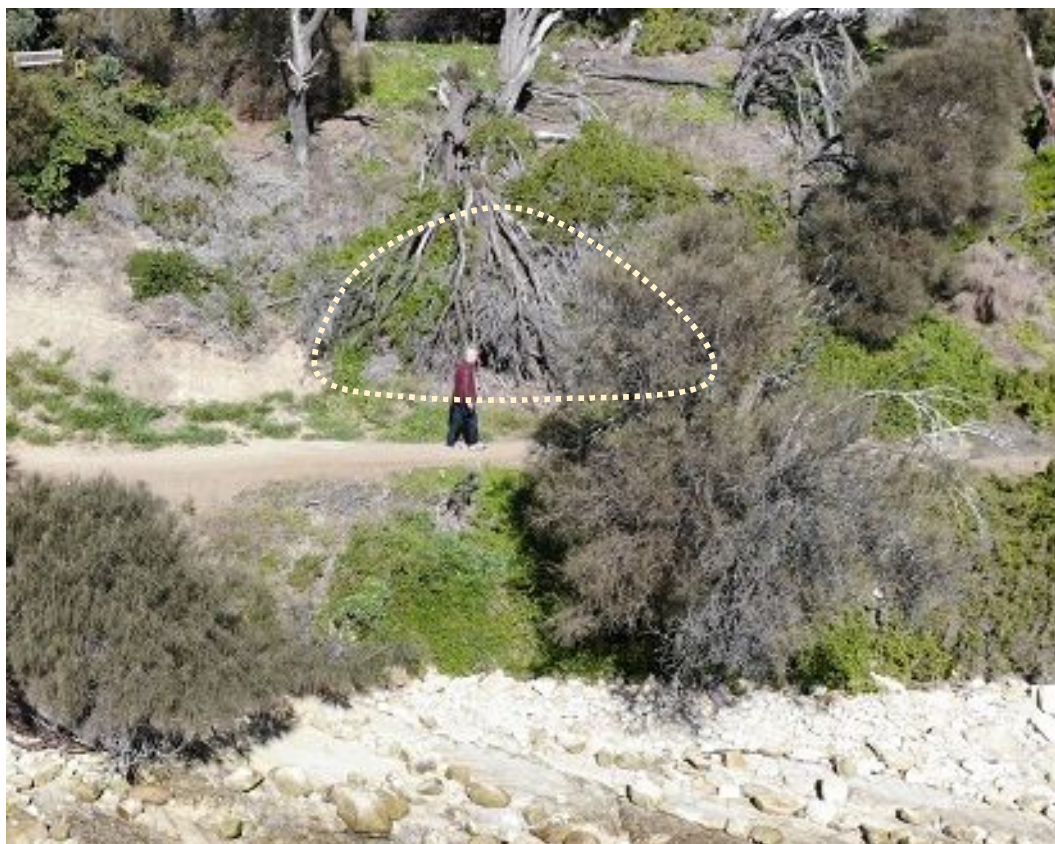
Rockfalls on the higher side of the track are locally present from small cliff-like exposures past about chainage 130m. A very small landslide occurs between about chainages 105 – 115m (Figure 3).

Figure 3. A very small landslide in soil has occurred between approximate chainages 105 – 115m. Sandstone and siltstone bedrock dipping 5 – 10° WSW is exposed on the shore platform in the foreground, and in the light-coloured cutting to the left of the landslide.

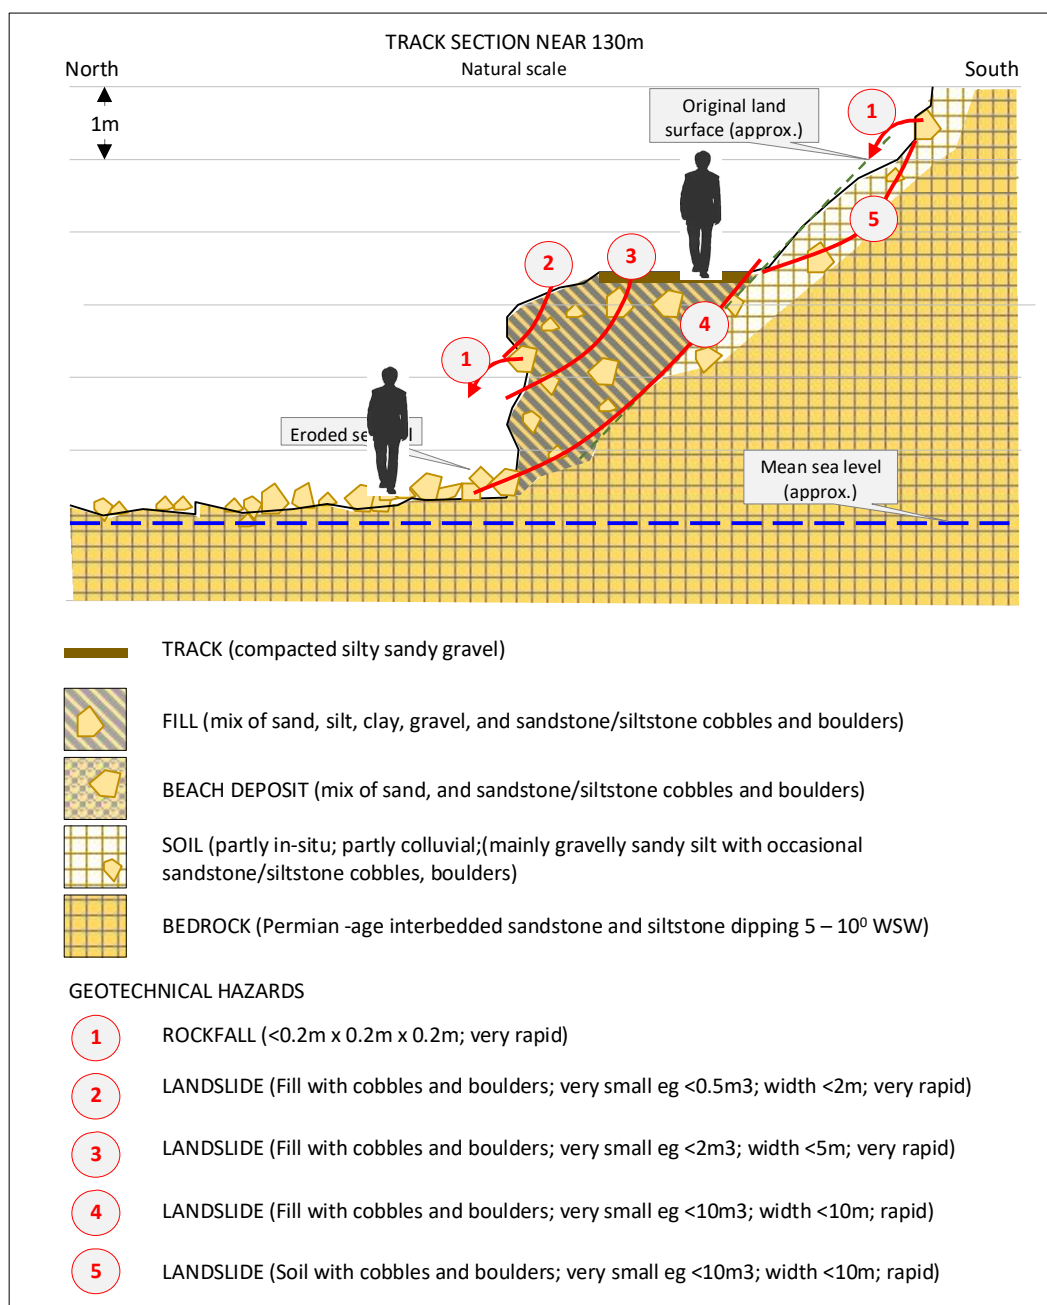
The types of observed and potential slope instability hazards adjacent to the track past about chainage 130m are schematically shown in Figure 4.

Figure 4. Potential and observed slope instability hazards 1 – 5 on the Suncoast Headland Track after approximate chainage 130m.

Visual inspection of the seaward embankment fill indicates it is of variable but mainly low strength, and in places is not strong enough to support fence posts along the outer edge of the track. Furthermore, the presence of buried cobbles and boulders in the fill will make it difficult to excavate for the posts, and continued coastal erosion will increase the likelihood of the geotechnical hazards depicted in Figure 4.

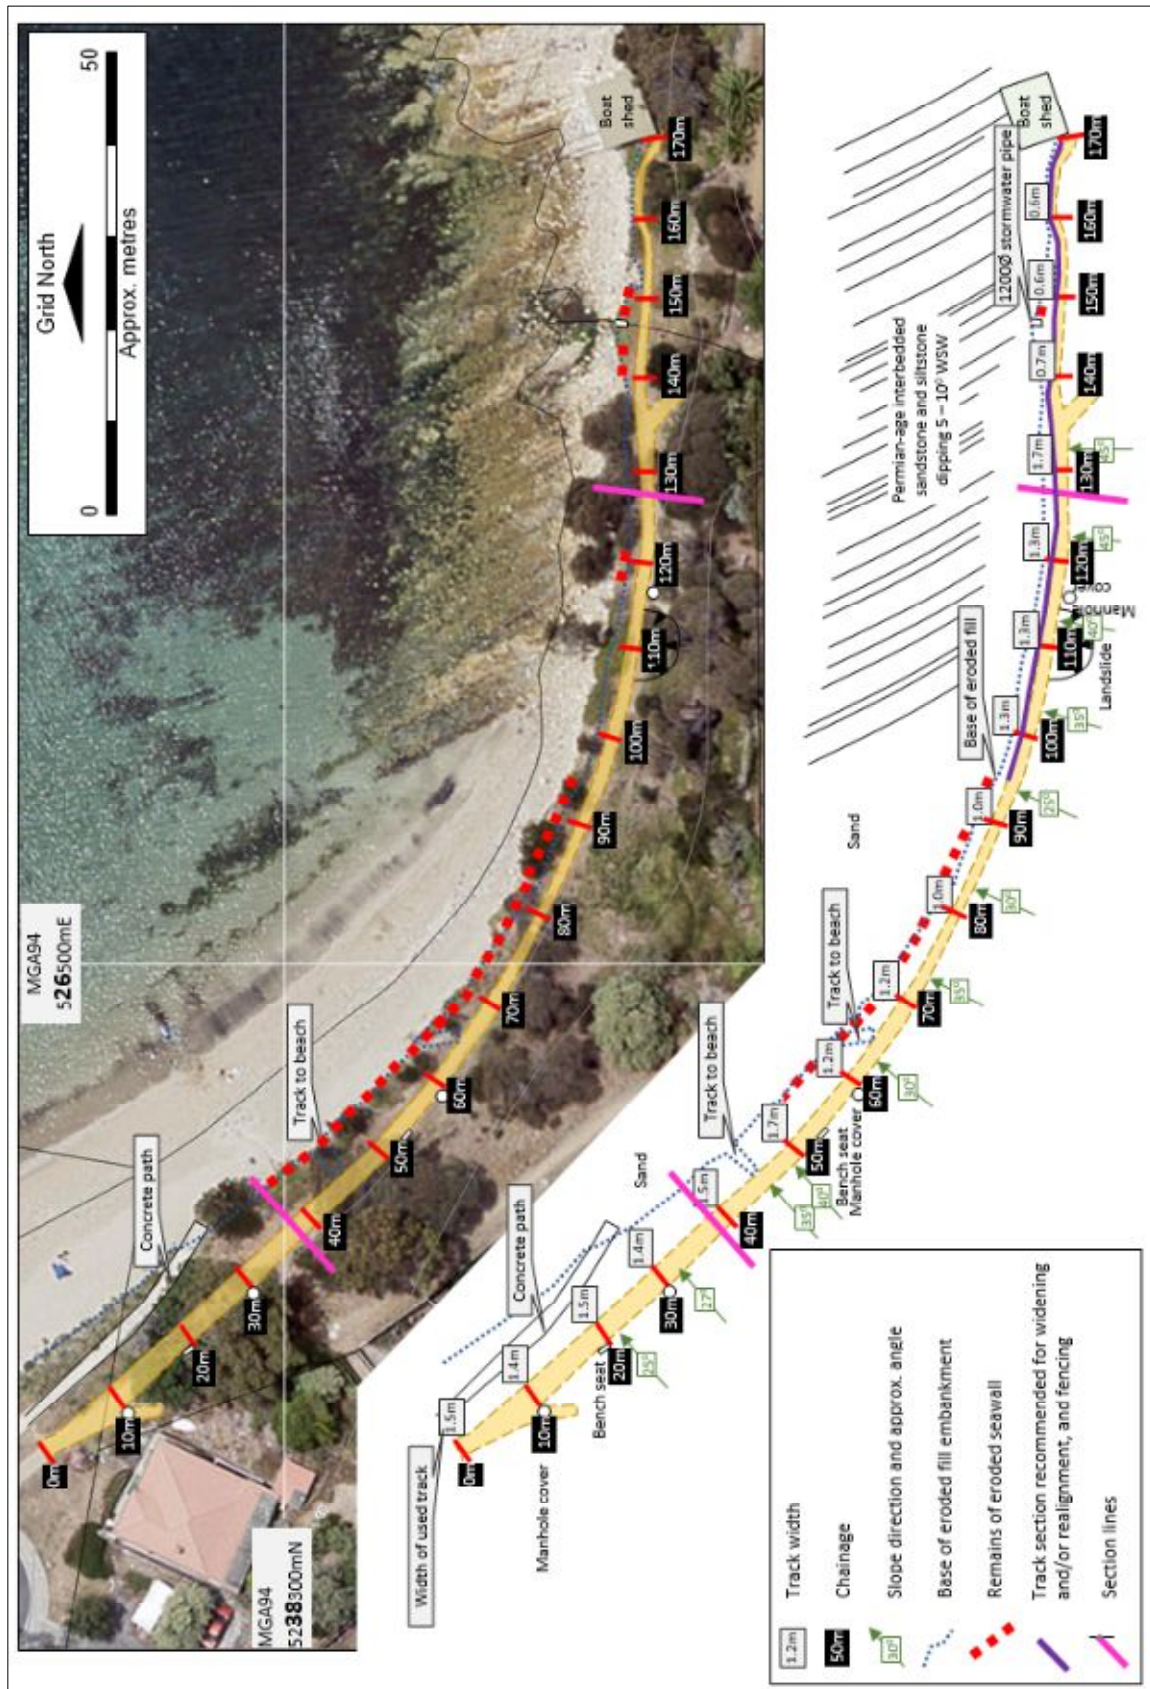
Used track width<sup>5</sup> remains fairly constant in the 1.2 – 1.5m range to about chainage 70m. Between chainage 70m and 140m, used width is in the 1.0 – 1.3m range (locally 1.7m). From about chainage 140m to 170m, it narrows to about 0.6 – 0.7m (Figure 5).

Figure 5. Track chainages and widths, landward slope angles, locations of cross sections in Figure 1, remains of seawall, and suggested track widening and/or realignment and fencing

Up to about chainage 60m, there is no embankment lip (upper diagram in Figure 1). Elsewhere, distance to the lip ranges from about 0.5 – 1.5m (several Plates in Attachment 2, and Figure 5).

It is suggested that because of relatively gentle seaward embankment slopes, fencing to mitigate the risk of falls is unnecessary from 0m to about 95m (Figure 5). This distance may be varied by Council.

Fencing should be considered over the remaining distance to the boatshed – from about 95m to 170m.

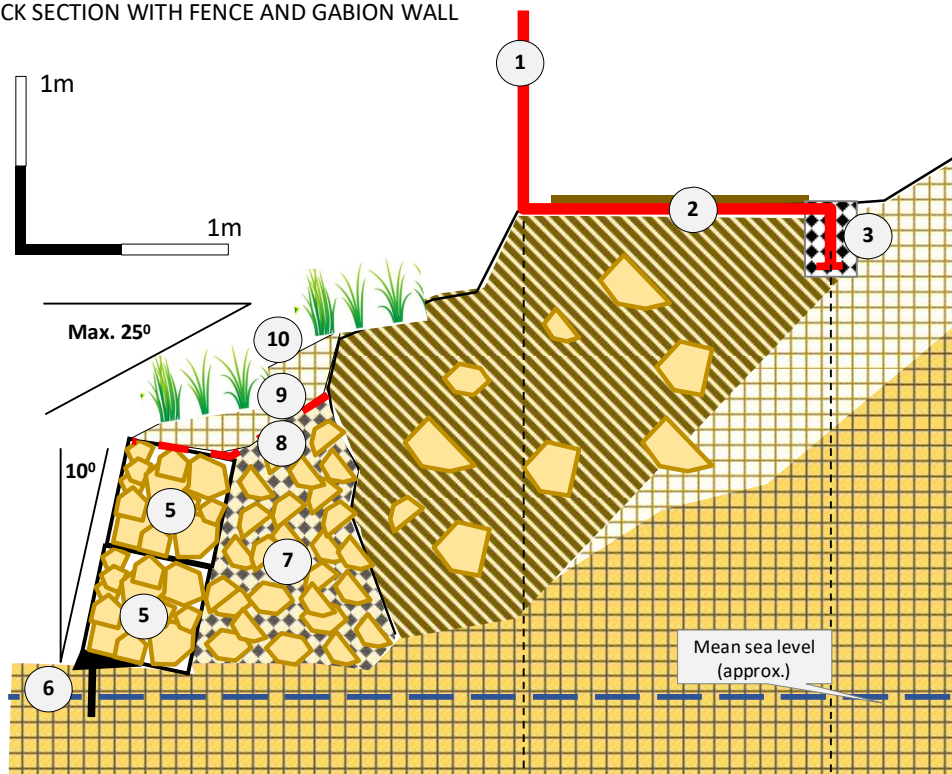
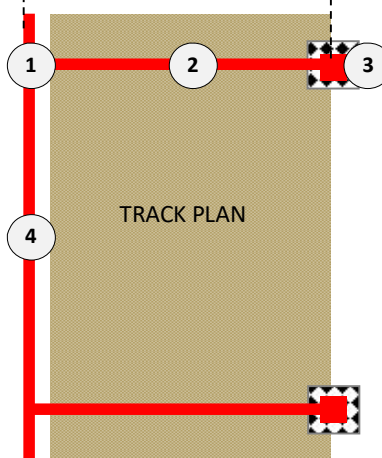
Figure 6. Suggested design for a fence (which avoids posts in low-strength and eroding fill) from about chainage 95 – 170m along the Suncoast Headland Track. Also shown is a suggested design for a spall-backed gabion wall as a form of coastal defence from chainage 0 – 170m.

Fencing is typically a timber rail and post design in accordance with AS2156:2. However, because of the locally low fill strength on the outer edge of the track, it is suggested that posts should be galvanised steel welded to horizontal beams extending out from the landward side of the track and anchored in concrete, and buried in the track (Figure 6).

If the fence posts are securely anchored at point 3 in Figure 6, the fence may be located within about 0.3 – 0.5m of the lip of the embankment. However, from about chainage 140m to 170m, where the embankment is subvertical, this distance should be increased to one metre. This will necessitate minor track realignment (Plates 24, 26 and 28 in Attachment 2)

Numerous types of coastal defences are available for the site. It is beyond the Brief of this report to canvass each one. Instead, partly with aesthetics in mind, it is suggested that a gabion wall of on- an off-site sandstone be erected, as schematically shown in Figure 6. Constructed with high strength stainless steel cages nominally 3m long and 0.6m square, and tied ends and tops with similar stainless steel, these will weigh more than a tonne each and should be strong enough to withstand marine erosion. A wall nominally 1.2m (2 gabions) high with a horizontal base into or onto sandstone bedrock should be sufficient, and an extra row or more can be added in future to counter predicted sea level rise.

- 1 Fence post nom. 90mm galv steel 1.2m high topped with timber railing; welded to 2.
- 2 Fence bearer nom. 90mm galv steel buried in track or later covered; welded to 1 and 3

- 3 Fence post nom. 90mm galv steel 0.5m long with square 150mm base plate in 0.25m x 0.25m x 0.6m concrete; welded to 2.
- 4 Fence beam nom. 90mm galv steel; horizontal, at ground level, welded to 1 both ends; length to be specified by Council.

- 5 Gabion 0.6m x 0.6m x 3m long; high strength stainless steel cage; use on- and off-site durable sandstone 0.15-0.25m; tie gabions top and ends
- 6 Cut gabion base into bedrock, and/or construct concrete base bolted to bedrock with stainless steel bolts

- 7 Fill behind gabions with durable screened spalls. Important: average size must be larger than average size of apertures in gabions
- 8 Geofabric cover over spalls and top of gabions

- 9 On- or off-site soil
- 10 Hydro mulch (or similar) cover, and revegetation with appropriate coastal plants and shrubs

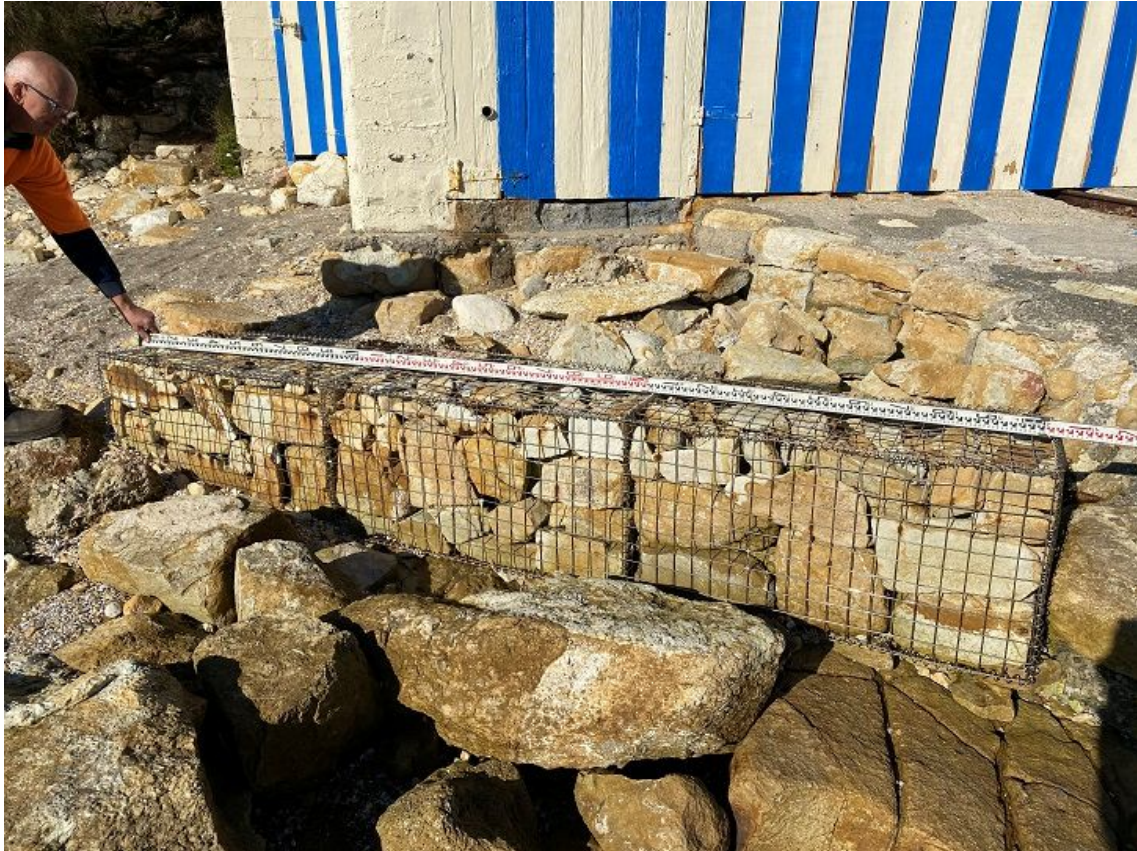
A single gabion of this design lies on the rock platform at the boatshed, and appears to have withstood marine action well. (Figure 7).

Figure 7. A 3m long gabion of on-site sandstone blocks encased in a high-strength stainless steel cage has survived intact on the rock platform at the boatshed near chainage 170m. Similar gabions are suggested as an aesthetically acceptable coastal defence from chainage 0 – 170m to mitigate embankment erosion.

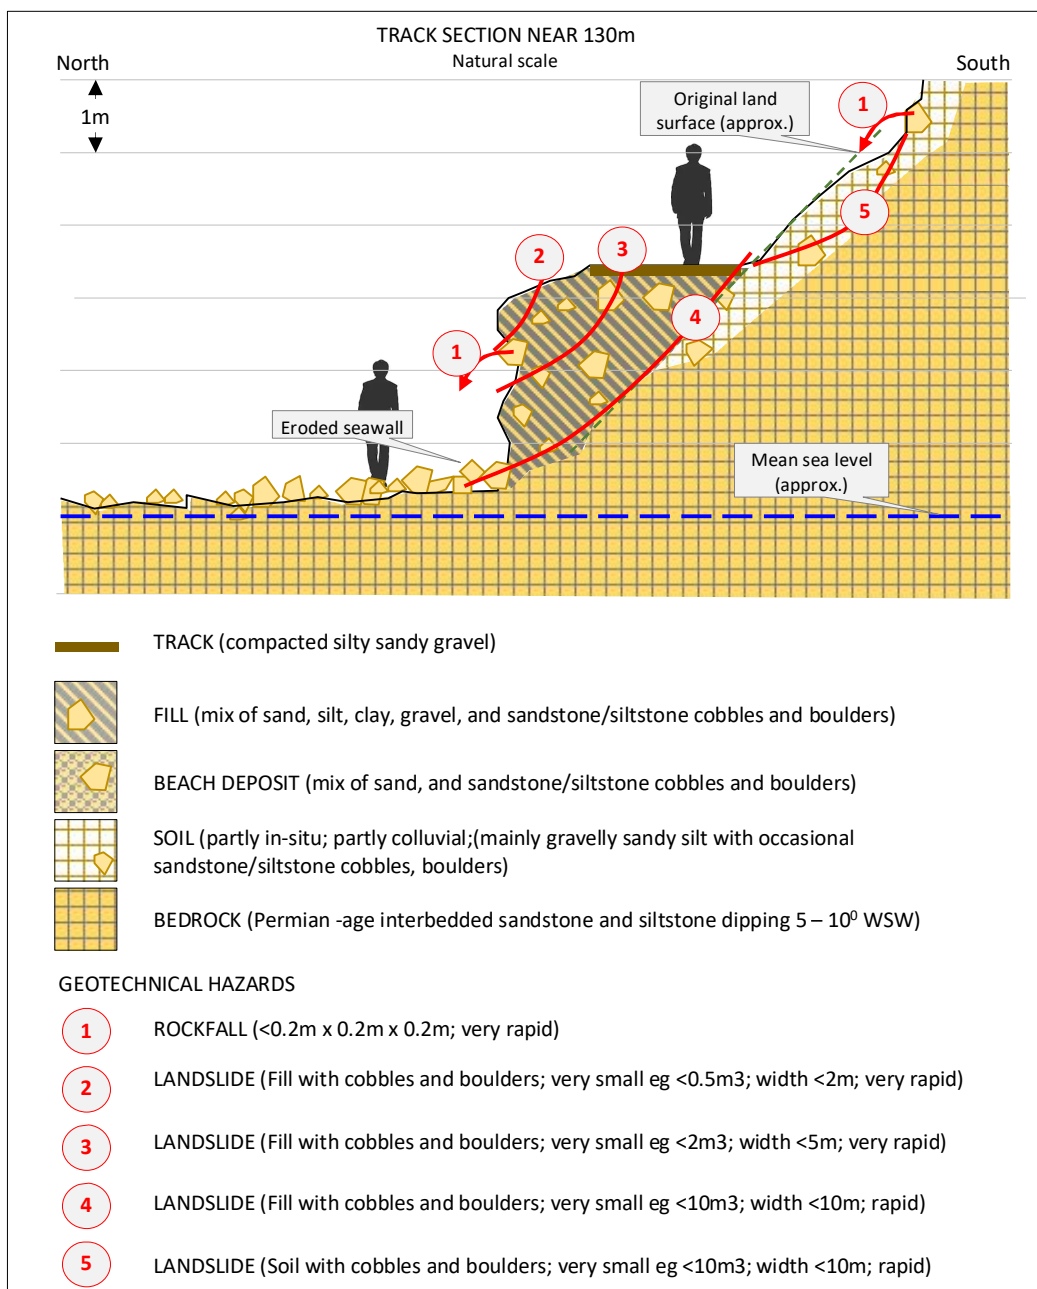
Five geotechnical hazards have been identified on the track<sup>6</sup>. Their occurrence is more likely after about chainage 90m, and they include rockfalls and very small landslides as schematically depicted and characterised in Figure 3.1.

Figure 3.1. Schematic description and characterisation of geotechnical hazards identified after about chainage 90 on the Suncoast Headland Track

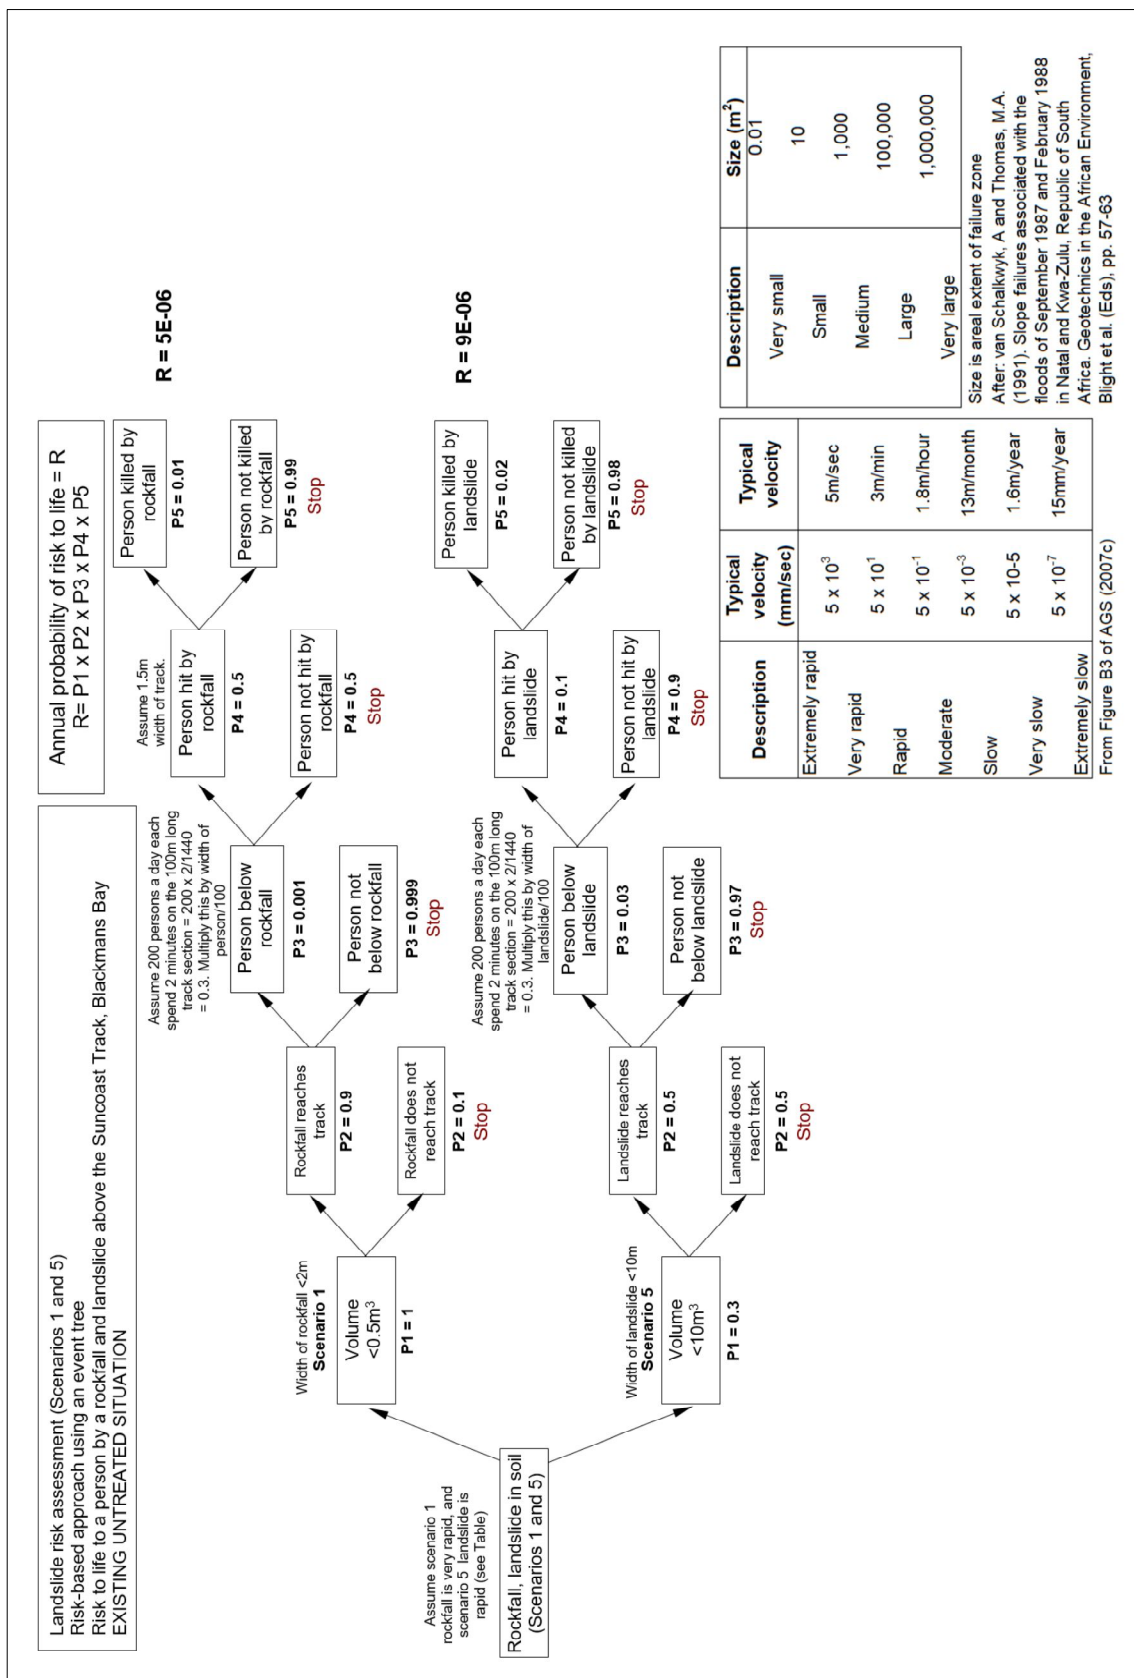
Figure 3.3. Estimated risks to life from Scenarios 1 and 5 for an individual most at risk walking along the track between approximate chainages 90m and 170m. The estimated likelihoods and consequences depicted in this tree are subjective but thought to be reasonable. Other risk assessors might adopt different inputs. The velocity and size inset tables apply to Figure 3.4 also.

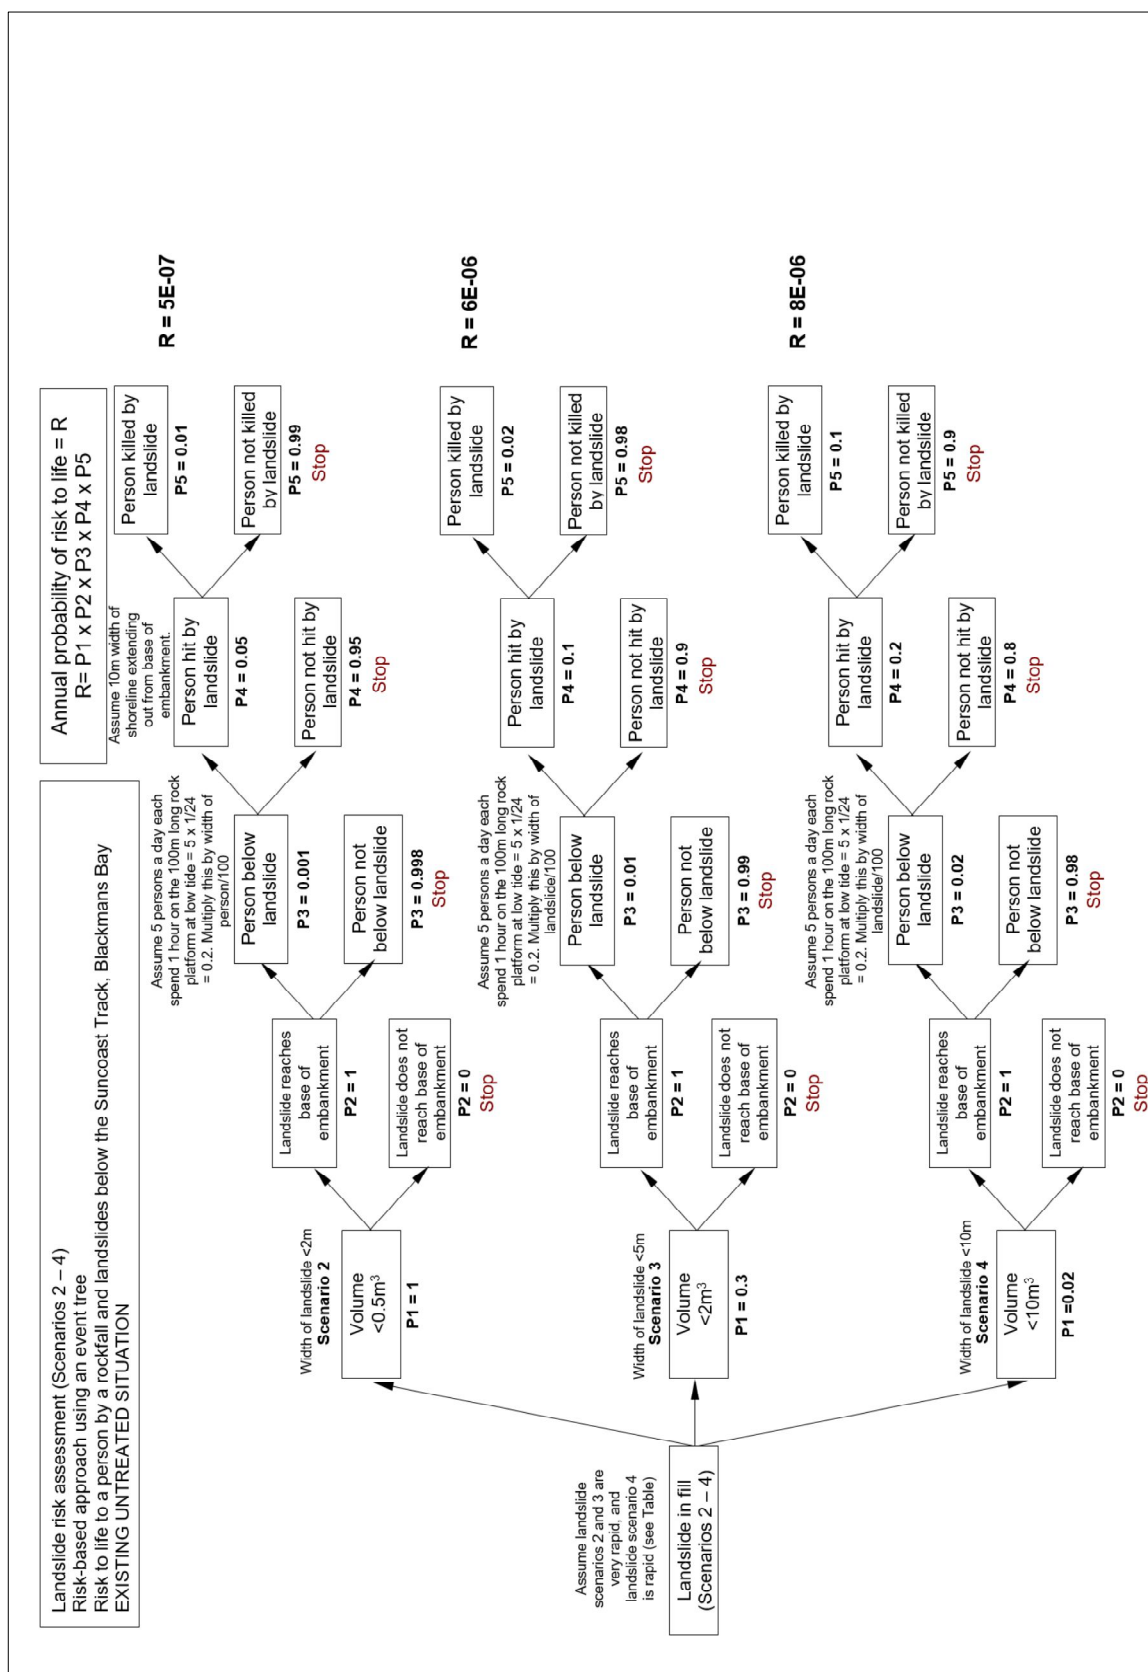
Figure 3.4. Estimated risks to life from Scenarios 2, 3 and 4 for an individual most at risk on the rock platform at low tide between approximate chainages 90m and 170m. The estimated likelihoods and consequences depicted in this tree are subjective but thought to be reasonable. Other risk assessors might adopt different inputs.
