Kingborough Community Halls Strategy

2021 -2026

Kingborough Community Halls Condition Report

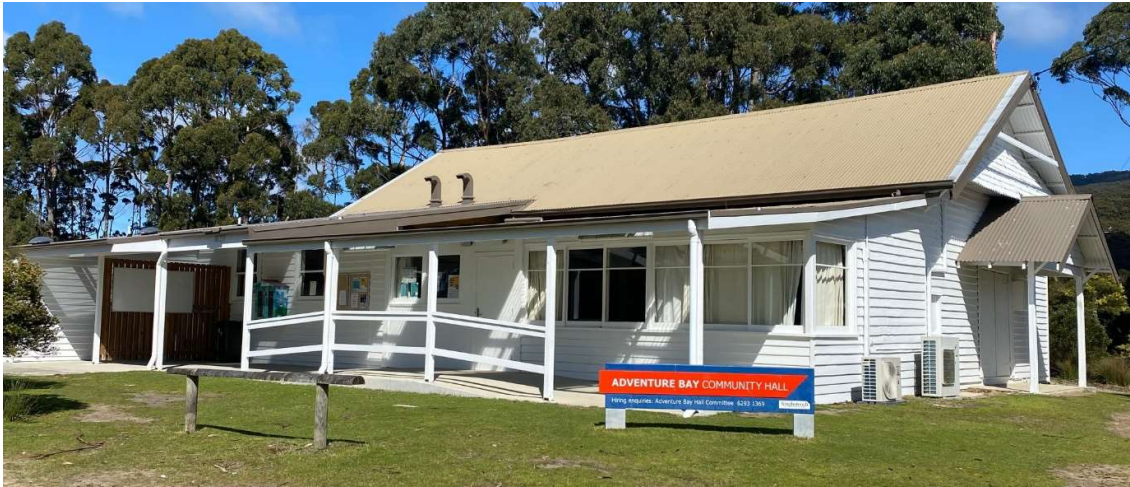
9.1 Adventure Bay Hall

Current Condition – Most elements of the building were assessed as either good or very good condition. The one issue itemised as being in poor condition was the roof at the rear of the building and shingles above the exit door.

Issues – Issues identified by the Hall Management Committee were sealing the carpark, replacement of gas heaters to heat pump, insulation in the roof and solar panels.

1. Replacement of gas heating system with heat pumps
2. Sealing of carpark
3. Installation of energy efficiency initiatives (solar and insulation)

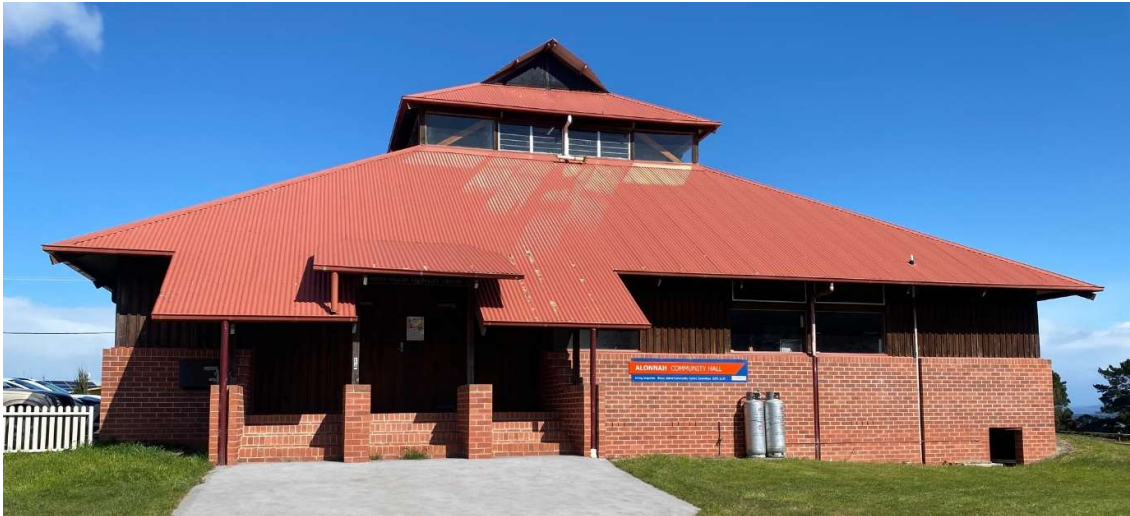
9.2 Bruny Island Community Centre (Alonnah)

Current Condition – The facility is rated as being good to very good and has recently been upgraded via a state government grant.

1. Address the maintenance items as per Optimus Building Surveyors report (doors and walls)
2. Re-oil external timber walls
3. Relocate cleaning supply cupboard
4. Repair leaks in roof and guttering

1. Upgrade toilet facilities to meet disability access standards.

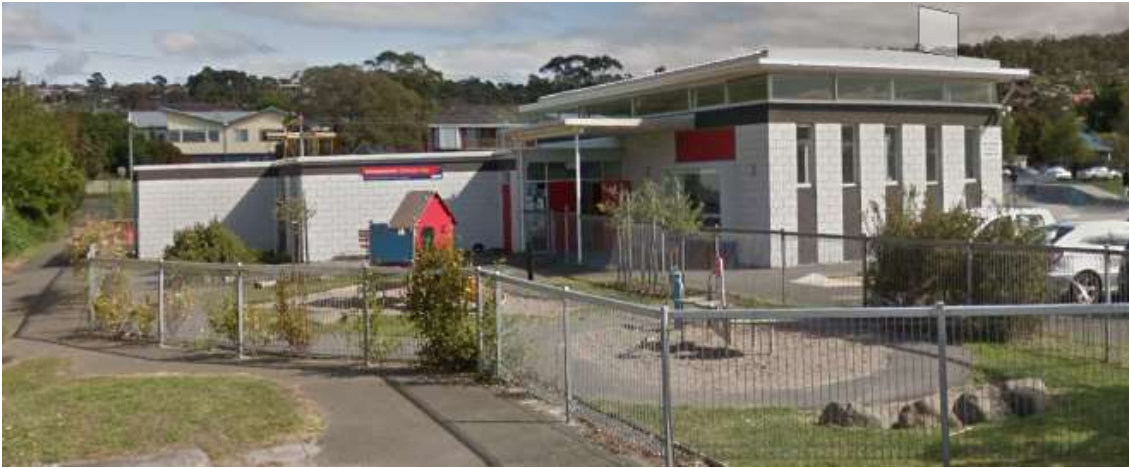
9.3 Blackmans Bay Hall

Current Condition – Most elements of the building are rated in either fair or poor condition.

Issues – the building is showing signs of age with cracking to the block work, subsidence to the floor in the stage area and water damage to the carpet and floor of the meeting room.

1. Address the subsidence issues pending outcome of investigations
2. Roof replacement

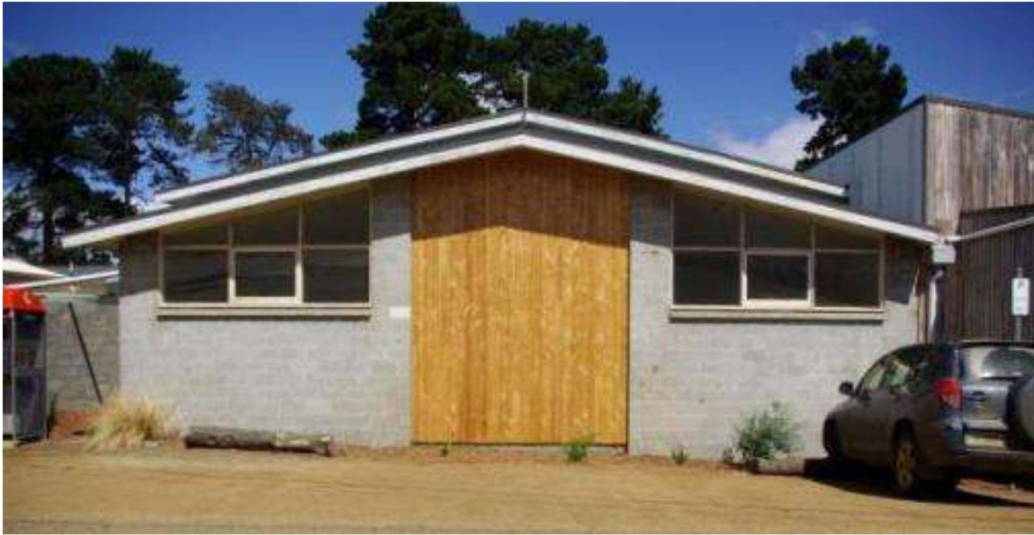
9.4 Dennes Point Hall

Current Condition – The majority of the building elements are rated in good condition.

1. Upgrade of side entrance

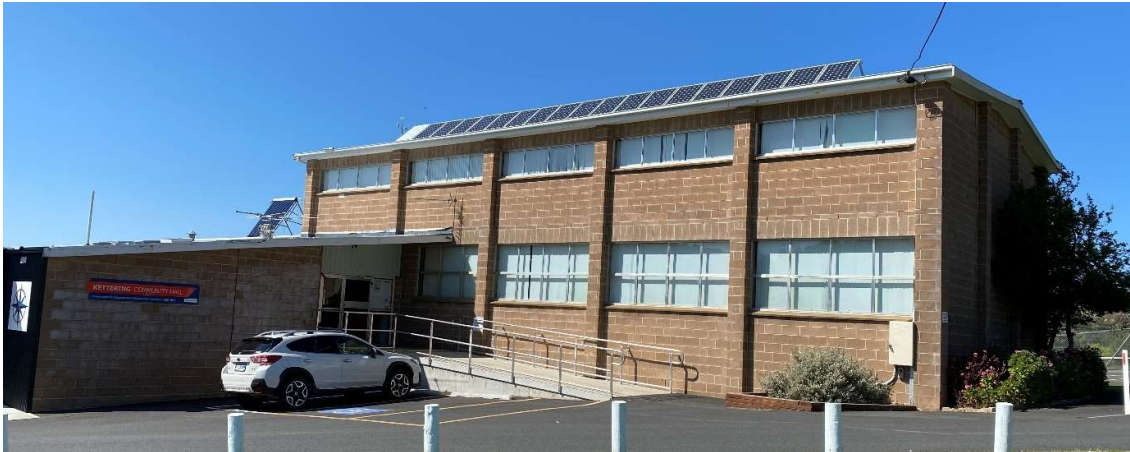
9.5 Kettering Hall

Current Condition – most elements of the building are rated as either good or very good.

1. Compliant disability access toilet inside the hall
2. Kitchen upgrade
3. Floor replacement

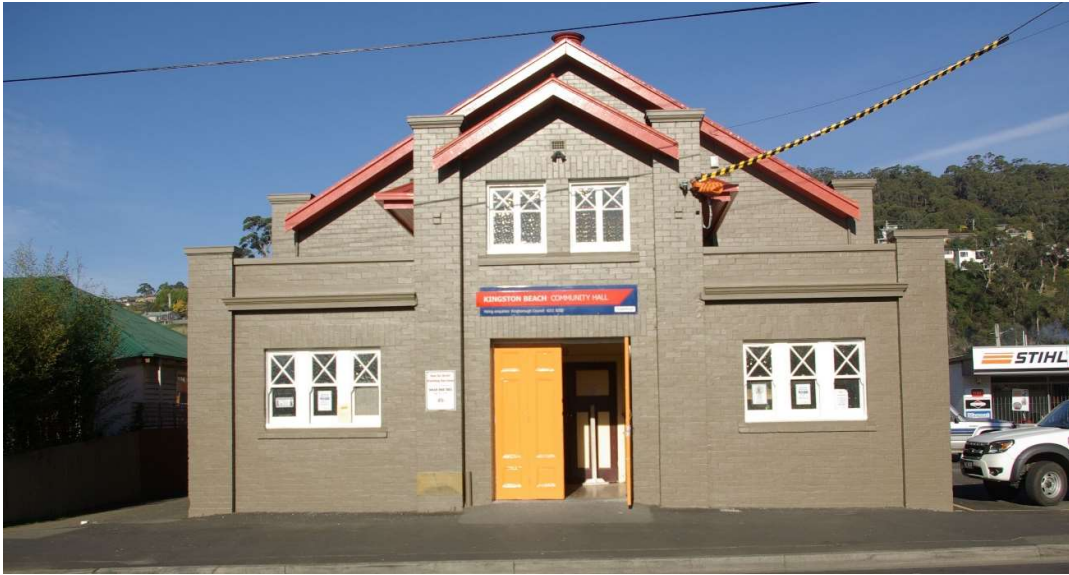
9.6 Kingston Beach Hall

Current Condition – The building is rated as being in good condition except for windows, doors, and toilets that are rated fair.

Issues – The disability access toilet is non-compliant, the front ticket room is currently used for storage but is in poor condition and better use could be made of this space.

1. Compliant disability access toilet
2. Upgrade of ticket room
3. Disability access to gallery space

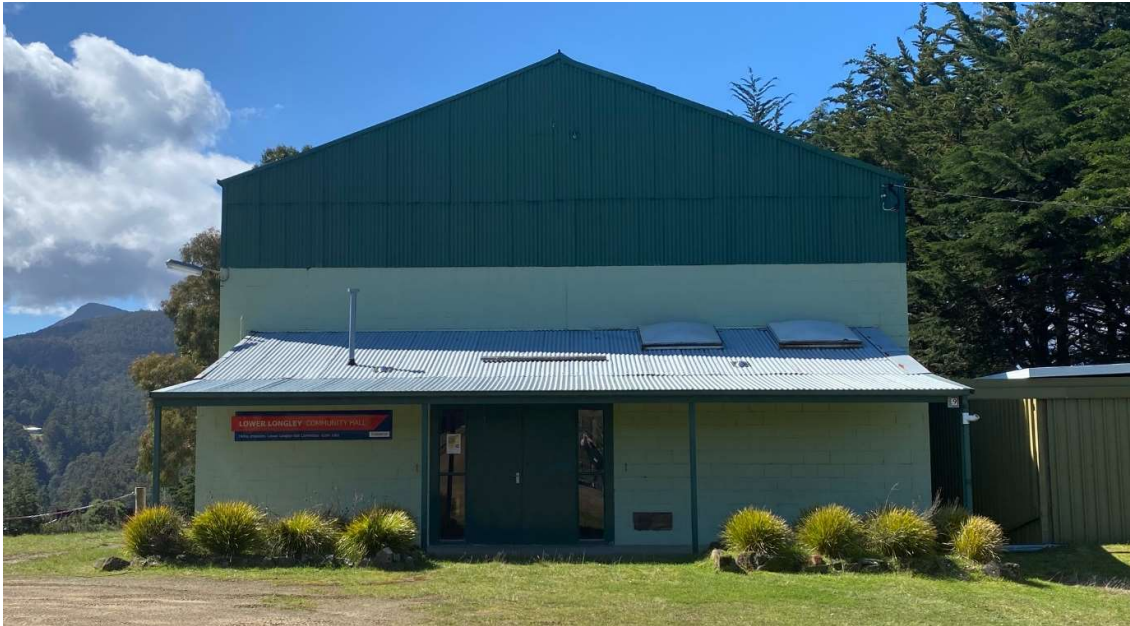
9.7 Lower Longley Hall

Current Condition – the building is rated as being in fair condition with some elements being rated as poor (ceilings and external paths).

Issues – the hall is dated and it is questionable as to whether its design is suitable for the current and future needs of the community. However, there is currently no consensus as to whether the facility should be refurbished or replaced.

1. Refurbishment or replacement pending further consultation with the Hall Management Committee and local community.

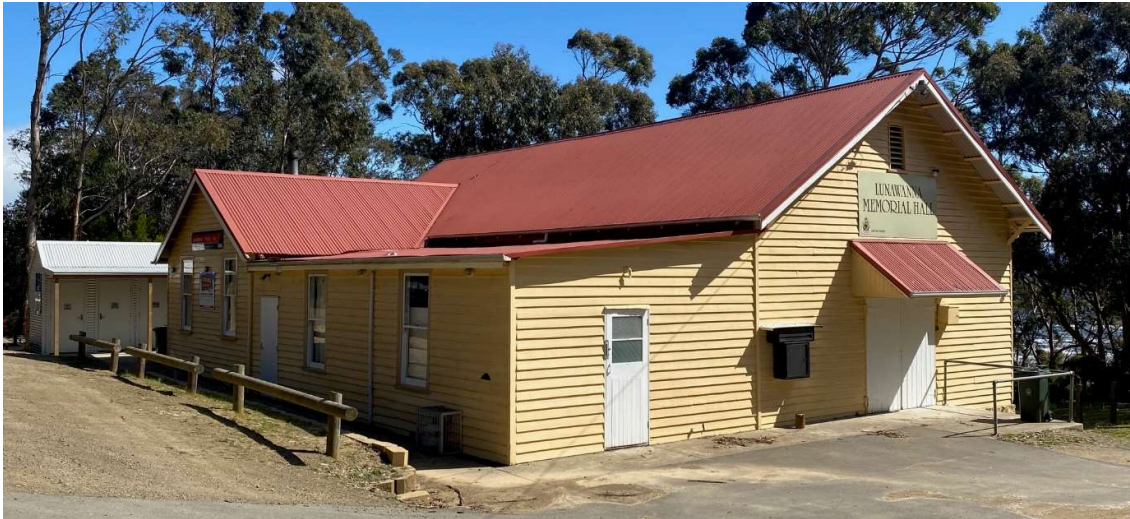
9.8 Lunawanna Hall

Current Condition – The building is rated as being in good condition.

1. Sealing of the carpark
2. Construction of a deck on the water side

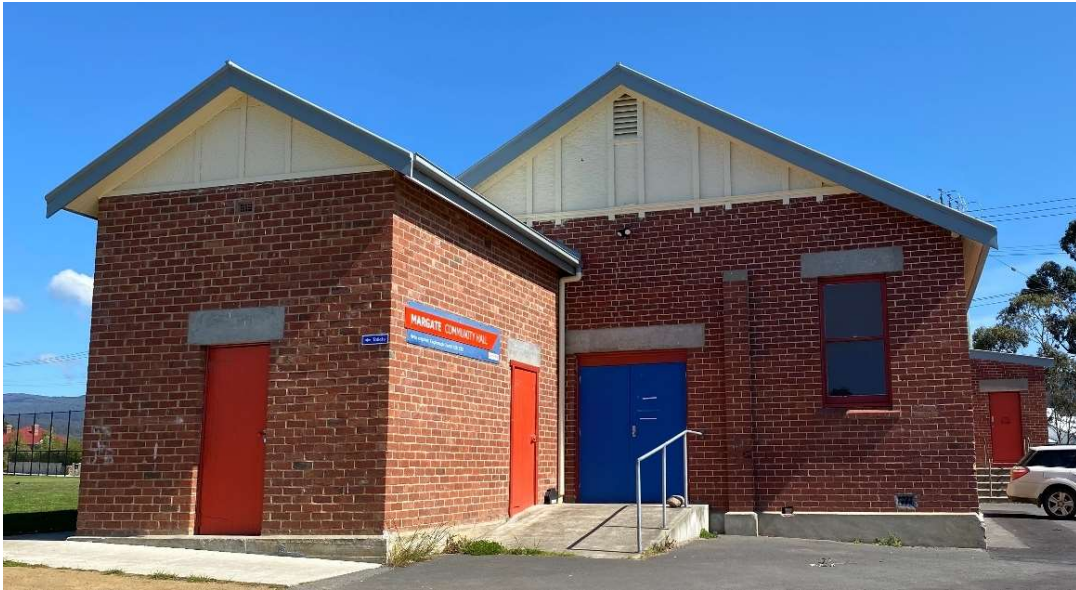
9.9 Margate Hall

Current Condition – Most elements of the building are rated as being in good condition with the exception of windows, doors and the stage floor.

Issues – The toilets are in poor condition and there is no compliant disability access facility. The external ramp to the hall is also non-compliant.

1. Toilet upgrade as per Toilet Strategy
2. Main entrance access ramp

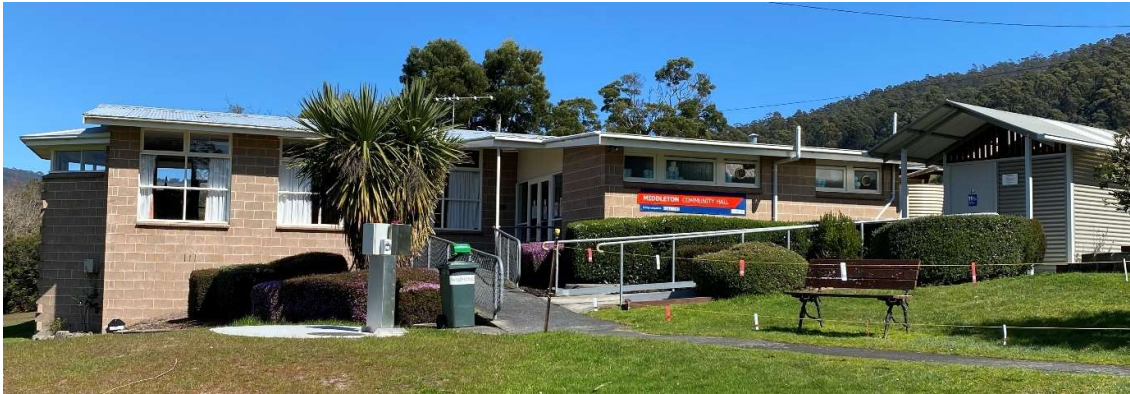
9.10 South Channel Community Hall (Middleton)

Current Condition – The building is rated as being in good condition with the exception of some minor maintenance required on doors and walls.

1. Upgrade of internal toilet facilities

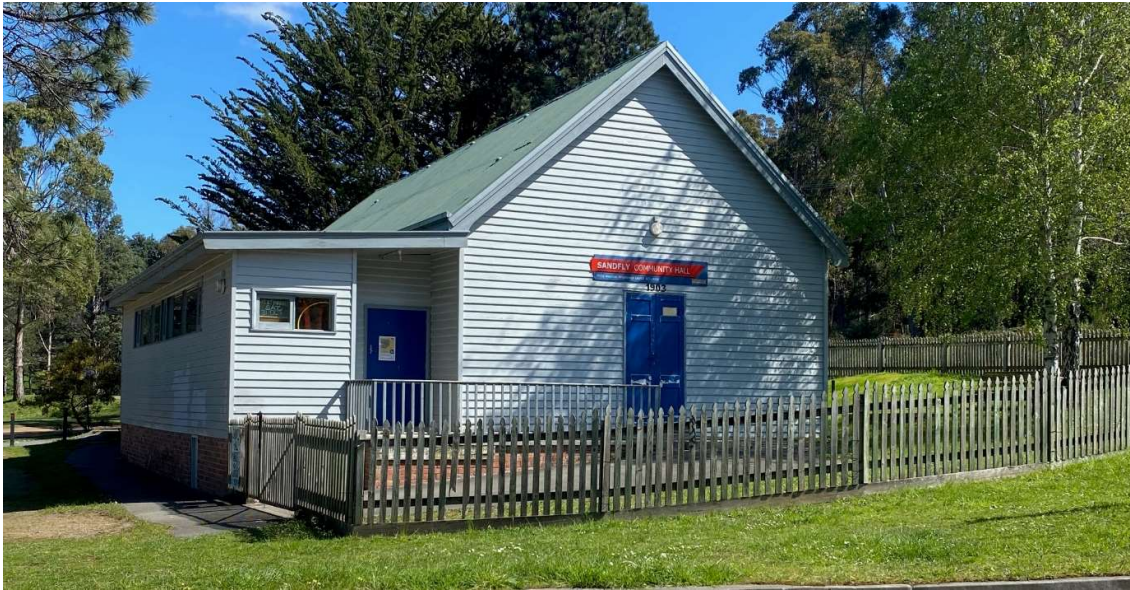
9.11 Sandfly Hall

Current Condition – The building is rated as fair and good condition with some elements rated as poor.

1. Roof, sub floor/foundations
2. Toilet facilities
3. External access
4. Kitchen upgrade

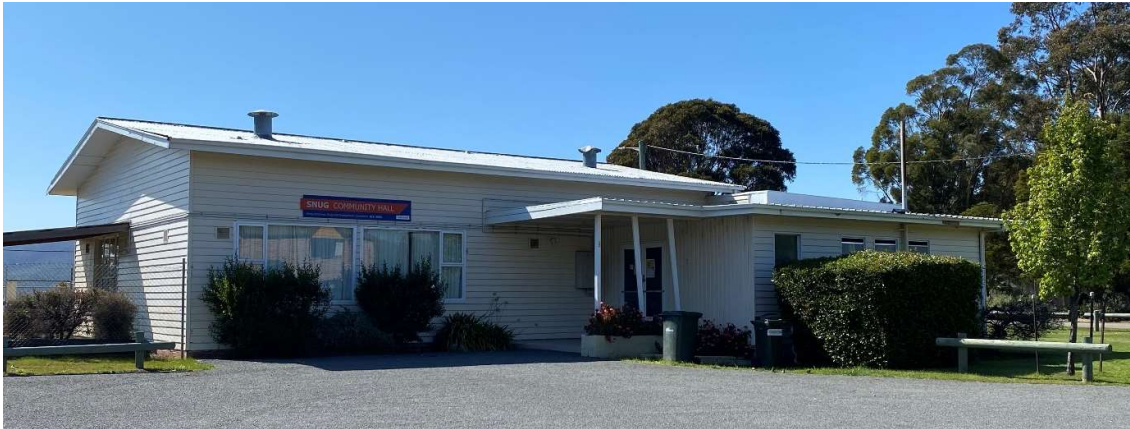
9.12 Snug Hall

Current Condition – Most of the elements of the building are rated in fair condition.

Issues – Most elements of this facility require upgrading. The Hall Management Committee has requested that Council give consideration to solar panels and replacement of the heating system. The roof is scheduled for replacement in the 2020/21 financial year.

1. Kitchen upgrade
2. Heating system upgrade

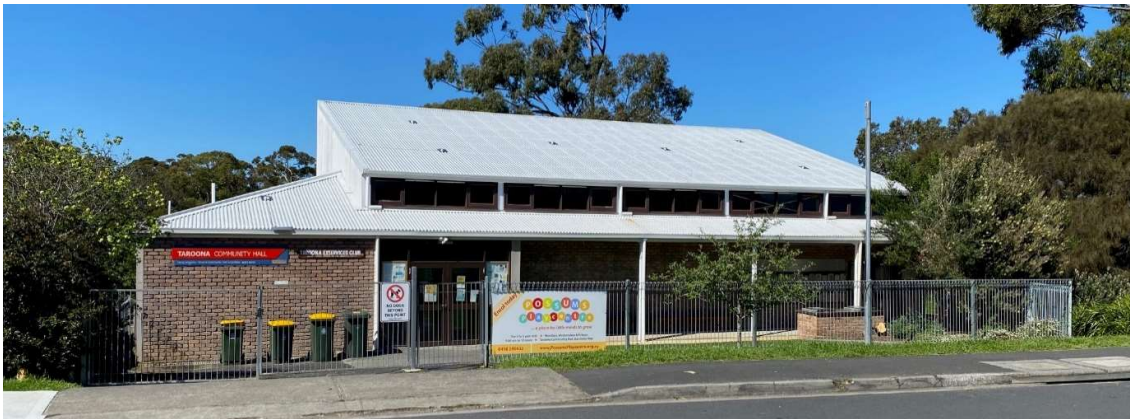
9.13 Taroona Hall and Cottage

Current Condition – Overall the facilities are rated as being in good condition with some general maintenance required on windows and doors. There are some cracks evident in the brick work that have been assessed by an Engineer and found to be of minor concern.

1. As identified in Taroona Hall Masterplan.

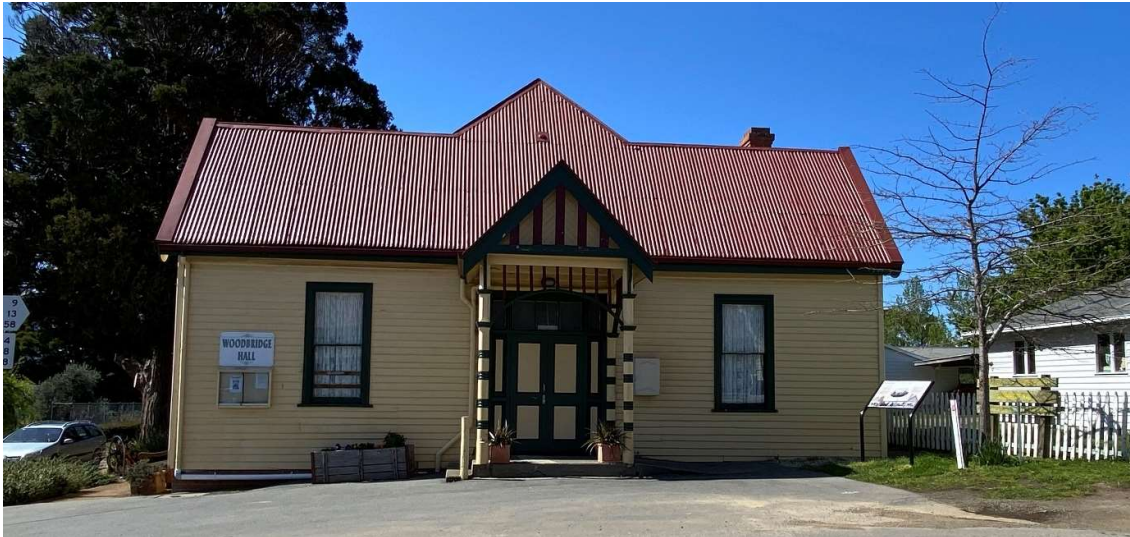
9.14 Woodbridge Hall

Current Condition – Overall the building is rated as being in fair condition except apart from the kitchen which was recently upgraded. An upgrade of the toilets and front porch is being undertaken in the current financial year along with the replacement of the roof.

1. Heating upgrade
2. Deck on the northern side (subject to tree removal)

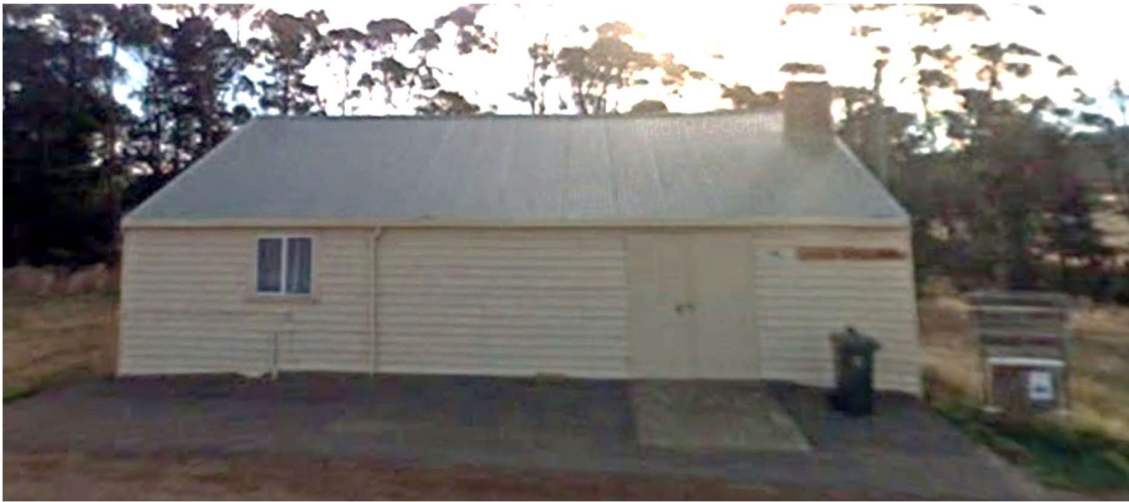
9.15 CWA Barnes Bay Hall

Current Condition – Overall the facility is rated in good condition.

Issues – Current lease conditions state that if the building is not properly maintained, then Council reserves the right to sell it.

1. Address the maintenance items as per Optimus Building Surveyors report (general maintenance schedule) in accordance with lease conditions.

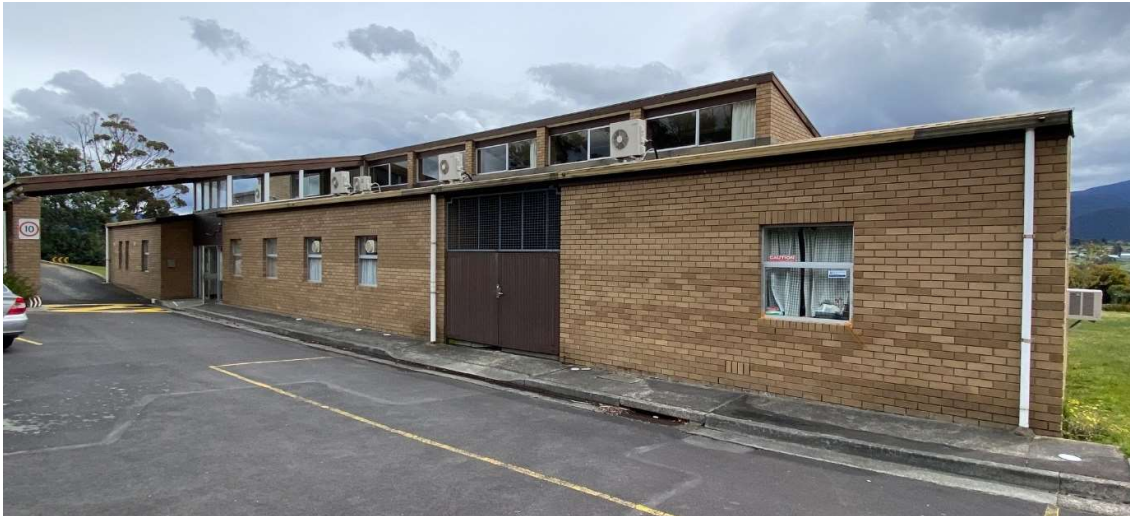
9.16 Kingborough Community Centre (Senior Citizens Club)

Current Condition – Overall the facility is rated in good condition.

1. Address the maintenance items as per Optimus Building Surveyors report (facias, walls, ceiling in kitchen and areas in the Meals on Wheels room) in accordance with lease conditions.

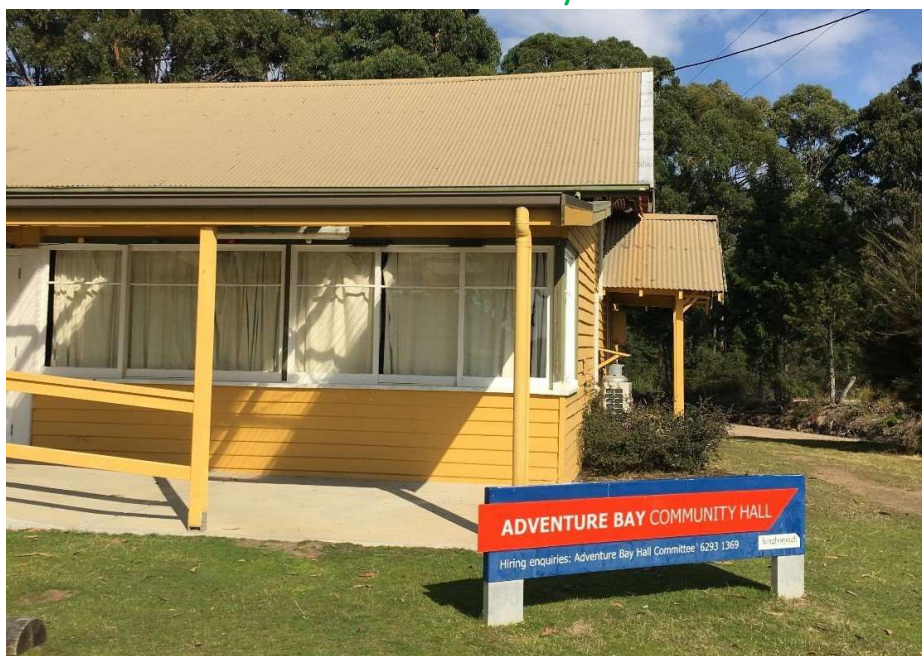
Adventure Bay Hall

It appeared that the lean-to and entrance porch had been fitted with new gutters and downpipes recently and these were still in good condition. The condition at the rear of the building was poor and repair will be required. The roof to the rear of the building was in poor condition with some dips in the sheeting which may lead to future problems.

The shingles to the side of the building above the exit door were in poor condition and require replacement.

The weatherboards to the exterior of the building were in good condition around the front of the building, however the sides and rear of the building were in fair condition. General maintenance is recommended.

Windows throughout the building appeared to be quite old and some of the windows had been boarded up in the main hall area. The timber frames will require regular maintenance. No windows appeared to be cracked.

The stage floor needs repair as some of the floorboards were loose or damaged, the condition is fair.

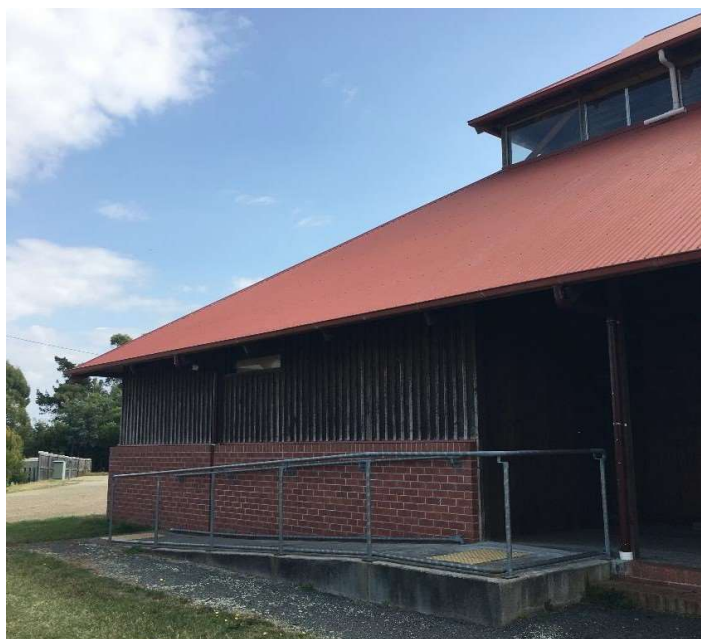
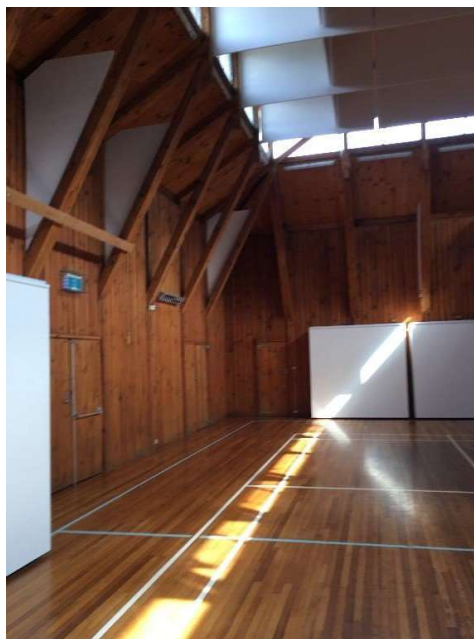
Alonnah Hall

The roof was in very good condition and appears to be well maintained. Upkeep maintenance is recommended with no significant work expected in the near future.

External cladding was in very good condition and does not appear to be showing signs of defects. General maintenance is recommended.

These appeared to be in good condition and well maintained. Braille signage has not been installed where required and the accessible sanitary facility does not achieve the required circulation spaces.

The building was in very good condition and regular normal maintenance routines are recommended.

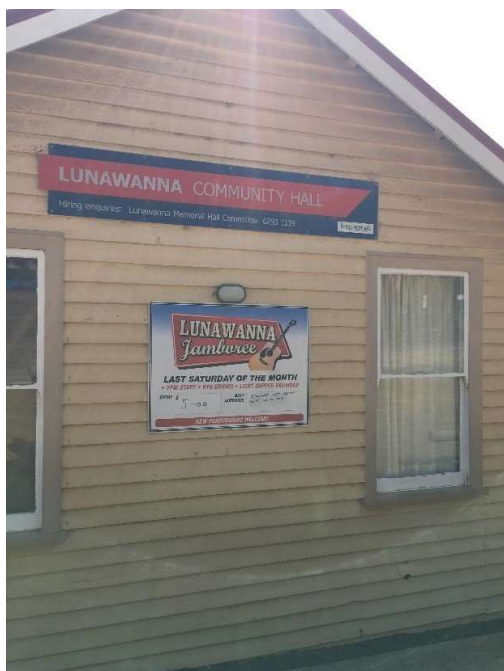
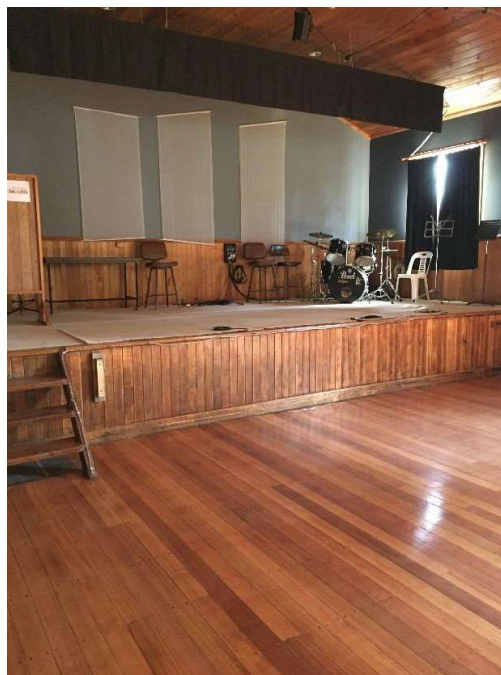
Lunawanna Hall

The roof was in good condition however there were several gaps around the valley's which could lead to vermin entering the building. Upkeep maintenance recommended.

The weatherboards to the exterior of the building were in fair condition with only minor damages. General maintenance is recommended.

The stage was in good condition with no obvious signs of floor damage, however there was equipment set up at the time of the inspection so some areas were not visible.

There was a room to the side of the stage which could not be inspected as access was not available. The building was in good condition and regular normal maintenance routines are recommended.
