## **Geomorphological considerations in landscaping options for Tinderbox Beach and adjacent backshore**

Report to Kingborough Council

By Chris Sharples

December 2021

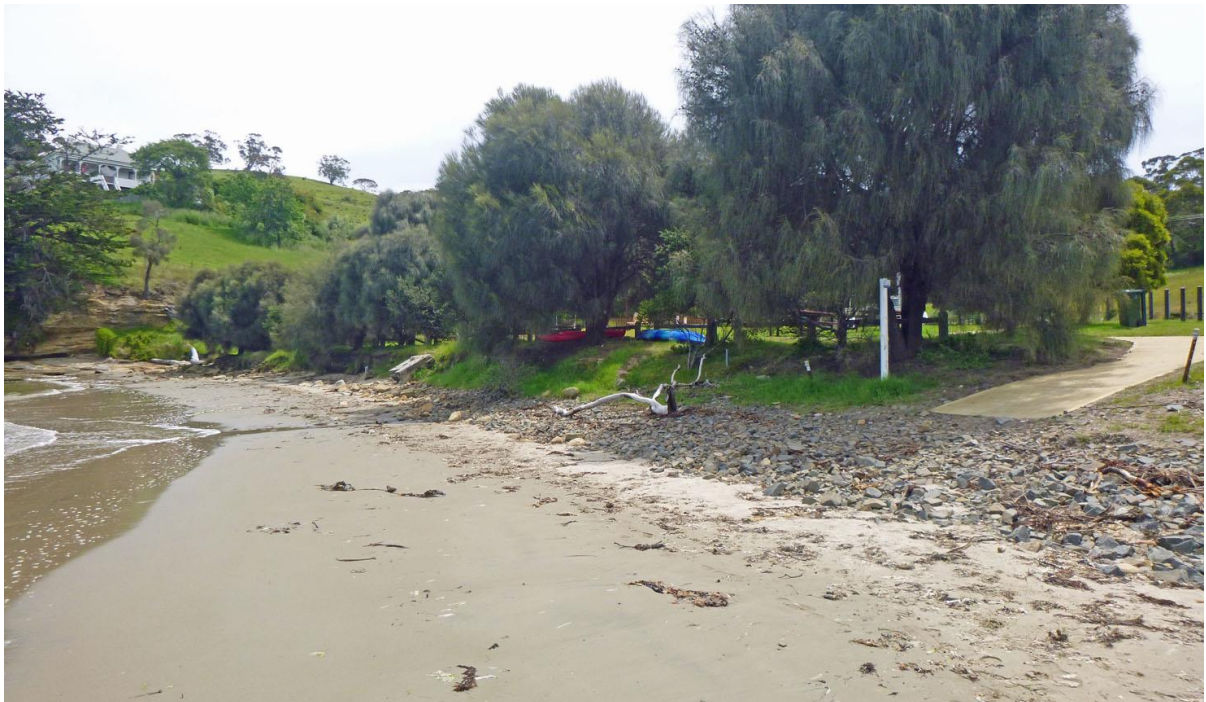
**Front cover photo:** View westwards along Tinderbox Beach and its backing fill and soil margin. Much of the soil margin visible immediately behind the beach is being actively eroded by wave action (see more detailed photos in text)  
Photo by Chris Sharples 23<sup>rd</sup> November 2021.

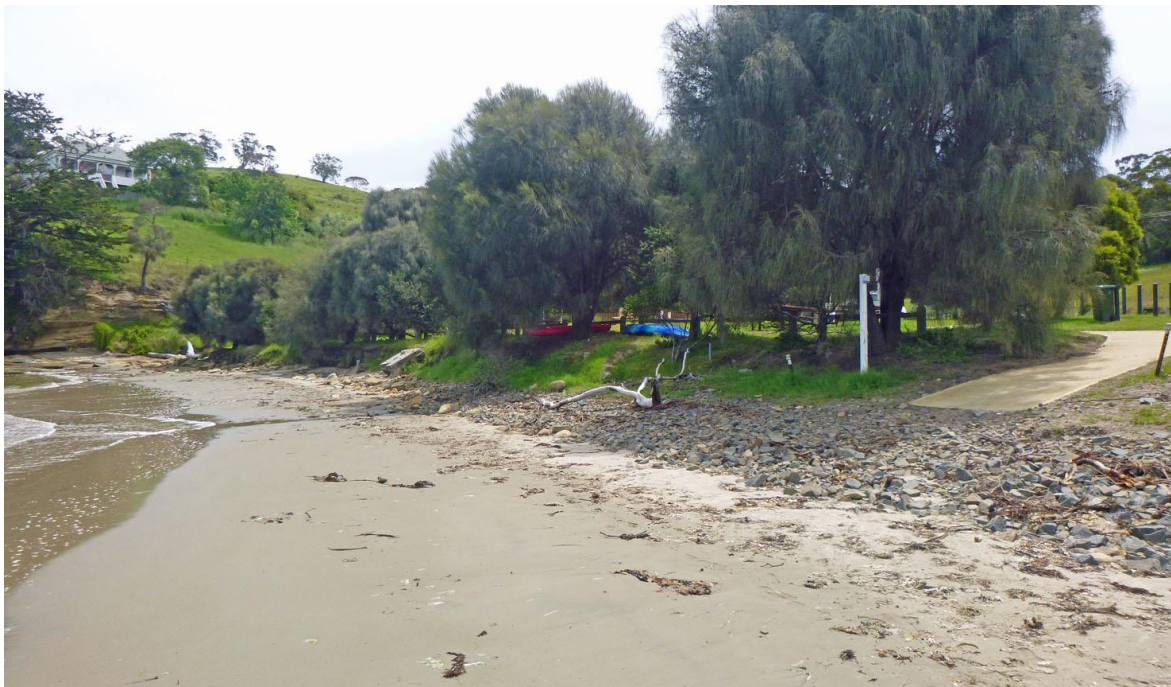
**Figure 3:** View westwards along Tinderbox Beach. This view shows the upper beach cobble berm backed in turn by the rising bouldery soil margin which is the seawards edge of artificial fill placed over backshore areas at an unknown time in the past (at least decades ago). Much of the soil margin visible immediately behind the beach is being actively eroded by wave action (see more detailed photos in text). Photo by Chris Sharples 23<sup>rd</sup> November 2021.

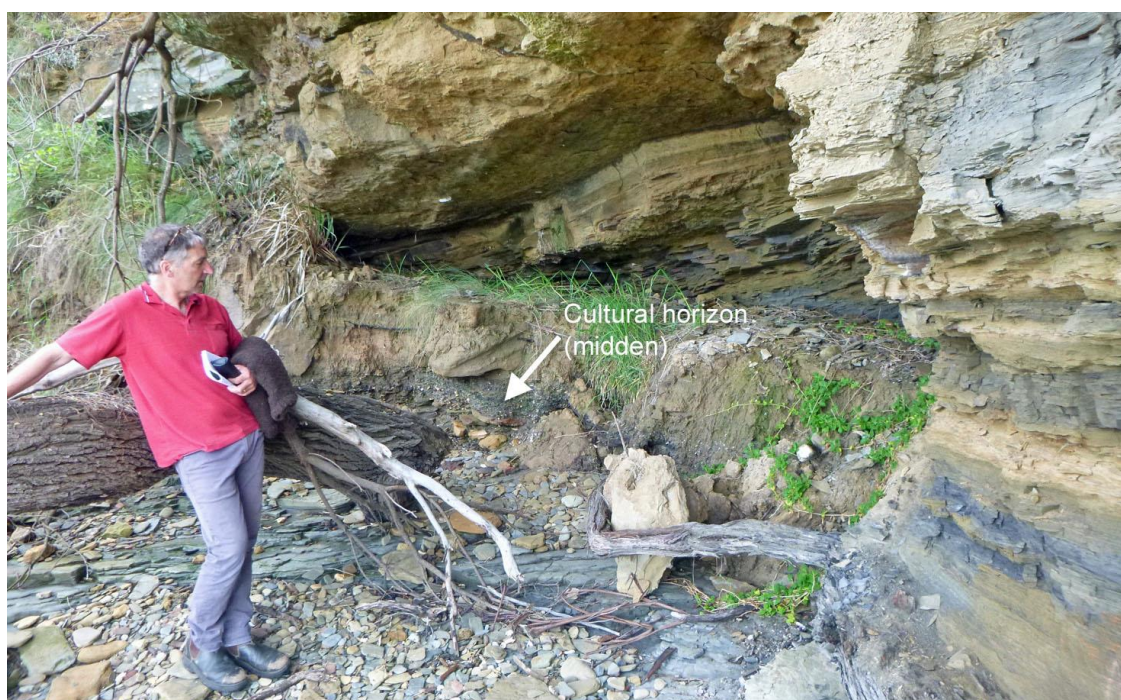
A notable midden deposit (containing shell fragments and charcoal) is exposed beneath about 0.3m depth of fine silty-sand non-midden sediment in a small sandstone sea-cave at the head of a small sandstone cove west of Tinderbox Beach. This deposit has been exposed by recent erosion and currently has a fresh erosion scarp (see Figure 7). The midden deposit has not been dated or otherwise studied; however, the presence of an overlying sediment layer suggests a considerable age. The freshness of the erosion suggests its cause may be related to the causes of other instances of fresh erosion directly behind Tinderbox Beach and further along the shore east of the beach (below).

**Figure 7:** Tinderbox resident Rolan Eberhard with actively wave-eroding midden layer in the floor of a small sea cave at the head of a small cove a short distance west of Tinderbox Beach. The cultural horizon has not been dated although radiometric dates could be obtained from carbonaceous fragments (including charcoal) in the midden. The apparent lack of midden components in the overlying approximately 30 cm of light brown sediment suggests the cultural layer could be of the order of millennia old. Photo by C. Sharples 23<sup>rd</sup> November 2021.

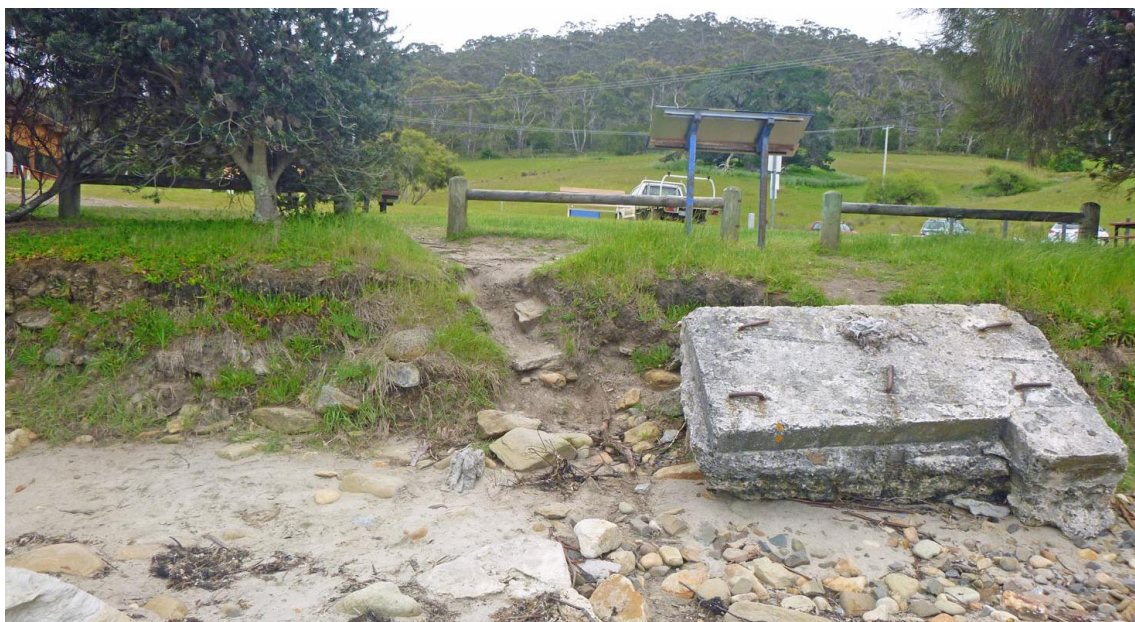
**Figure 8:** Relatively intact section of the seawards margin of the soil and artificial fill behind Tinderbox Beach (see also Figure 10 for a view of a freshly eroding scarp in the same soil margin just a few metres leftwards from the above location). Note the large concrete slab which is either part of the original artificial fill or has later been deliberately placed to prevent erosion, but in either case contributes to an ugly and messy beach front aesthetic. This view also shows an informal access route used by many visitors (including the writer) to carry kayaks and other recreational equipment from the carpark to the beach by a more direct route across the soil margin scarp than is provided by the recently constructed ramp at the east end of the beach. Photo by C. Sharples 23<sup>rd</sup> November 2021.

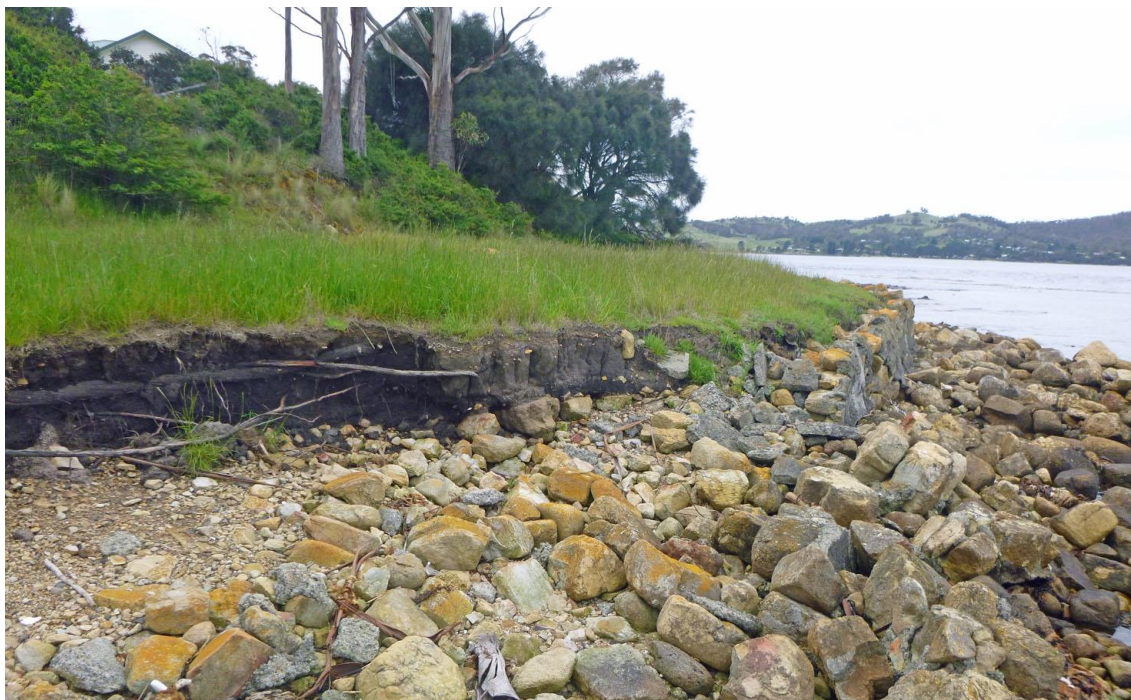
**Figure 9: Artificial terrace on private land approximately 100 m east of Tinderbox Beach and jetty.** Cement-and-stone seawall is intact on the right but has been destroyed by wave attack in the foreground – left. Recent wave erosion of the artificial terrace infill (soil) is apparent, with exposure of the roots of large living trees. Photo by C. Sharples 23<sup>rd</sup> November 2021.

Approximately 100 metres east of the beach is a notable flat terrace of soil and rock which has evidently been obtained by excavating the backing soil and sandstone outcrops (see Figure 9). The purpose and age of the terrace is unknown, and it is unclear what relationship it may have to the artificial infilling behind the beach. This terrace was protected from wave erosion by a cemented stone wall which has failed in parts, presumably under wave attack. Some sections of the terrace are now eroding on fresh soil scarps which are exposing the roots of large mature trees nearby (Figure 9). The artificial terrace is mainly or wholly located on private land (Rolan Eberhard *pers. comm.*).

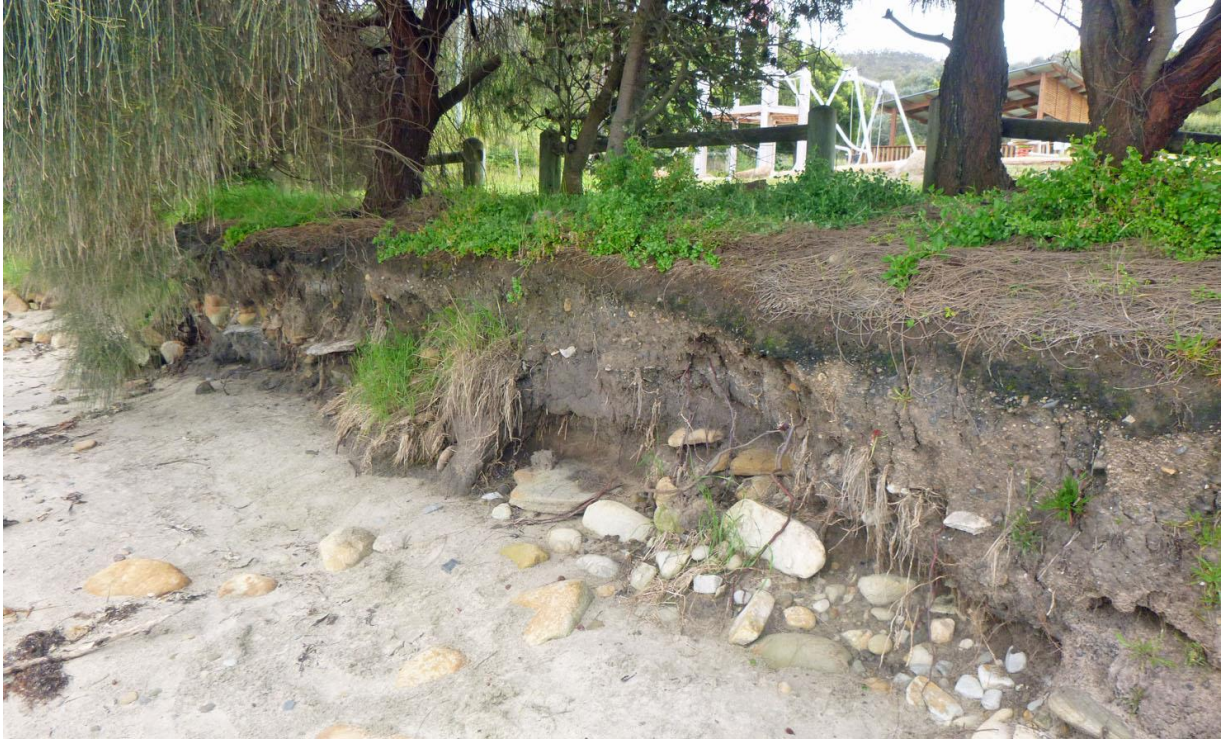
Comparison of historic air photos (see 1948 air photo in Figure 2) provides evidence that the freshly active erosion of the soil margin shown in Figure 10 is a relatively recent phenomenon. Direct comparison of the earliest and the most recent air photos of Tinderbox Beach available to the writer (1948 and 2012) demonstrate that the soil margin at the back of the beach did not detectably recede over that period. That is, any movement of the margin was less than the 0.7 m pixel size of the scanned air photos (and also less than the  $\pm 2.3$  m mean ortho-rectification error margin for these photos)<sup>2</sup>. Comparison of ground photos between 2007 and 2013 (Figure 12) show an active mostly fresh erosion scarp behind the beach over that period, but not a major shoreline retreat as yet.

**Figure 10: Fresh erosion scarp in the soil and artificial fill margin immediately behind the sandy beach at Tinderbox Beach.** Photo by C. Sharples 23<sup>rd</sup> November 2021.

not yet progressed very far inland. On the other hand, the freshness of parts of the erosion (see Figure 10) suggest that the rate may be recently increasing along some parts of the soil margin behind the beach. There is as yet unfortunately no quantitative monitoring data to test this inference against, however it is noteworthy that detectable landwards movement of an artificially placed dolerite cobble berm east of the beach (section 2.2) is a different type of evidence that is also suggestive of more rapid geomorphic change (due to higher wave action) at Tinderbox than in earlier decades.

It is recommended that the current opportunity to stabilise and landscape the eroding soil margin behind Tinderbox Beach be taken in order to replace a messy, eroding and potentially hazardous scarp with a stable landscaped feature incorporating safe steps or ramps directly to the beach. This will preserve council land (and existing trees) for recreational purposes. It is recommended that the local community be consulted with on the design and materials to be used for such hardening and landscaping (see section 3.1).

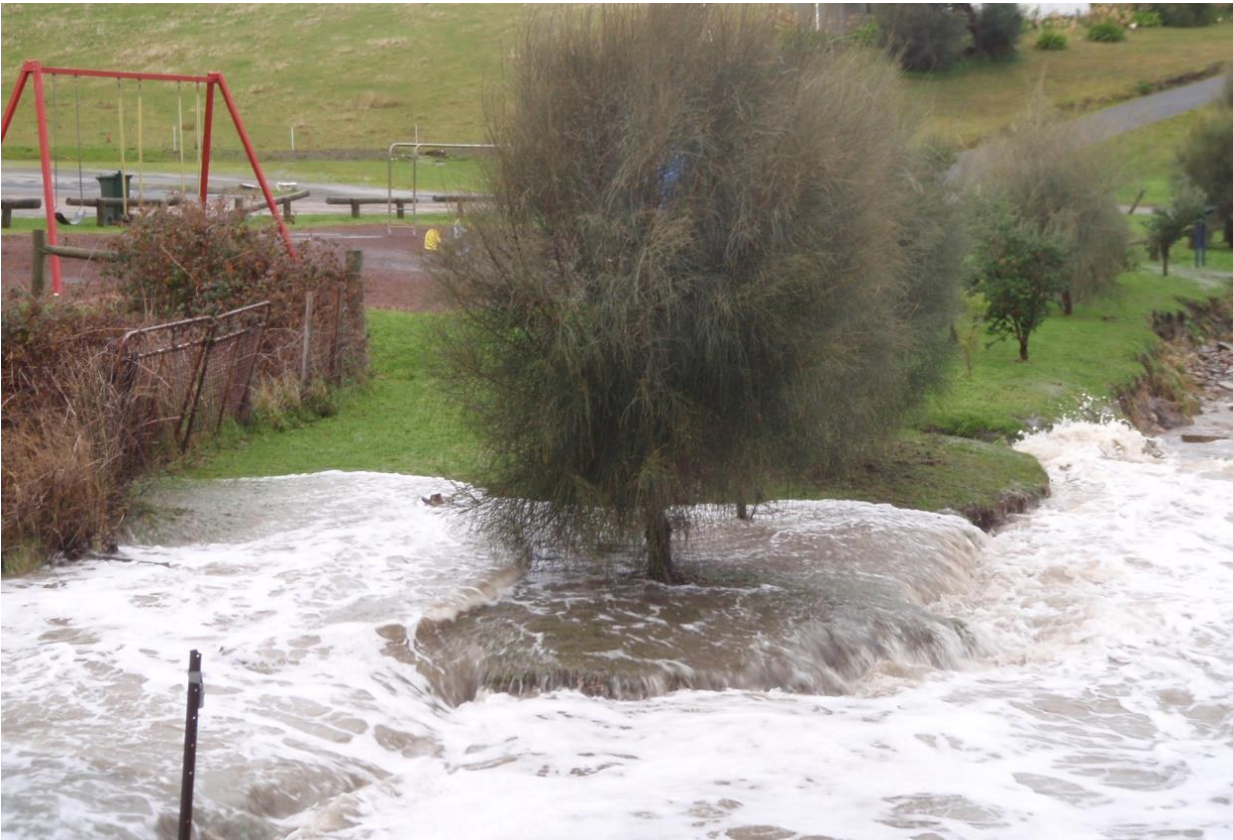
**Figure 11: Storm surge wave conditions at the west end of Tinderbox Beach (9<sup>th</sup> July 2011).** A large swell wave event on 9<sup>th</sup>-10<sup>th</sup> July 2011 caused shoreline erosion at numerous locations around Tasmania's coast. This view shows a wave impacting the soil margin at the back of Tinderbox Beach during this event and is indicative of the sort of storm surge wave that has caused erosion at Tinderbox Beach. Photo by Rolan Eberhard (Tinderbox resident).

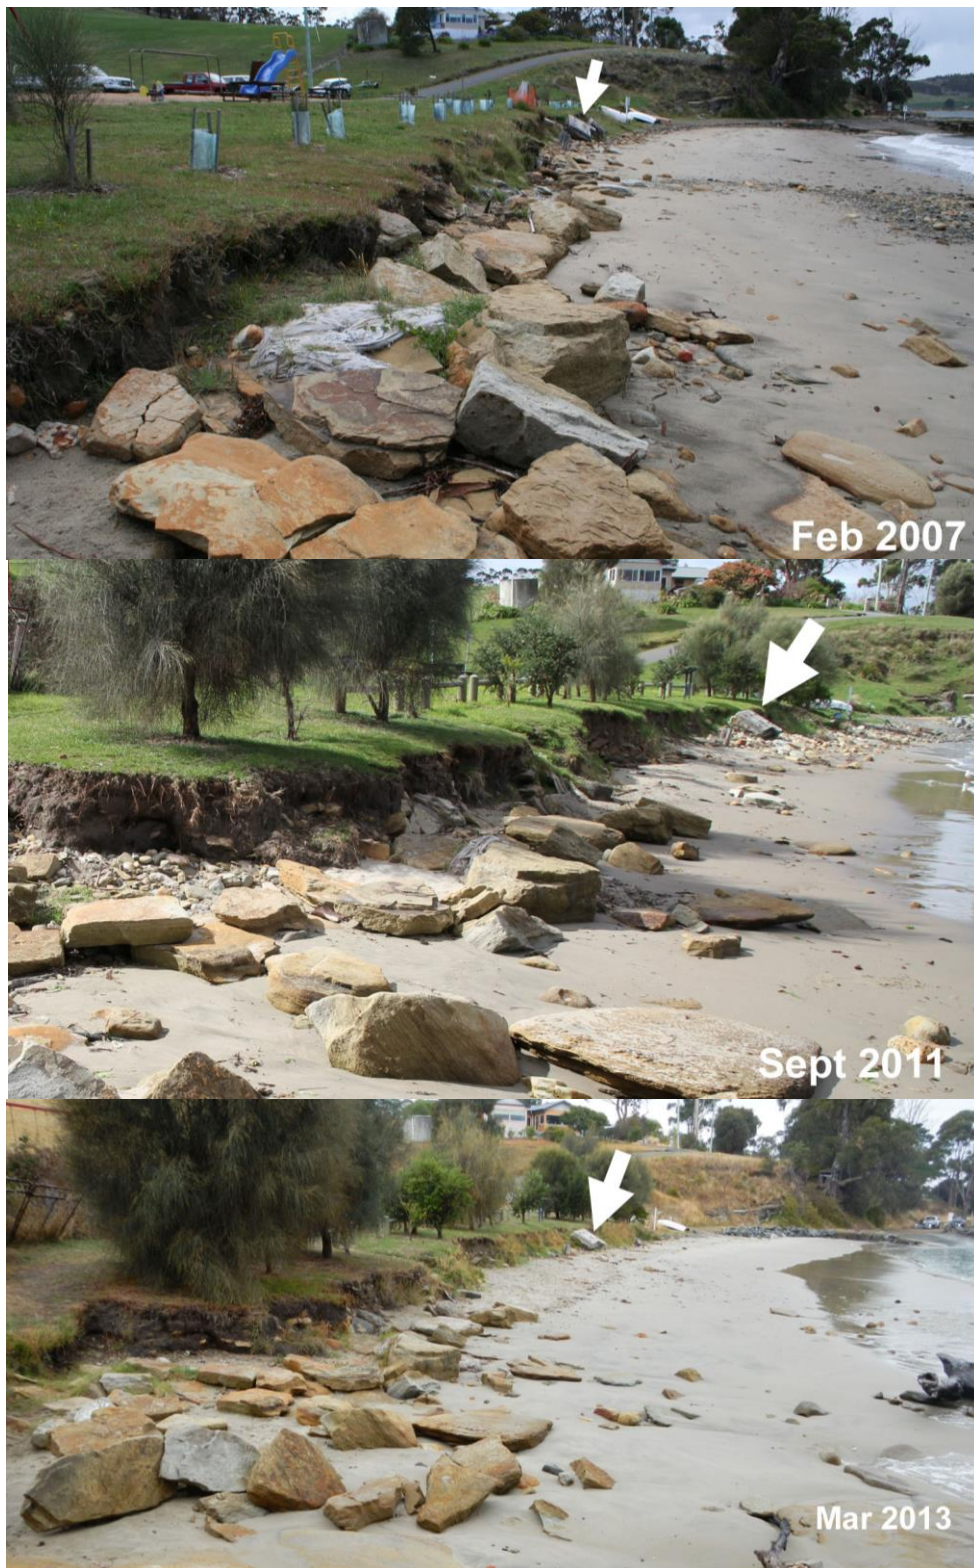
**Figure 12: Three views along the same section of Tinderbox Beach in 2007, 2011 and 2013.** View east from west end of beach; white arrow indicates the same concrete slab in each photo. The photos show a relatively fresh and active erosion scarp throughout the period, although the 2013 photo shows some vegetation growth since a major erosion event in 2011. Comparison with Figure 10 above shows a fresh scarp in 2021 equivalent to part of the scarp section close to the viewpoint in the 2013 photo above. However, no quantitative monitoring of change in this scarp has yet been undertaken. Photos by Rolan Eberhard.

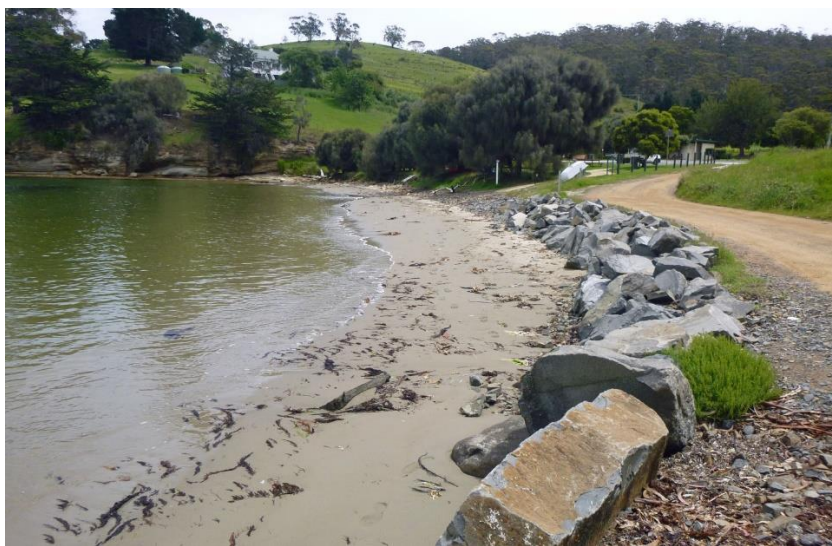
- Local resident Rolan Eberhard (recent comment to C. Sharples) notes that local residents generally do not like the existing revetment (or ‘wall’) of angular dolerite boulders which protects the jetty road at the eastern end of the beach (see Figure 1 and Figure 13). This is reported to be because the blue-grey angular dolerite boulders imported to make the wall are quite unlike the locally occurring brownish – yellowish and sometimes rounded sandstone and siltstone boulders found naturally along the foreshore. Ideally any further use of boulders and boulder walls for beach protection should use sandstone or siltstone boulders, ideally rounded if possible, so as to be more sympathetic with the nature Tinderbox environment.

**Figure 13: View west along Tinderbox Beach from the east end adjacent the Jetty.** The dolerite boulder wall (‘revetment’) in the foreground protects the jetty access road, beyond which the eroding soil margin directly backs the sandy beach. Photo by C. Sharples 23<sup>rd</sup> Nov 2021.
