Arboricultural Impact Assessment Report

Lyden Builders – Sam Siggins

**1179 Channel Hwy, Huntingfield,
TAS**

Consulting Arborist

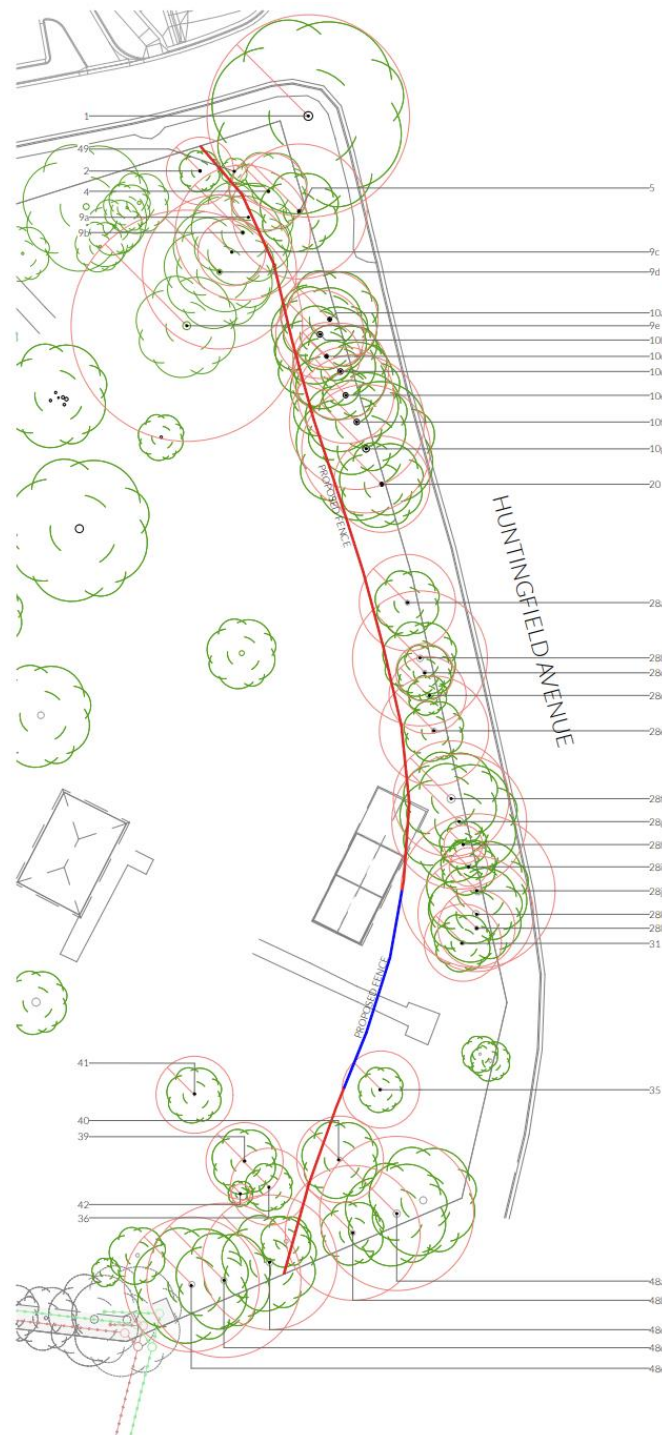
Figure 2. Drawing provided by Pinnacle showing the fence and trees. Also represented is the Tree Protection Zones (TPZ).

Trees
1, 2, 4, 5, 20, 31, 35, 36, 39, 40, 41, 42, 49
Groups
(9a, 9b, 9c, 9d, 9e) (10a, 10b, 10c, 10d, 10e, 10f, 10g) (28a, 28b, 28c, 28d, 28e, 28f, 28g, 28h, 28i, 28j, 28k, 28l) (48a, 48b, 48c, 48d, 48e)

- There are 12 individual trees that have varying levels of minor encroachment.
- There are 4 tree groups (9, 10, 28 and 48) which are multiple Cypress hedges (*Hesperocyparis macrocarpa*).

- All encroachment is minor.
- Proposed fence post holes to be 300mm x 300mm. This total surface area represents less than 10% in any TPZ.
- Fence posts to be 3 meters apart.

- The total fence length is approximately 150m long.
- Approximately 50 post holes.
- Fence post holes inside the TPZ to be installed under the supervision of a suitable qualified arborist (diploma or higher).

- Post holes withing TPZ to be hand dug to 30cm to ensure no root damage first before mechanical aid is used. Harsh soil profile suggest it will be unlikely to find roots deeper then 300mm.

- Bog mats and ground protection to be used to protect roots.
- Any roots damage to be pruned square with a hand saw.
- Minor adjustment of post hole location to avoid any significant roots.
