LANDSLIDE ASSESSMENT REPORT

Tarooma High School

104 Channel Highway

November 2023

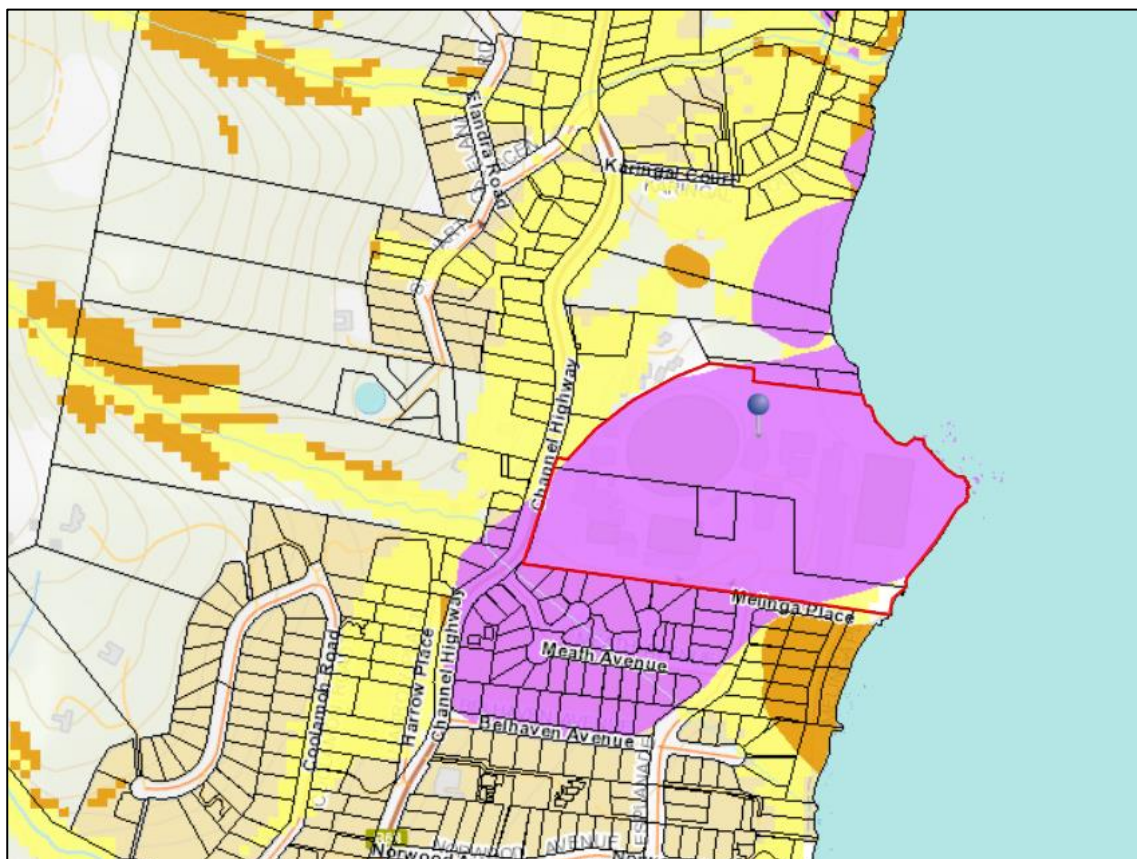
The proposed storage shed is located within a Medium Active Landslide Hazard Area overlay (figure 1). The mapped Landslide Hazard overlay has been generated by Mineral Resources Tasmania (MRT), but no known active landslides have occurred in the immediate area and are restricted to the coastline due to undercutting (see figures).

Figure 1: LIST Map topographic base map with the MRT Landslide Hazard Bands overlay: *Medium Active Landslide (purple)*. The blue pin marks the location of the proposed shed.

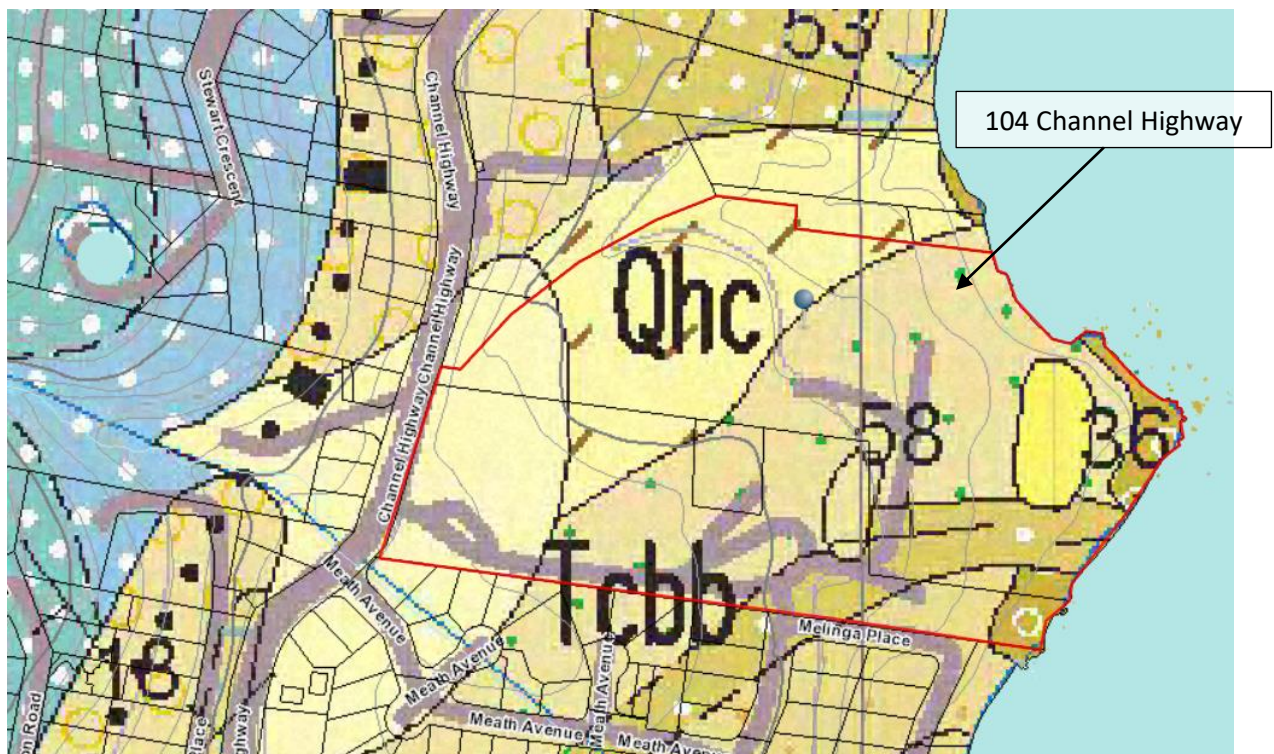
Figure 2: Mineral Resources Tasmania Geology 1:25 000 Tarooma sheet geological polygons of the environs around 104 Channel Highway, Tarooma. Pale yellow areas are mapped as Quaternary colluvium and pale brown areas are mapped as Tertiary boulder beds in clayey matrix.

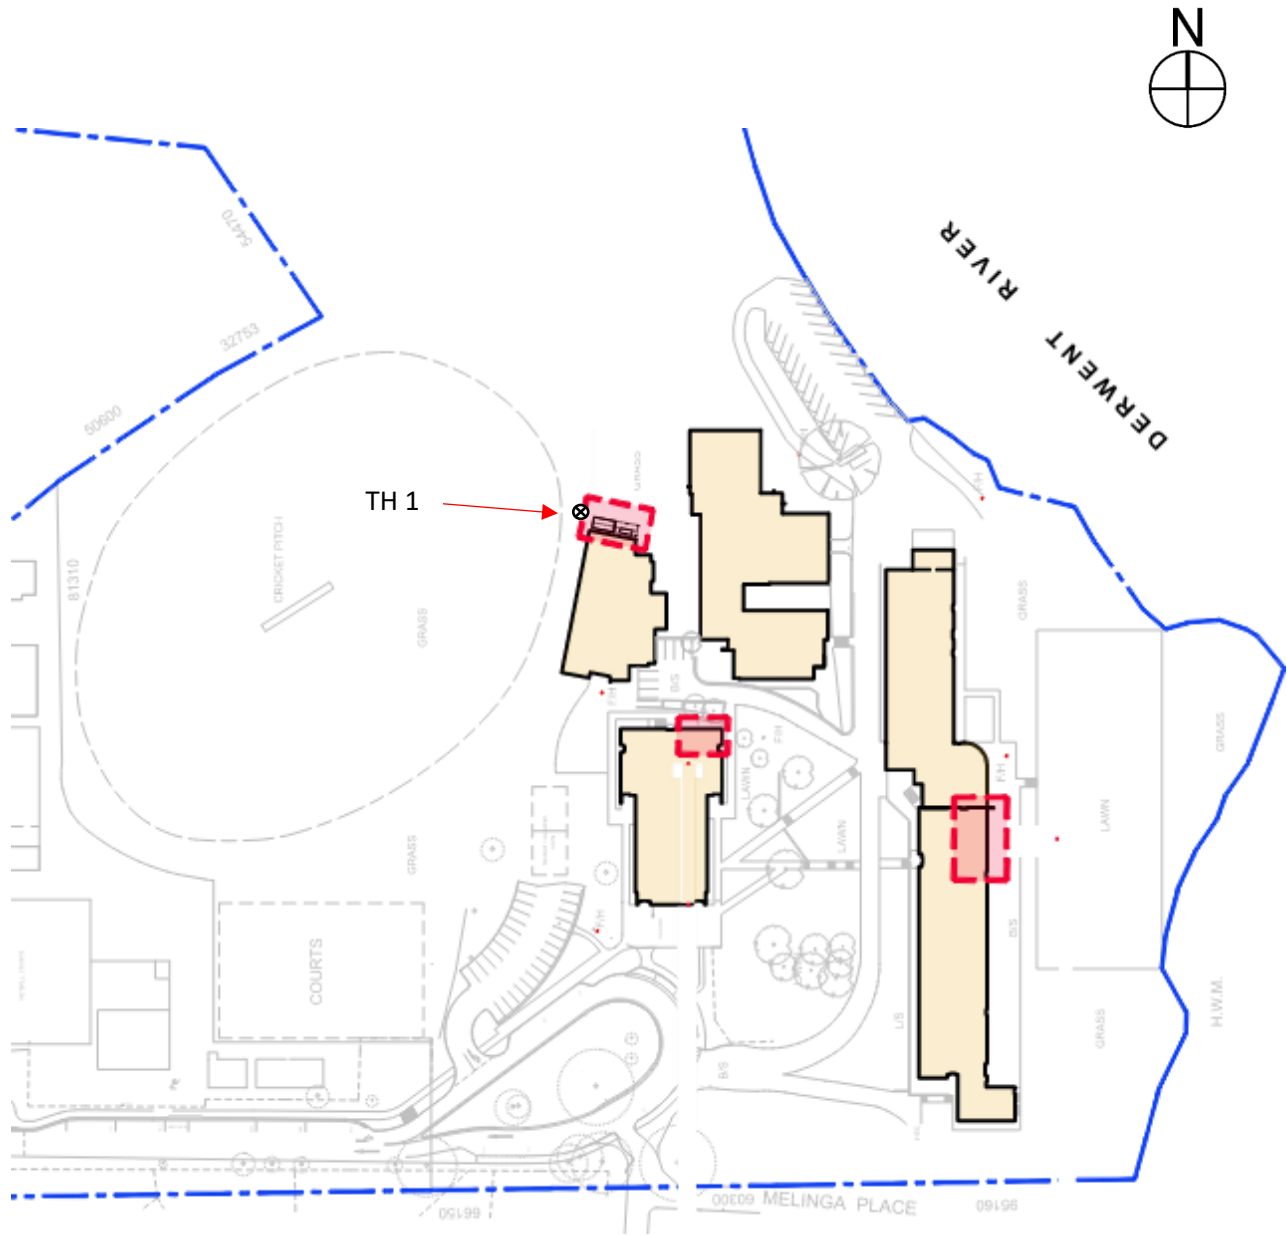
Appendix 1 – Approximate test hole location

The proposed development area is on moderate slopes of approximately 6 – 8° with well-established vegetative cover of grass. One auger hole and an assessment of an existing cut revealed *mostly* shallow clay and clay loam subsoils developing above variably weathered Tertiary boulder beds as mapped. Deeper pockets of more weathered and unconsolidated dolerite and earth material exist, to observed depths of approximately 1.9 m

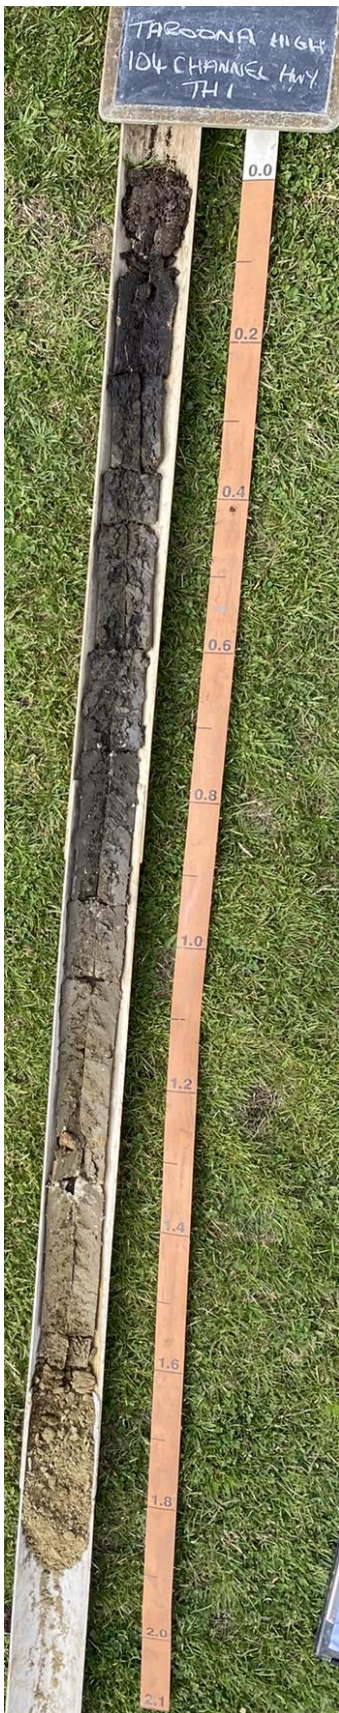
Appendix 4 – Soil Profiles – Test Hole 1

Depth (m)	Horizon	Description and field texture grade	USCS Class
0.0 – 0.2	A1	Very dark brown (10YR 2/2) Sandy Clay Loam , strong fine angular blocky structure, slightly moist loose consistency, common roots.	SC
0.2 – 0.35	B2 ₁	Black (10YR 2/2), Sandy Light Clay , massive, slightly moist soft consistency, few roots.	CH
0.35 – 0.9	B2 ₂	Dark grey (2.5y 4/1) Silty Light Clay , massive, moist soft consistency to 0.8 m then slightly moist firm consistency, black soil down cracks to to ~0.6 m, trace of carbonate from 0.6 m.	CH
0.9 – 1.6	B2 ₃	Greyish brown (2.5Y 5/2), Silty Light Clay , massive, slightly moist firm consistency, few rocks, carbonate nodule at ~1.35 m.	CH
1.6 – 1.9+	BC	Light yellowish brown (2.5Y 6/4) Gritty Sandy Clay Loam , slightly moist dense consistency, common fine gravels, no refusal.	SC
