Selected Tree Assessment Report

Site Address: 17 Roslyn Avenue, Kingston Beach, TAS 7050

Assessment Date: 3 August 2025

Report Author: Gareth Fryer, Tree Guy Tasmania Pty Ltd

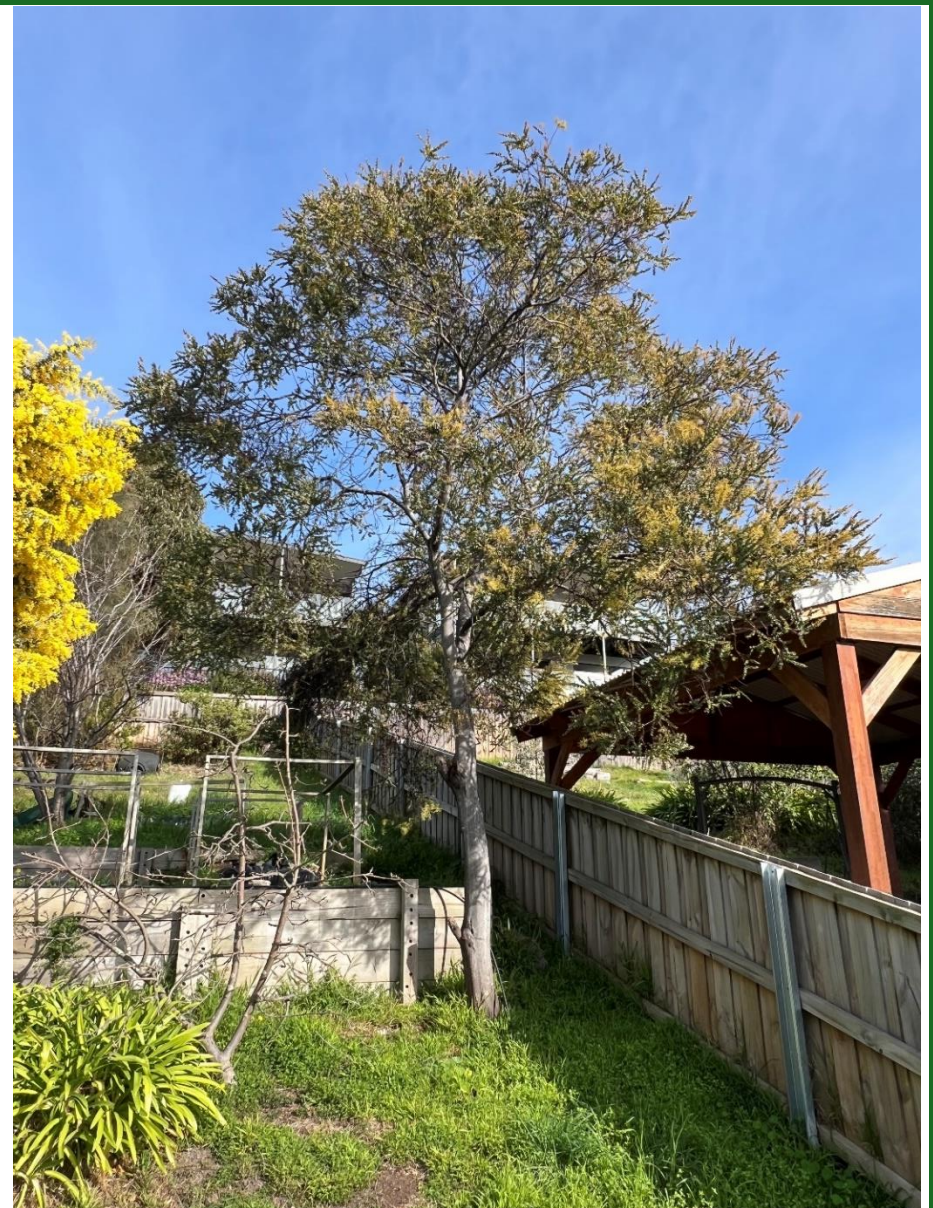
1. Tree AL: *Acacia pravissima* (Wedge leaved wattle) - 5.95m

- Located on northern boundary beside neighbour's upper garden patio structure
- Single trunk, DBH: 175mm
- Good form with average canopy cover
- Crown spread: 5.5m
- **TPZ radius:** 2.10m
- **SRZ radius:** 2.24m

1. **Protection Zone:** Establish 2.10m radius TPZ with robust fencing and signage
2. **Monitoring:** Regular inspection during construction for signs of stress
3. **Irrigation:** Ensure adequate water supply during dry periods
4. **Mulching:** Apply organic mulch to maintain soil moisture and temperature

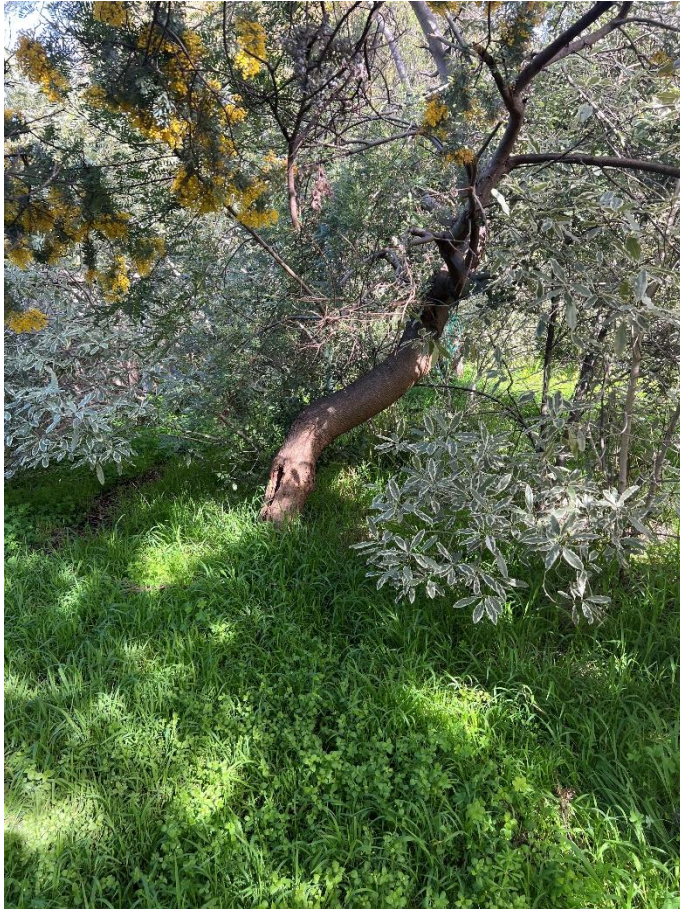
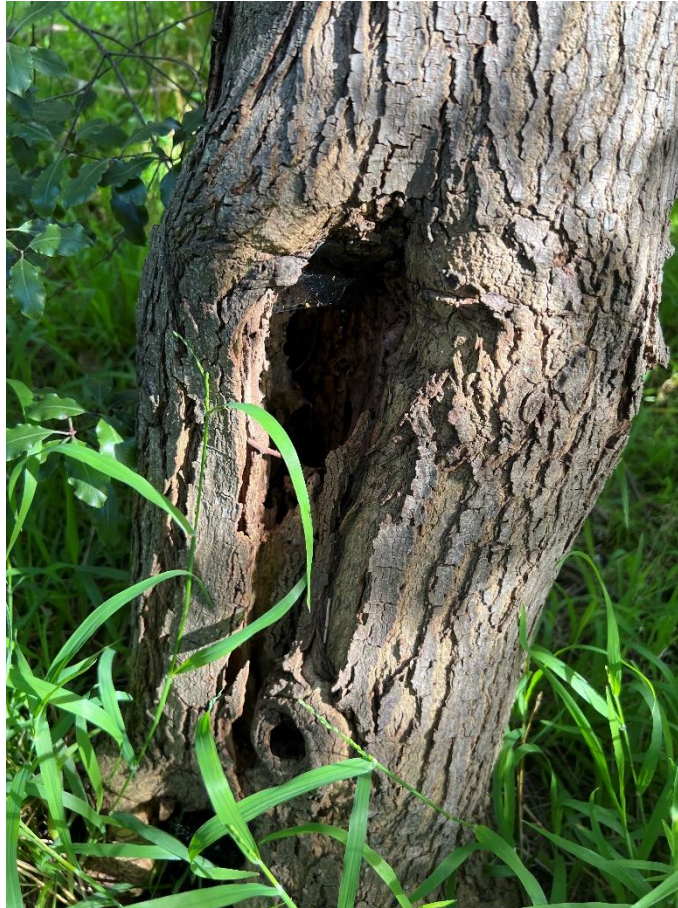
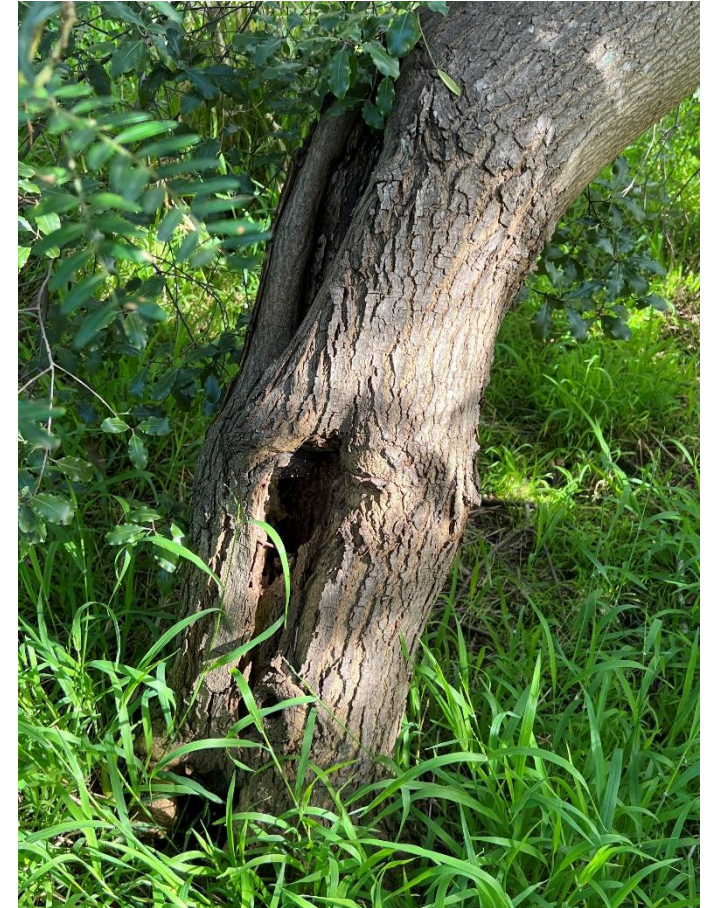
1. **Tree J (*Virgilia oroboides*):** Multiple pockets of decay, splitting and previous wounds. Tree is cantilevered towards the sun which adds more stress to these defects on the lower trunk, which will increase risk of failure.

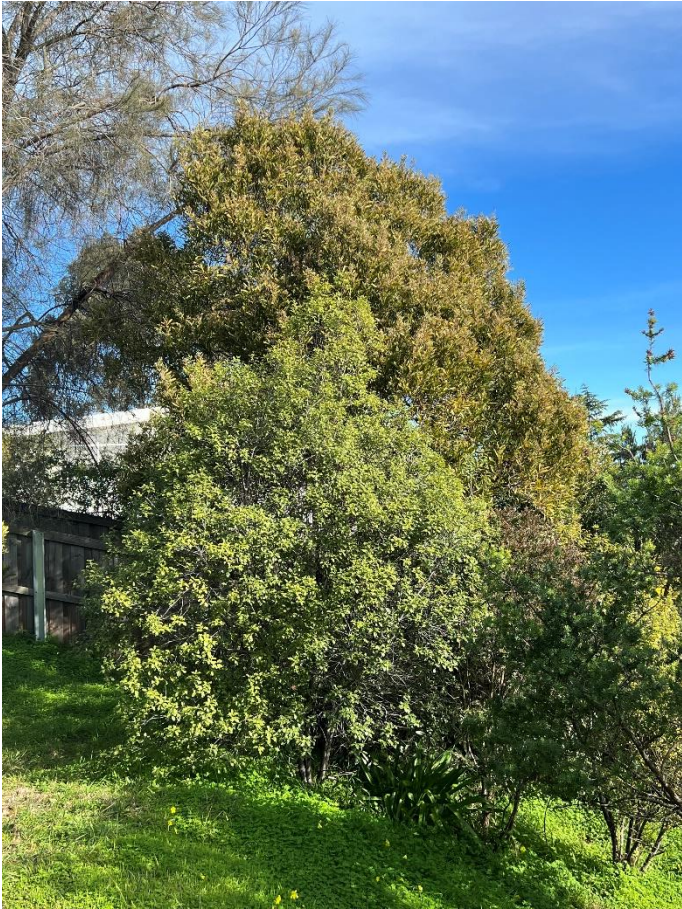
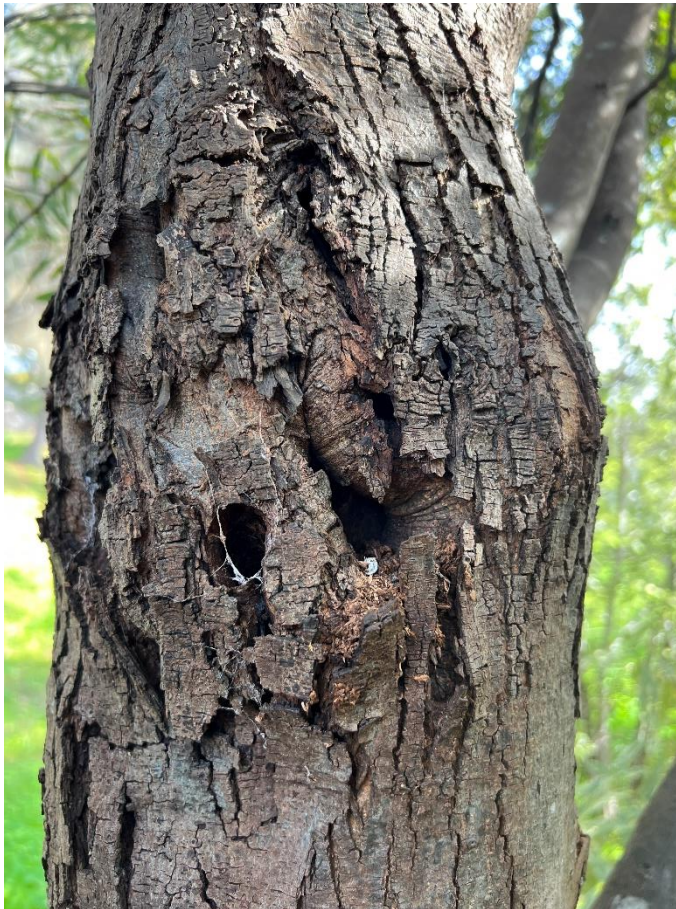
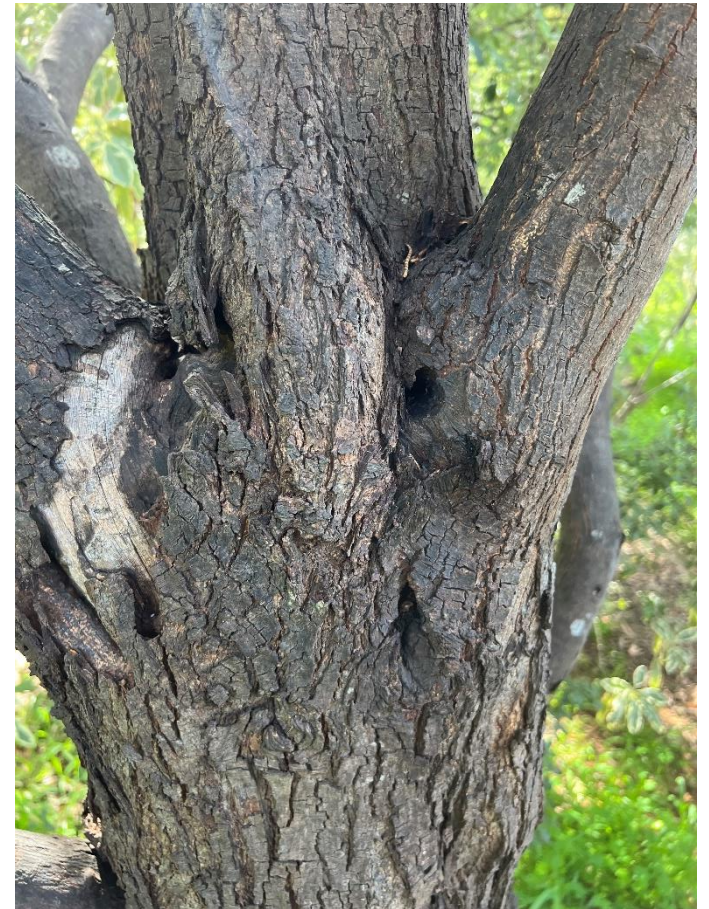
- 2. Tree H (*Acacia melanoxylan*):** Significant insect damage and included bark.

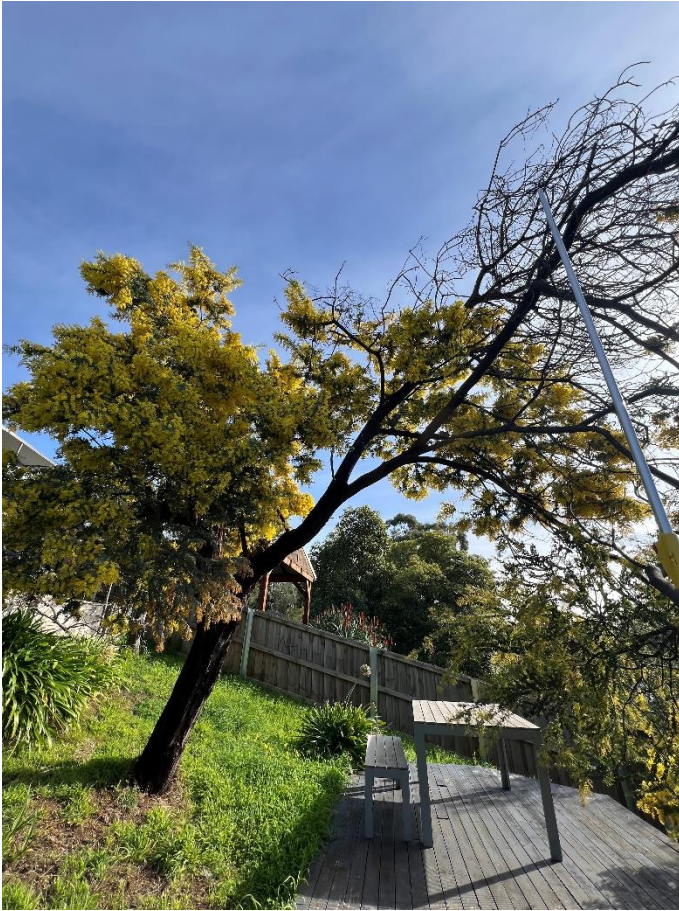
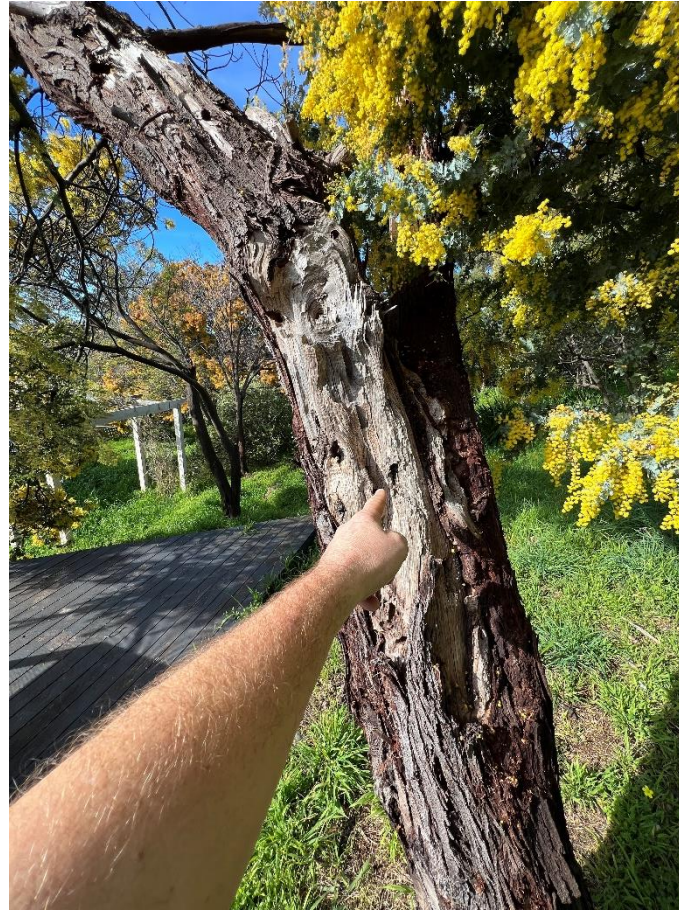
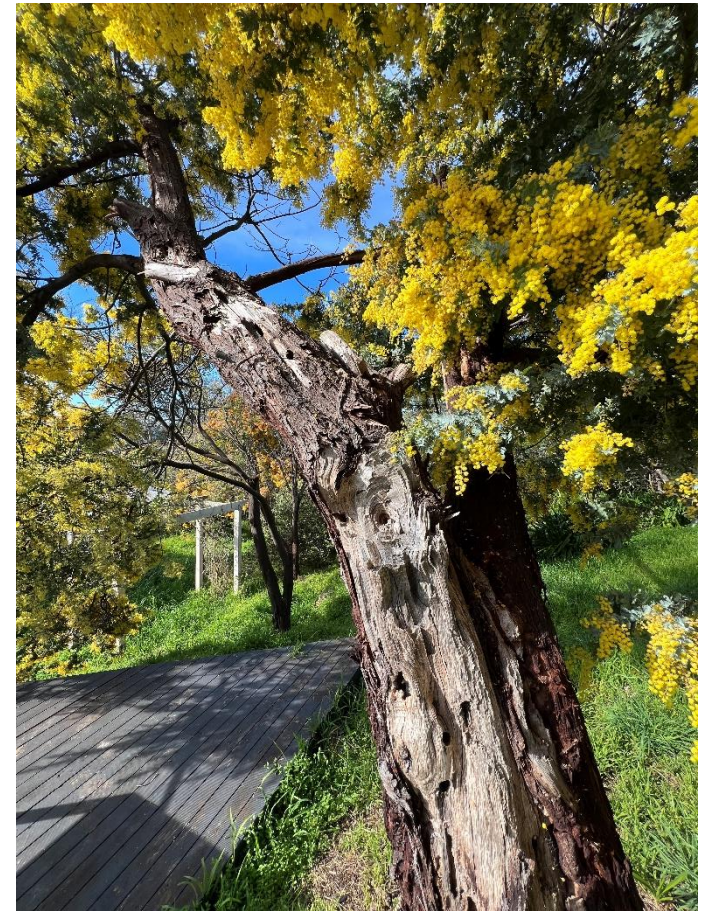
- 3. Tree L (*Acacia dealbata*):** Failure imminent, risk to life, located above upper deck.

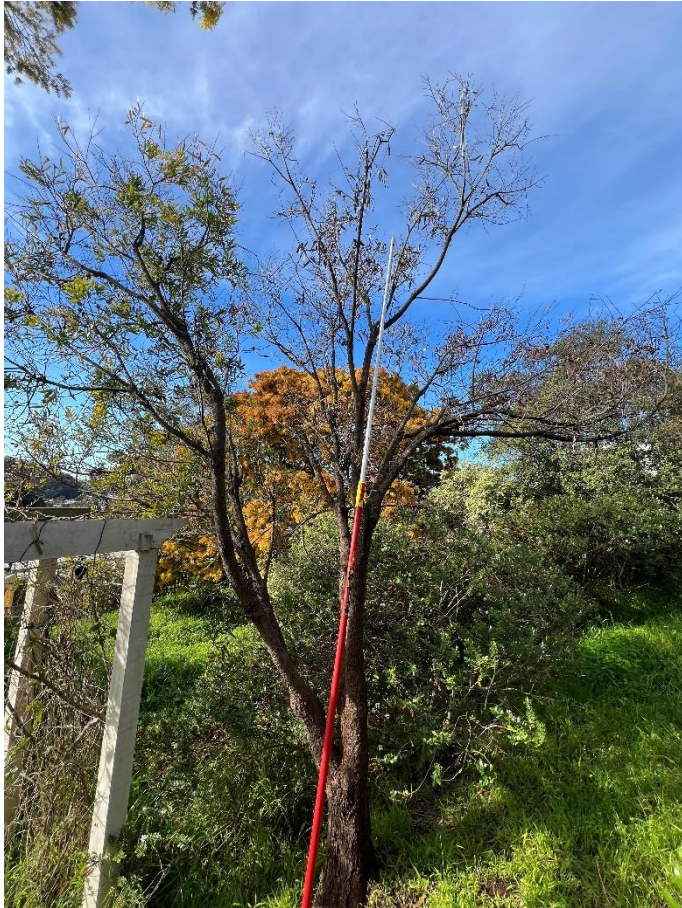
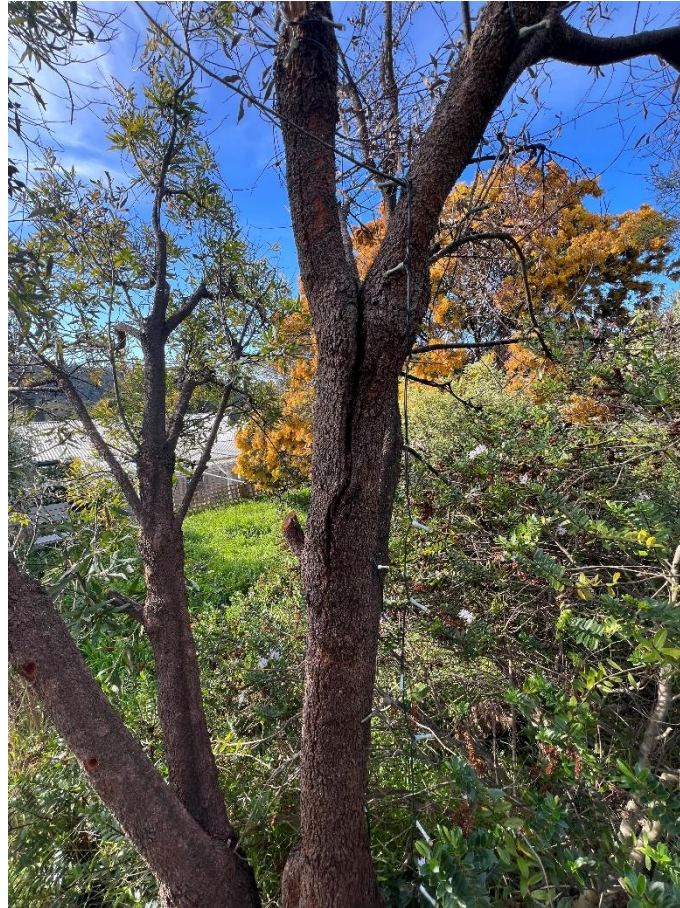
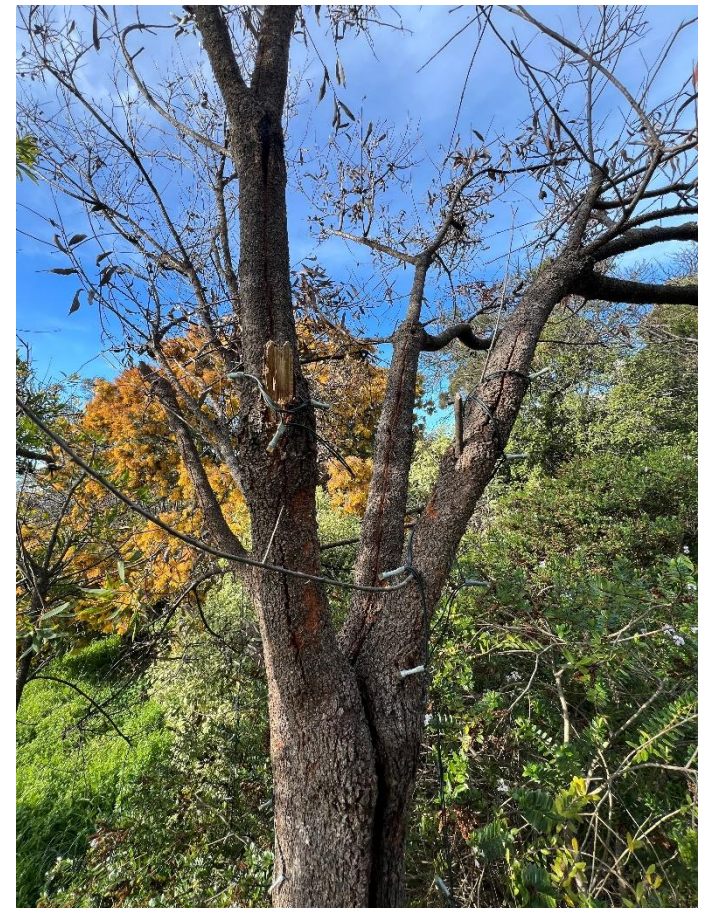
- 4. Tree AK (*Acacia melanoxylan*):** Failure imminent due to poor health and existing fracturing of stems and trunk.

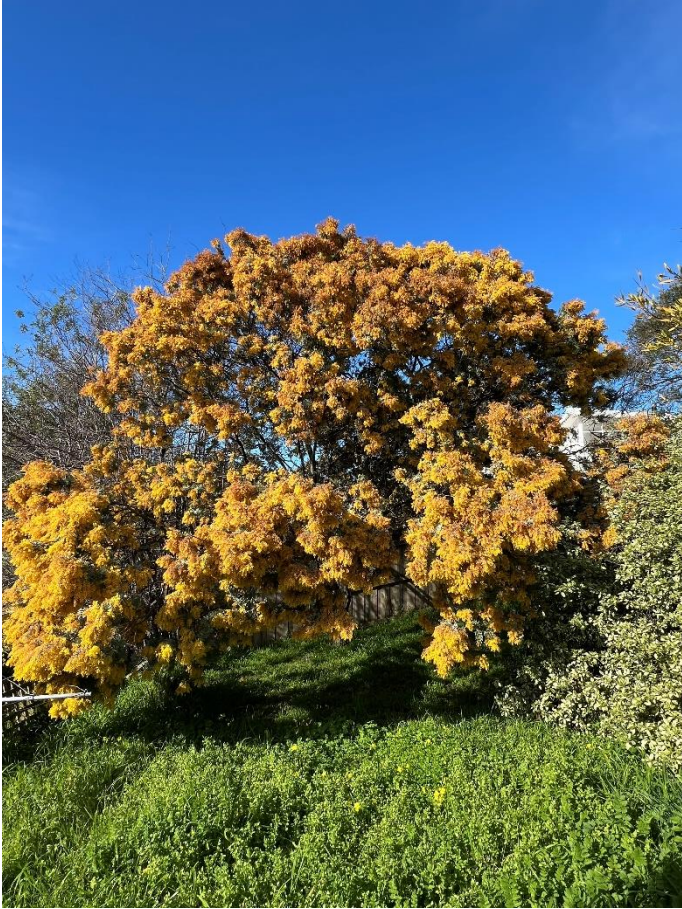
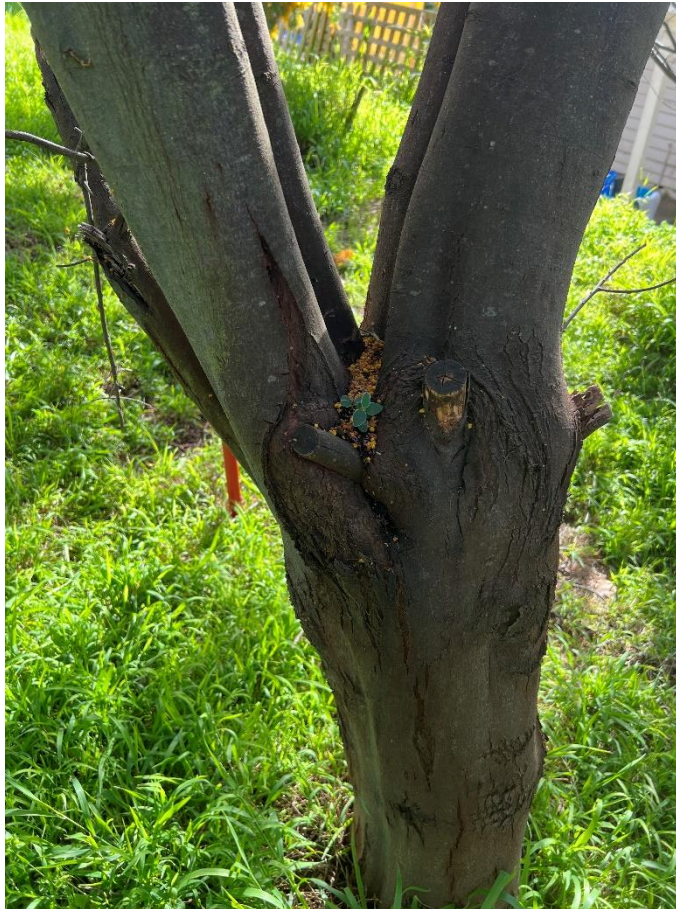
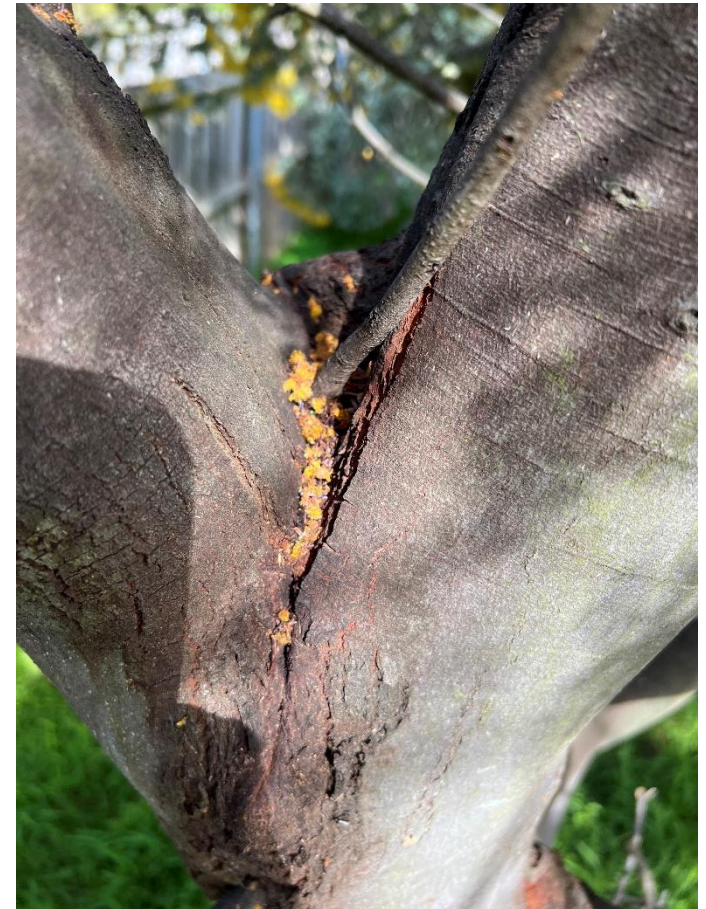
5. Tree F (*Acacia dealbata*): Included bark and decay pocket.

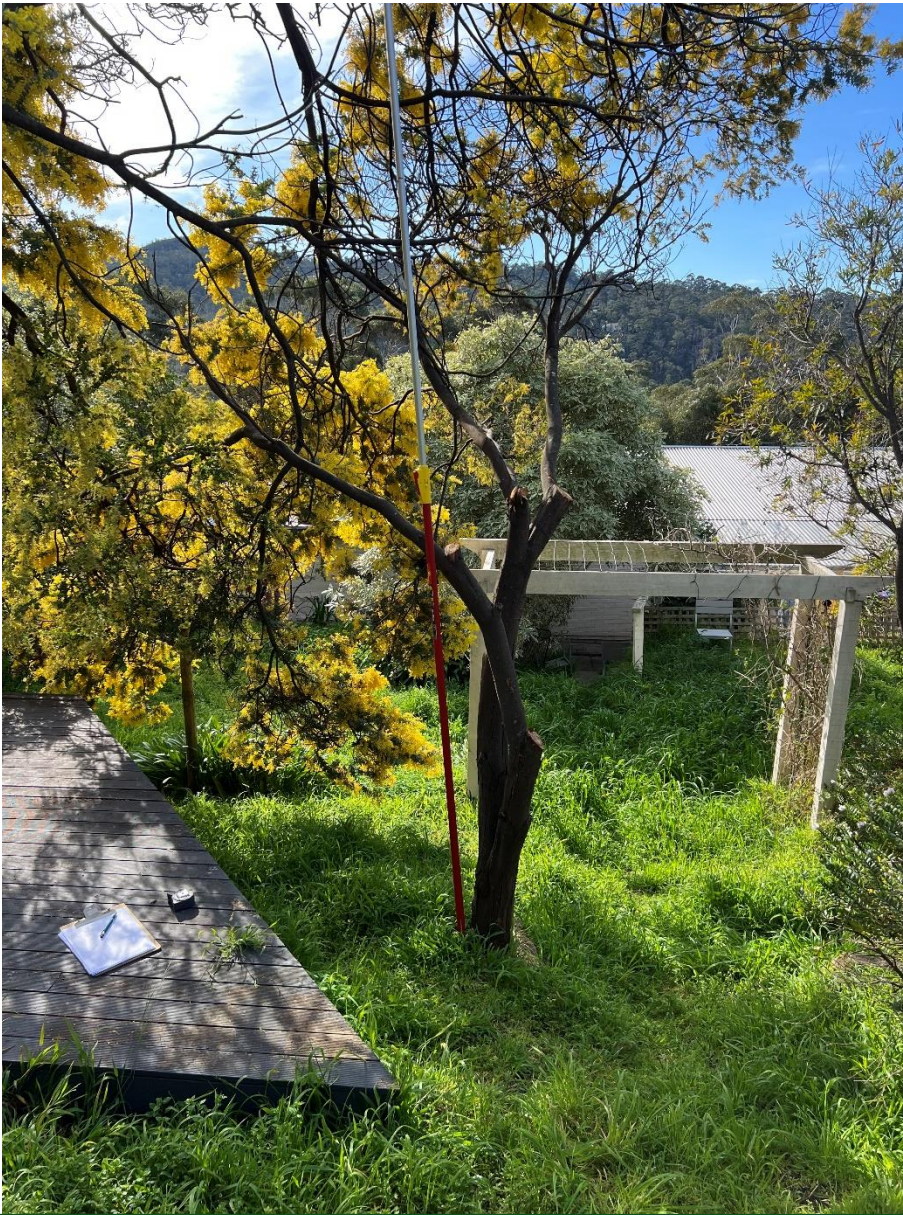
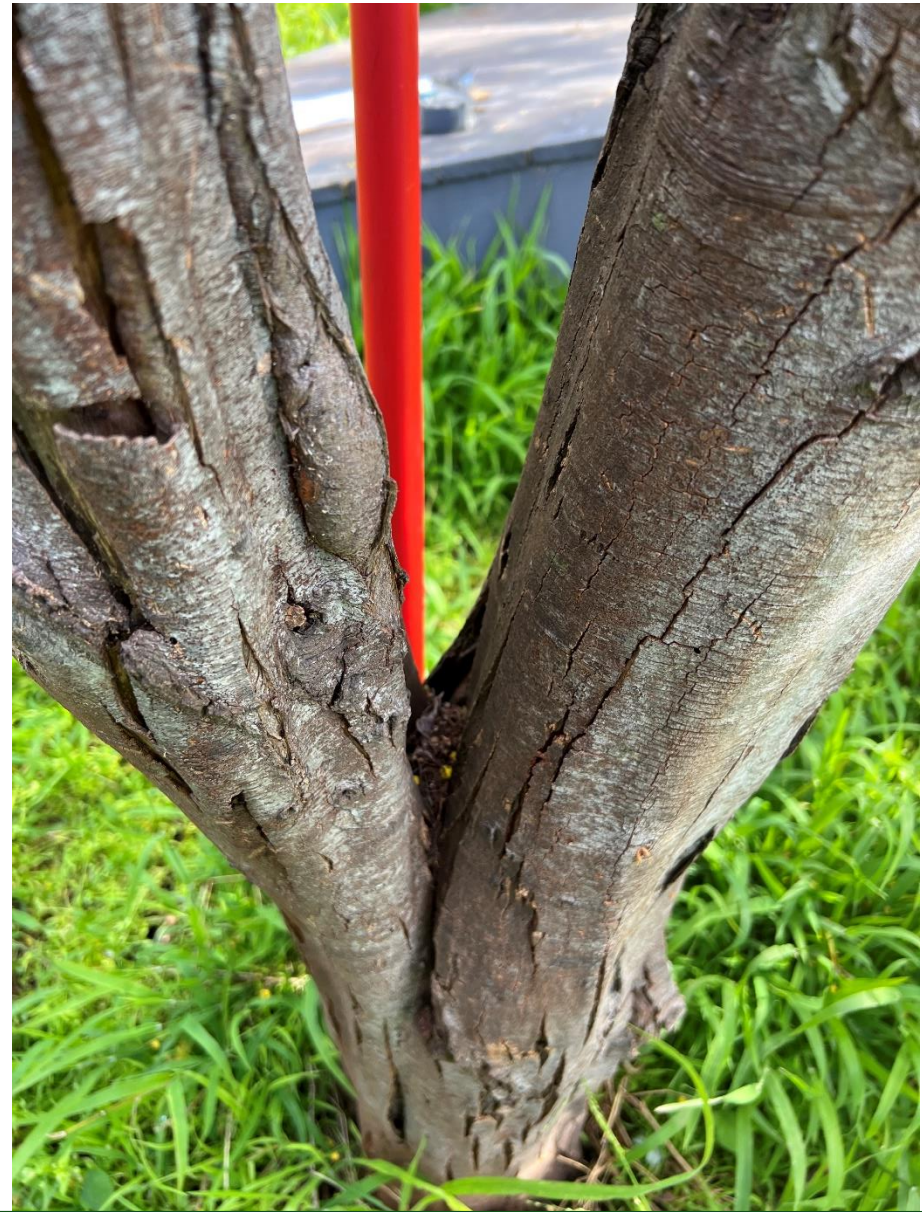
6. Tree AK2 (*Acacia dealbata*): Included bark and decay pocket.

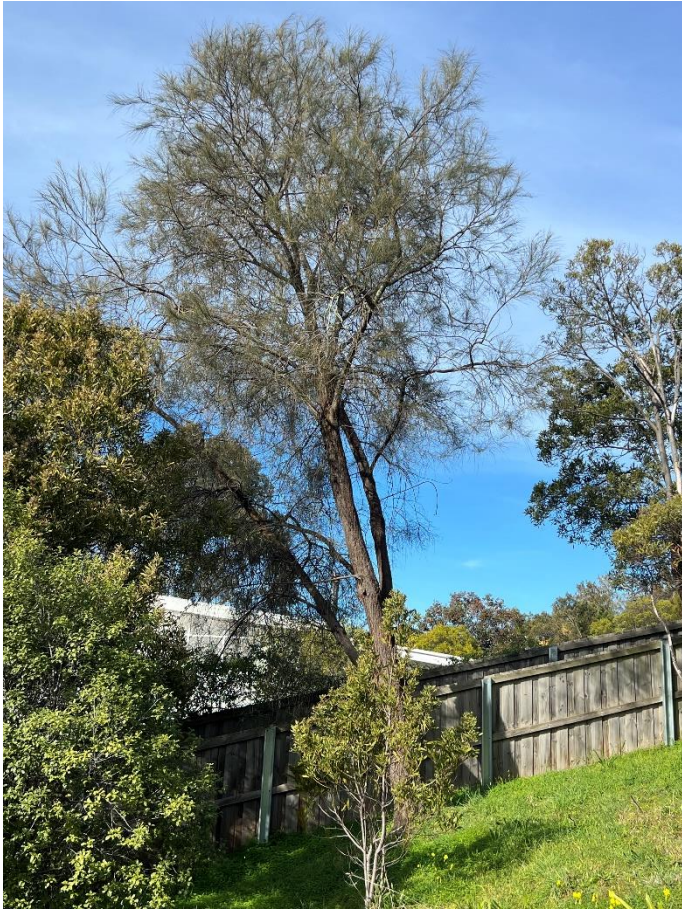
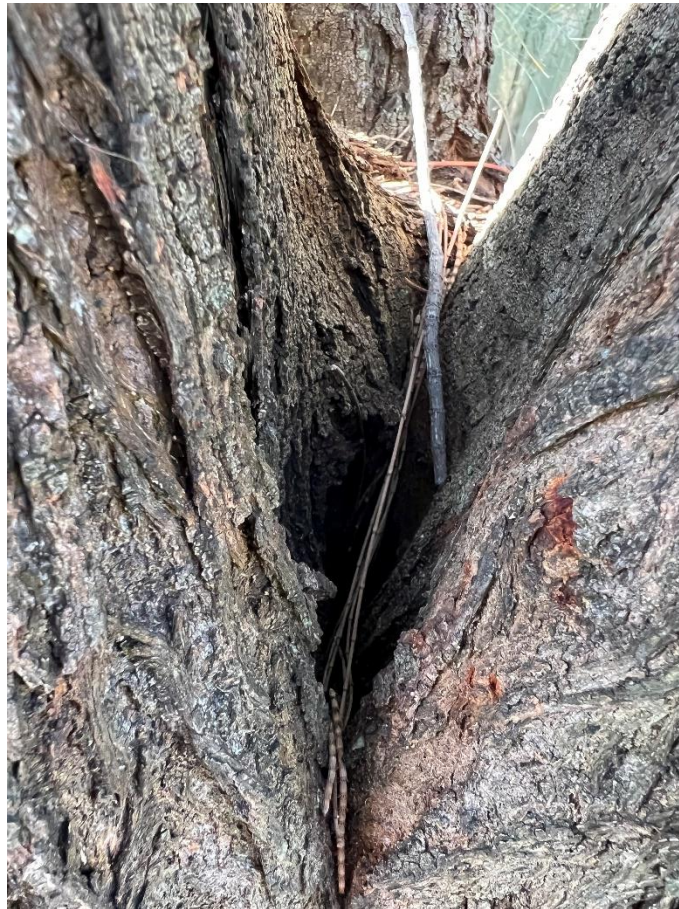
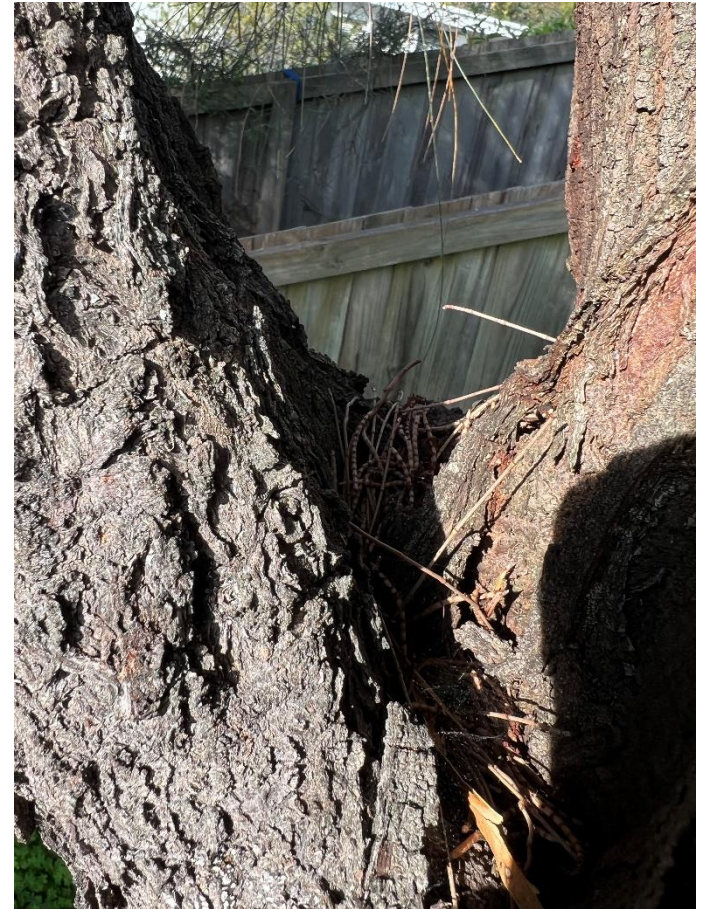
7. **Tree I (*Allocasuarina littoralis*):** Prone to wind damage, decay pockets, safety risk near adjoining public pedestrian access.

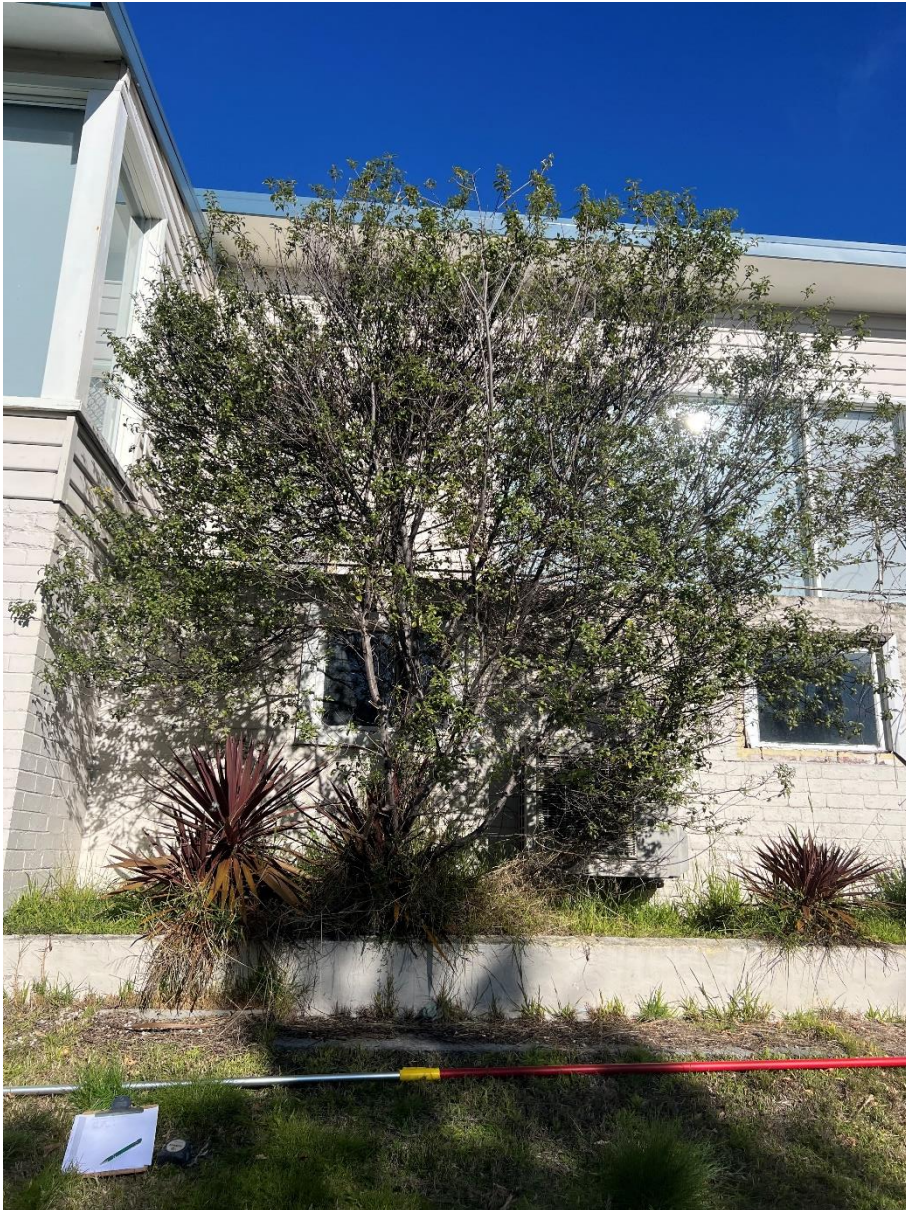
8. Tree N (*Pittosporum eugenioides*): Planted too close to house.

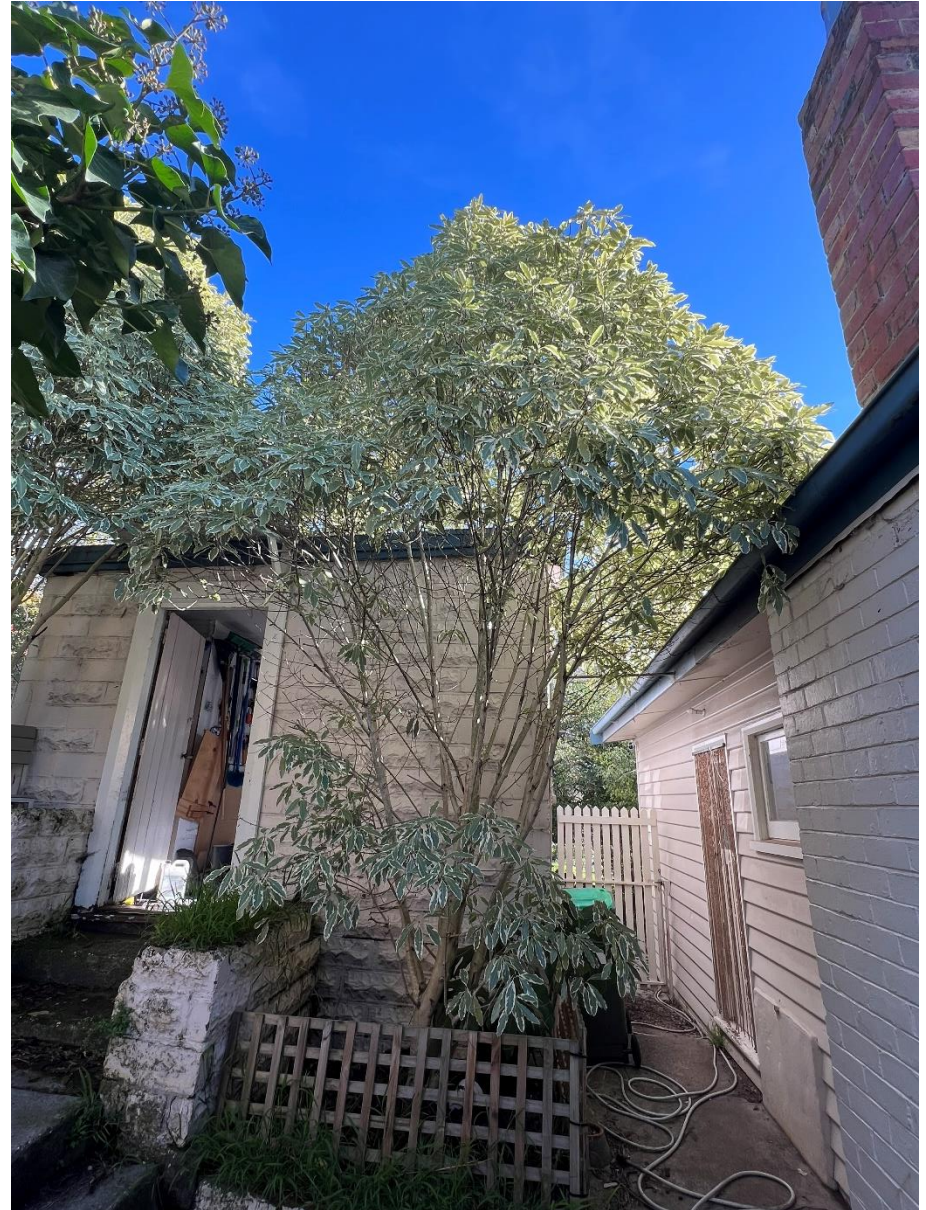
9. Trees AI (*Pittosporum eugenioides*): Planted in wrong locations.

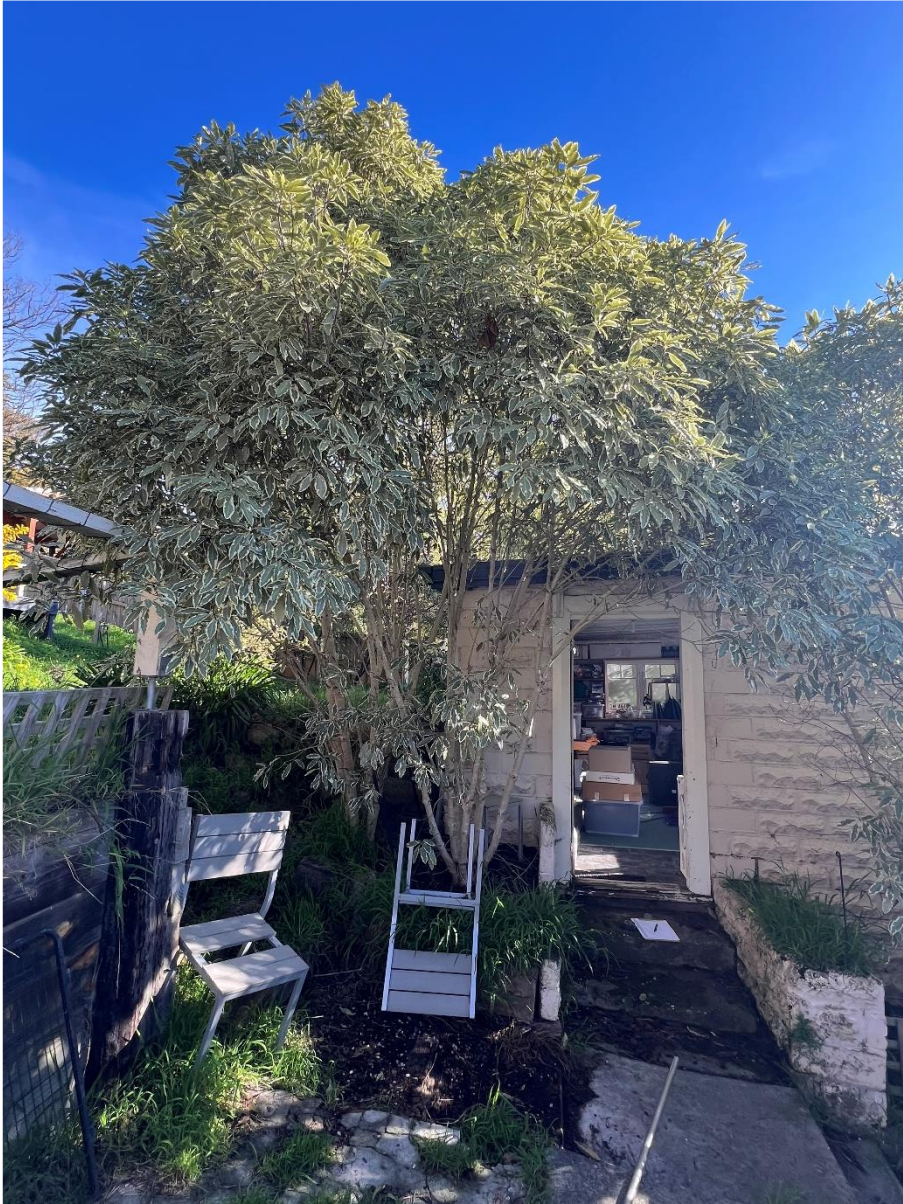
10. Trees B & C (*Pittosporum eugenioides*): Planted in wrong locations.

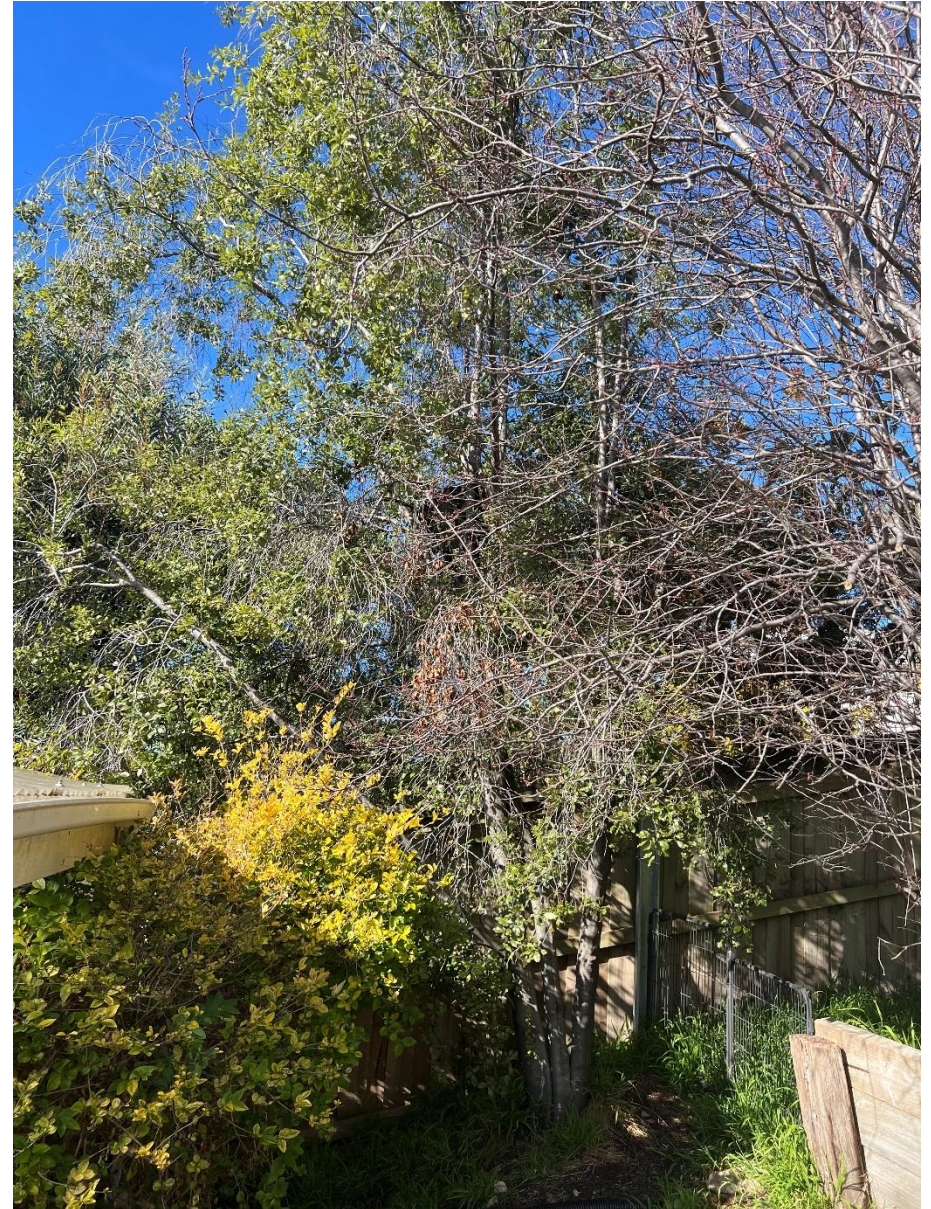
11. Tree D (*Pittosporum tenuifolium*): Planted in wrong location.

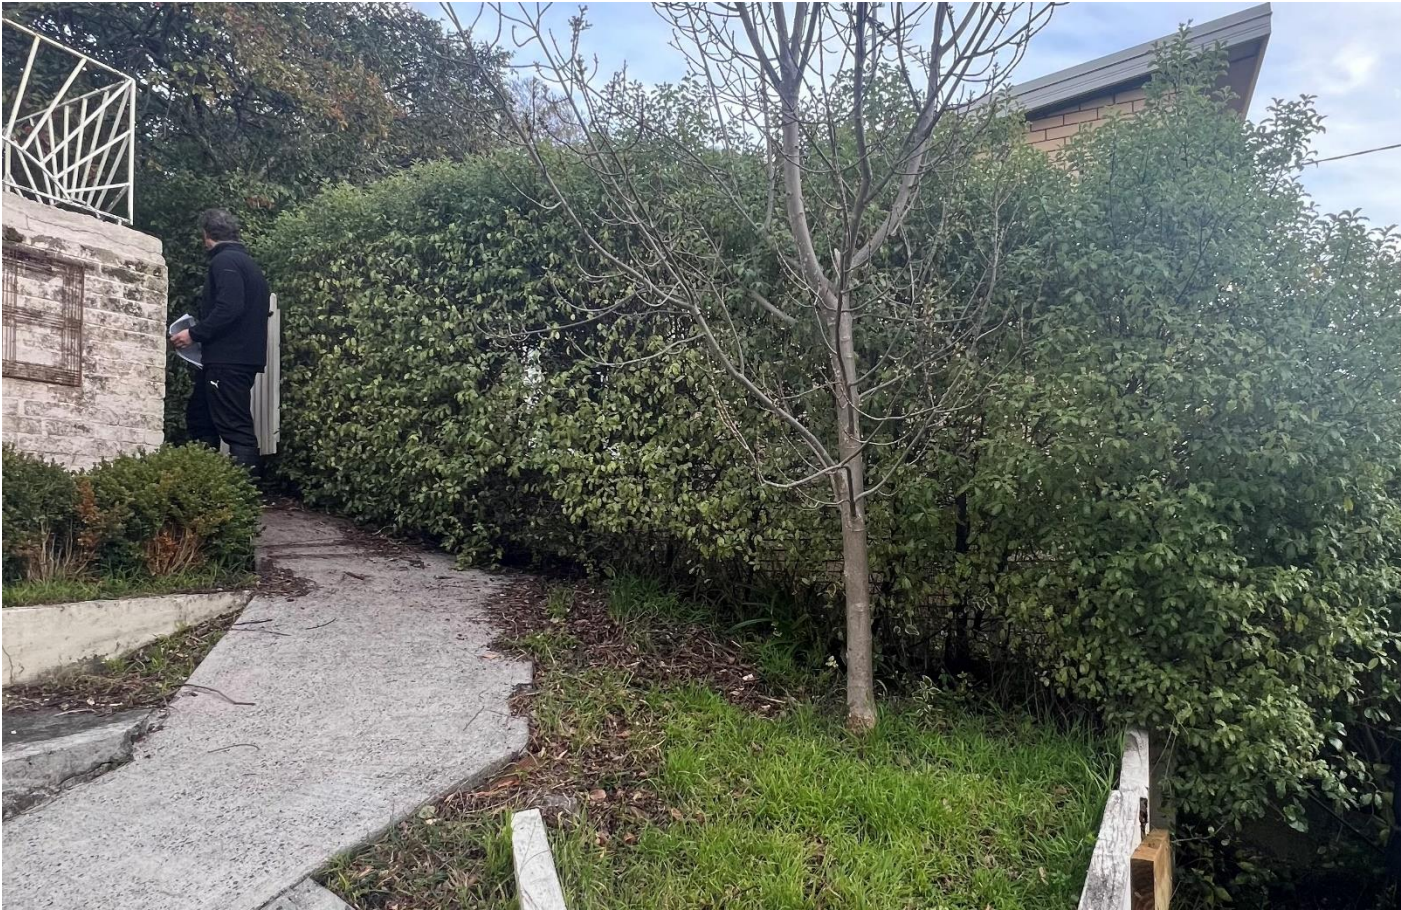
12. Hedge (*Pittosporum tenuifolium*): Encroaching on path, poor shape and not maintained. Preventing reinstatement of fencing.

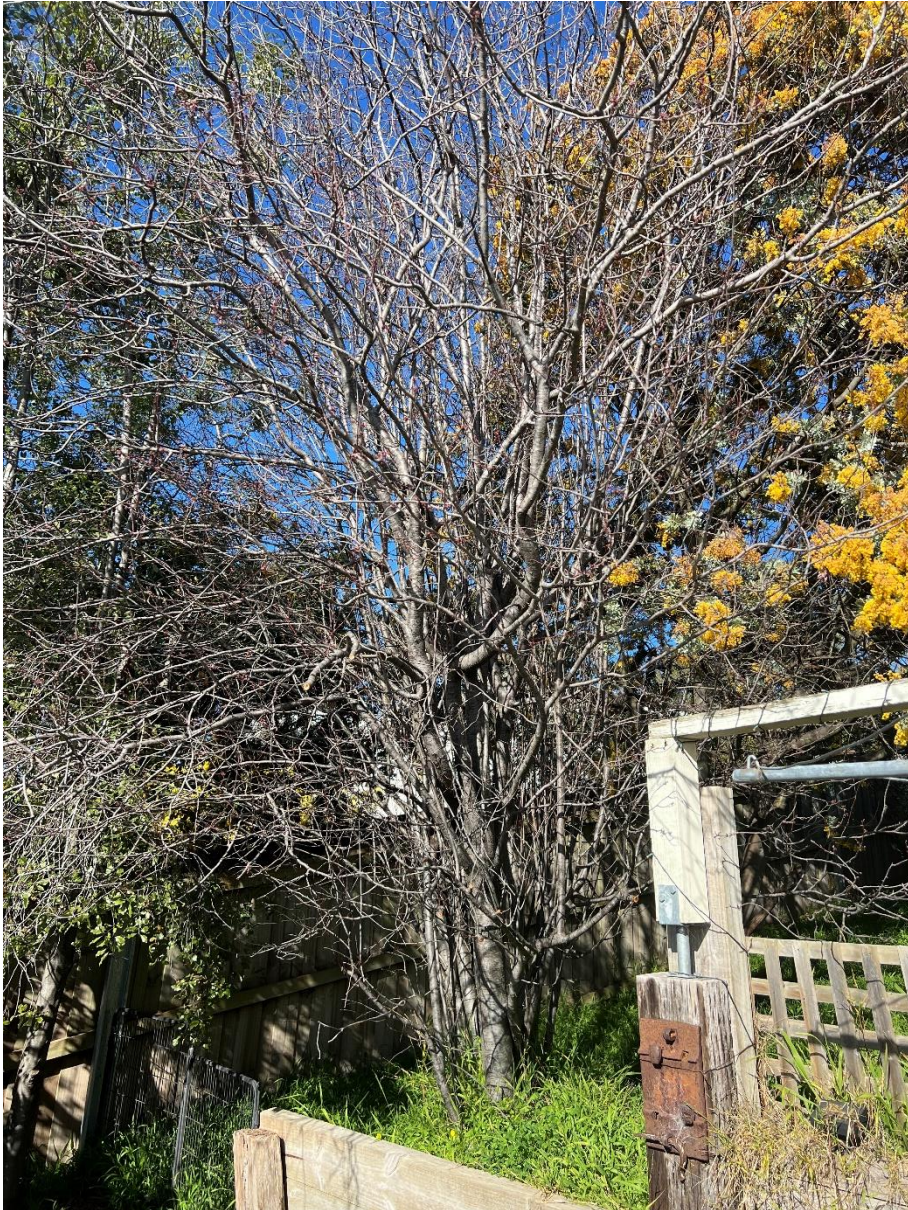
15. Tree E (*Prunus* spp.): Poor example with multitude of trunks.
