## BUSHFIRE HAZARD ASSESSMENT REPORT

PROPOSED CLASSROOMS  
32 MARANOA ROAD,  
KINGSTON

Dated April 2023

Report Code: J23-1

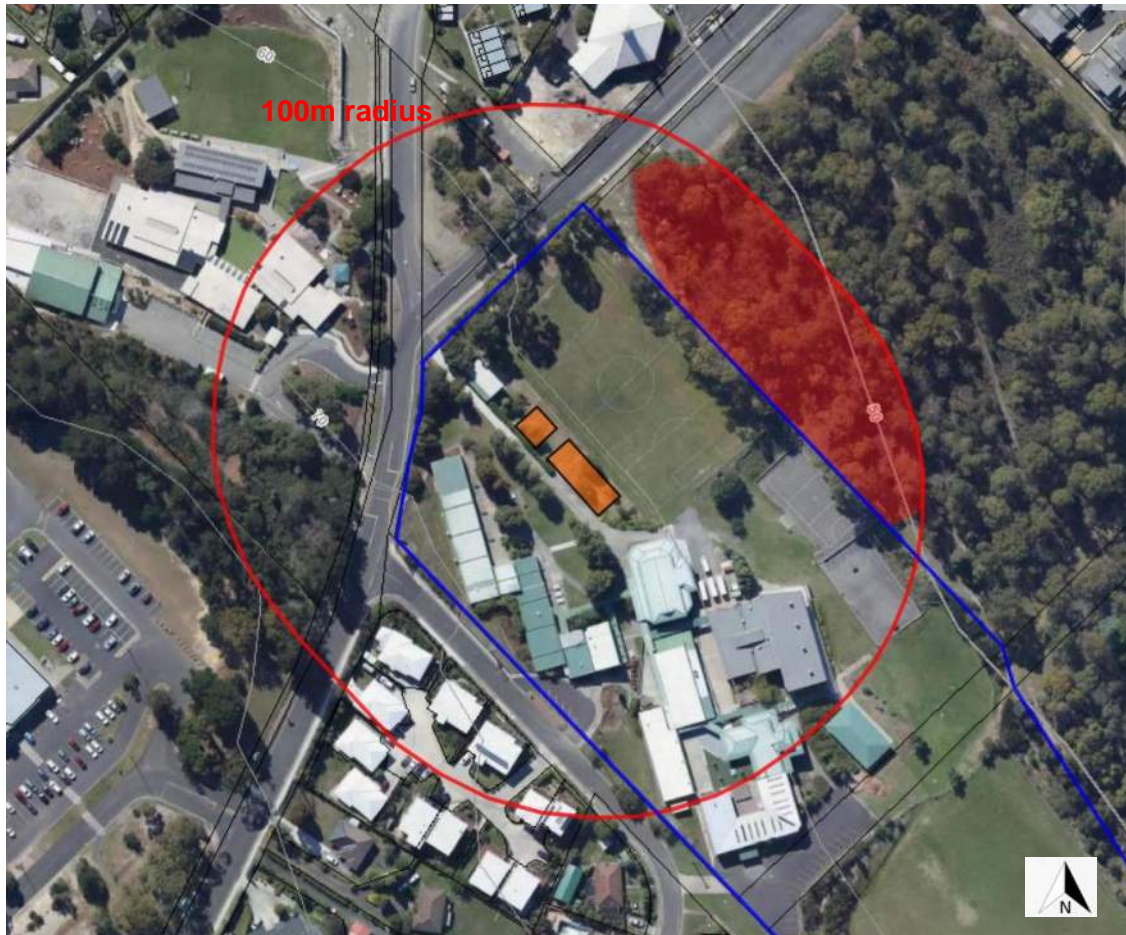
Figure 4: contoured TasVeg4.0 listmap. [www.thelist.tas.gov.au](http://www.thelist.tas.gov.au) Property outline in blue, proposed classrooms in orange. Red shading indicates down-slope bushfire prone woodland vegetation within 100m of proposal, approximately 55m from the site.

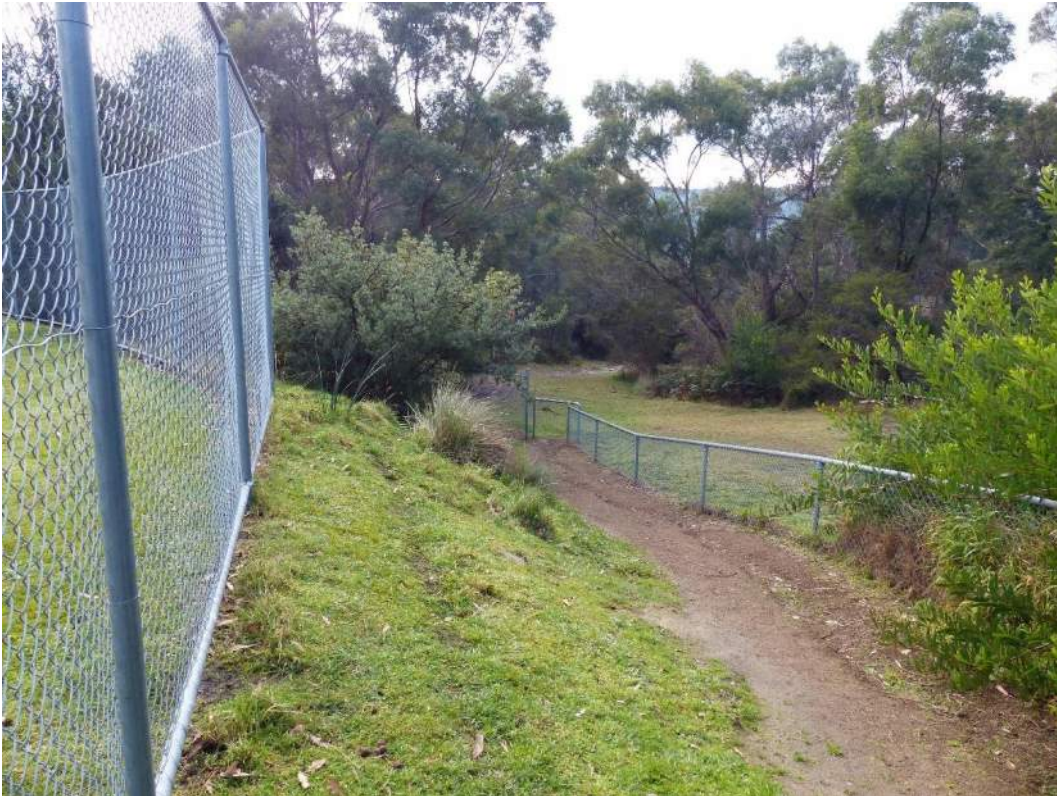
Photograph 9 – Looking north from start of pathway into woodland bushfire prone vegetation to the south east of proposal. Wire fence on left separates managed level area of school grounds.

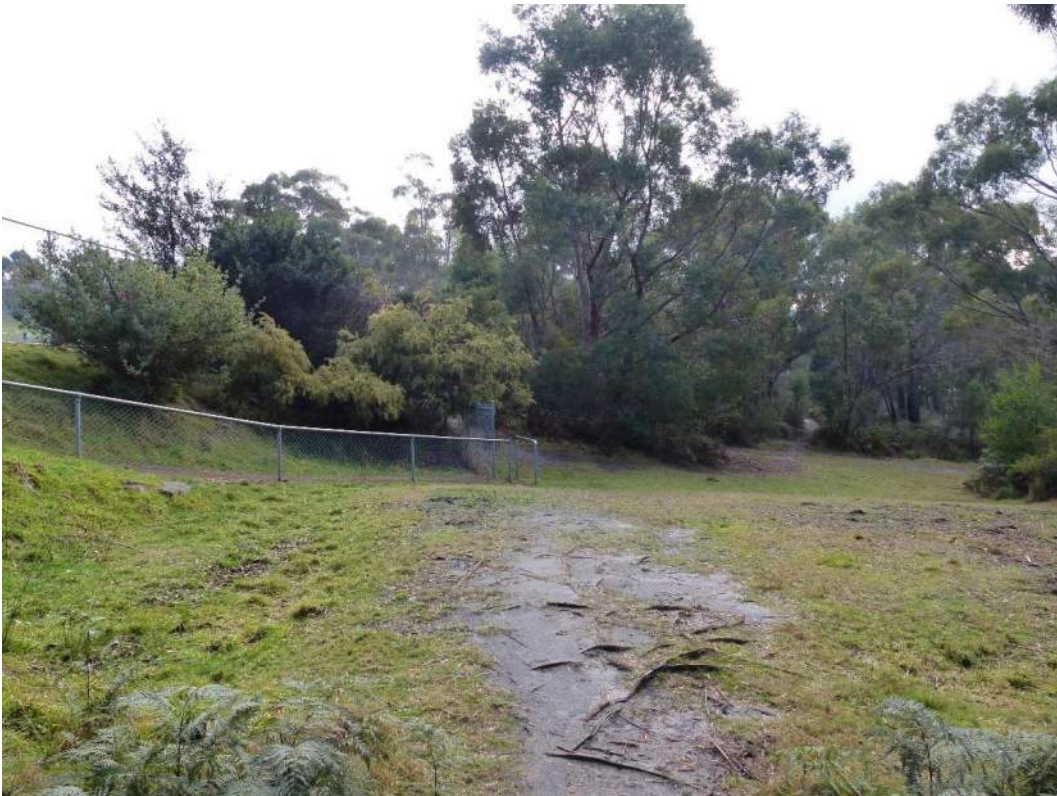
Photograph 10 – Looking north west along western section of bushfire prone vegetation, bordering the school grounds. Cleared pockets/strips are scattered throughout.

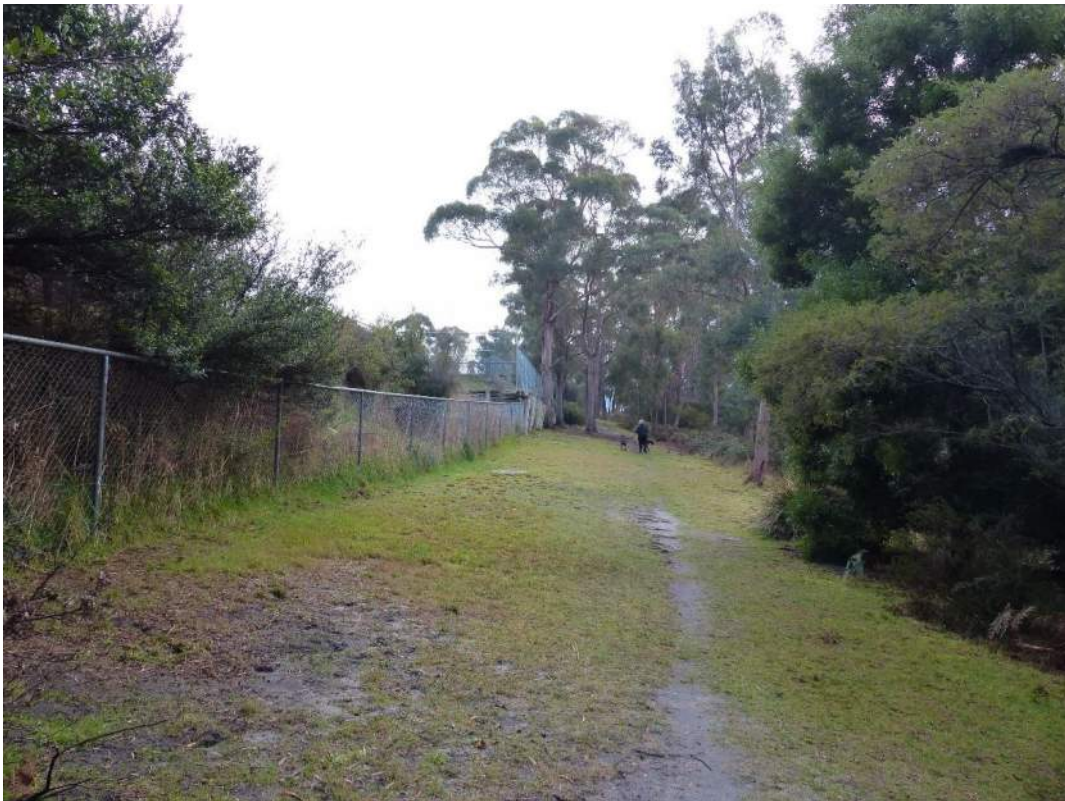
**Photograph 12 – Looking north west along eastern boundary of school grounds. Cleared and managed pathway strip approximately 9-11m wide, frequent use by community.**

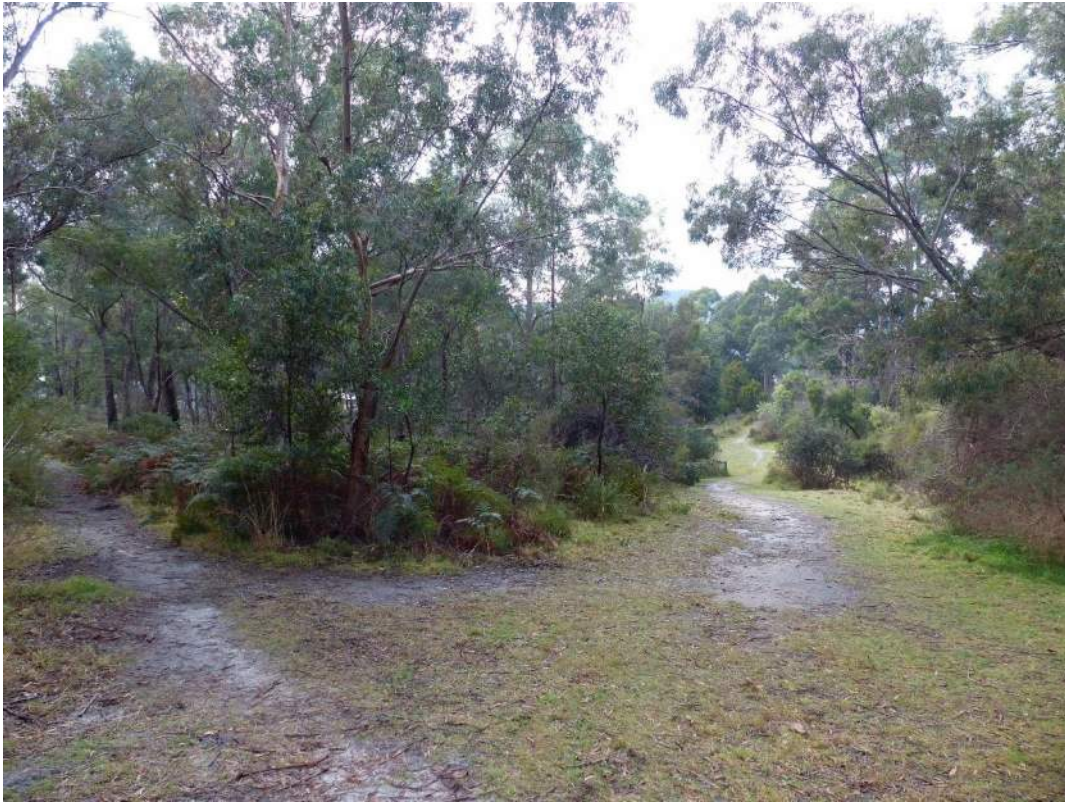
Photograph 13 – Looking east north east from 50m north east of proposed classroom. Paths through the reserve are common, with cleared strips ranging from 2-10m wide.

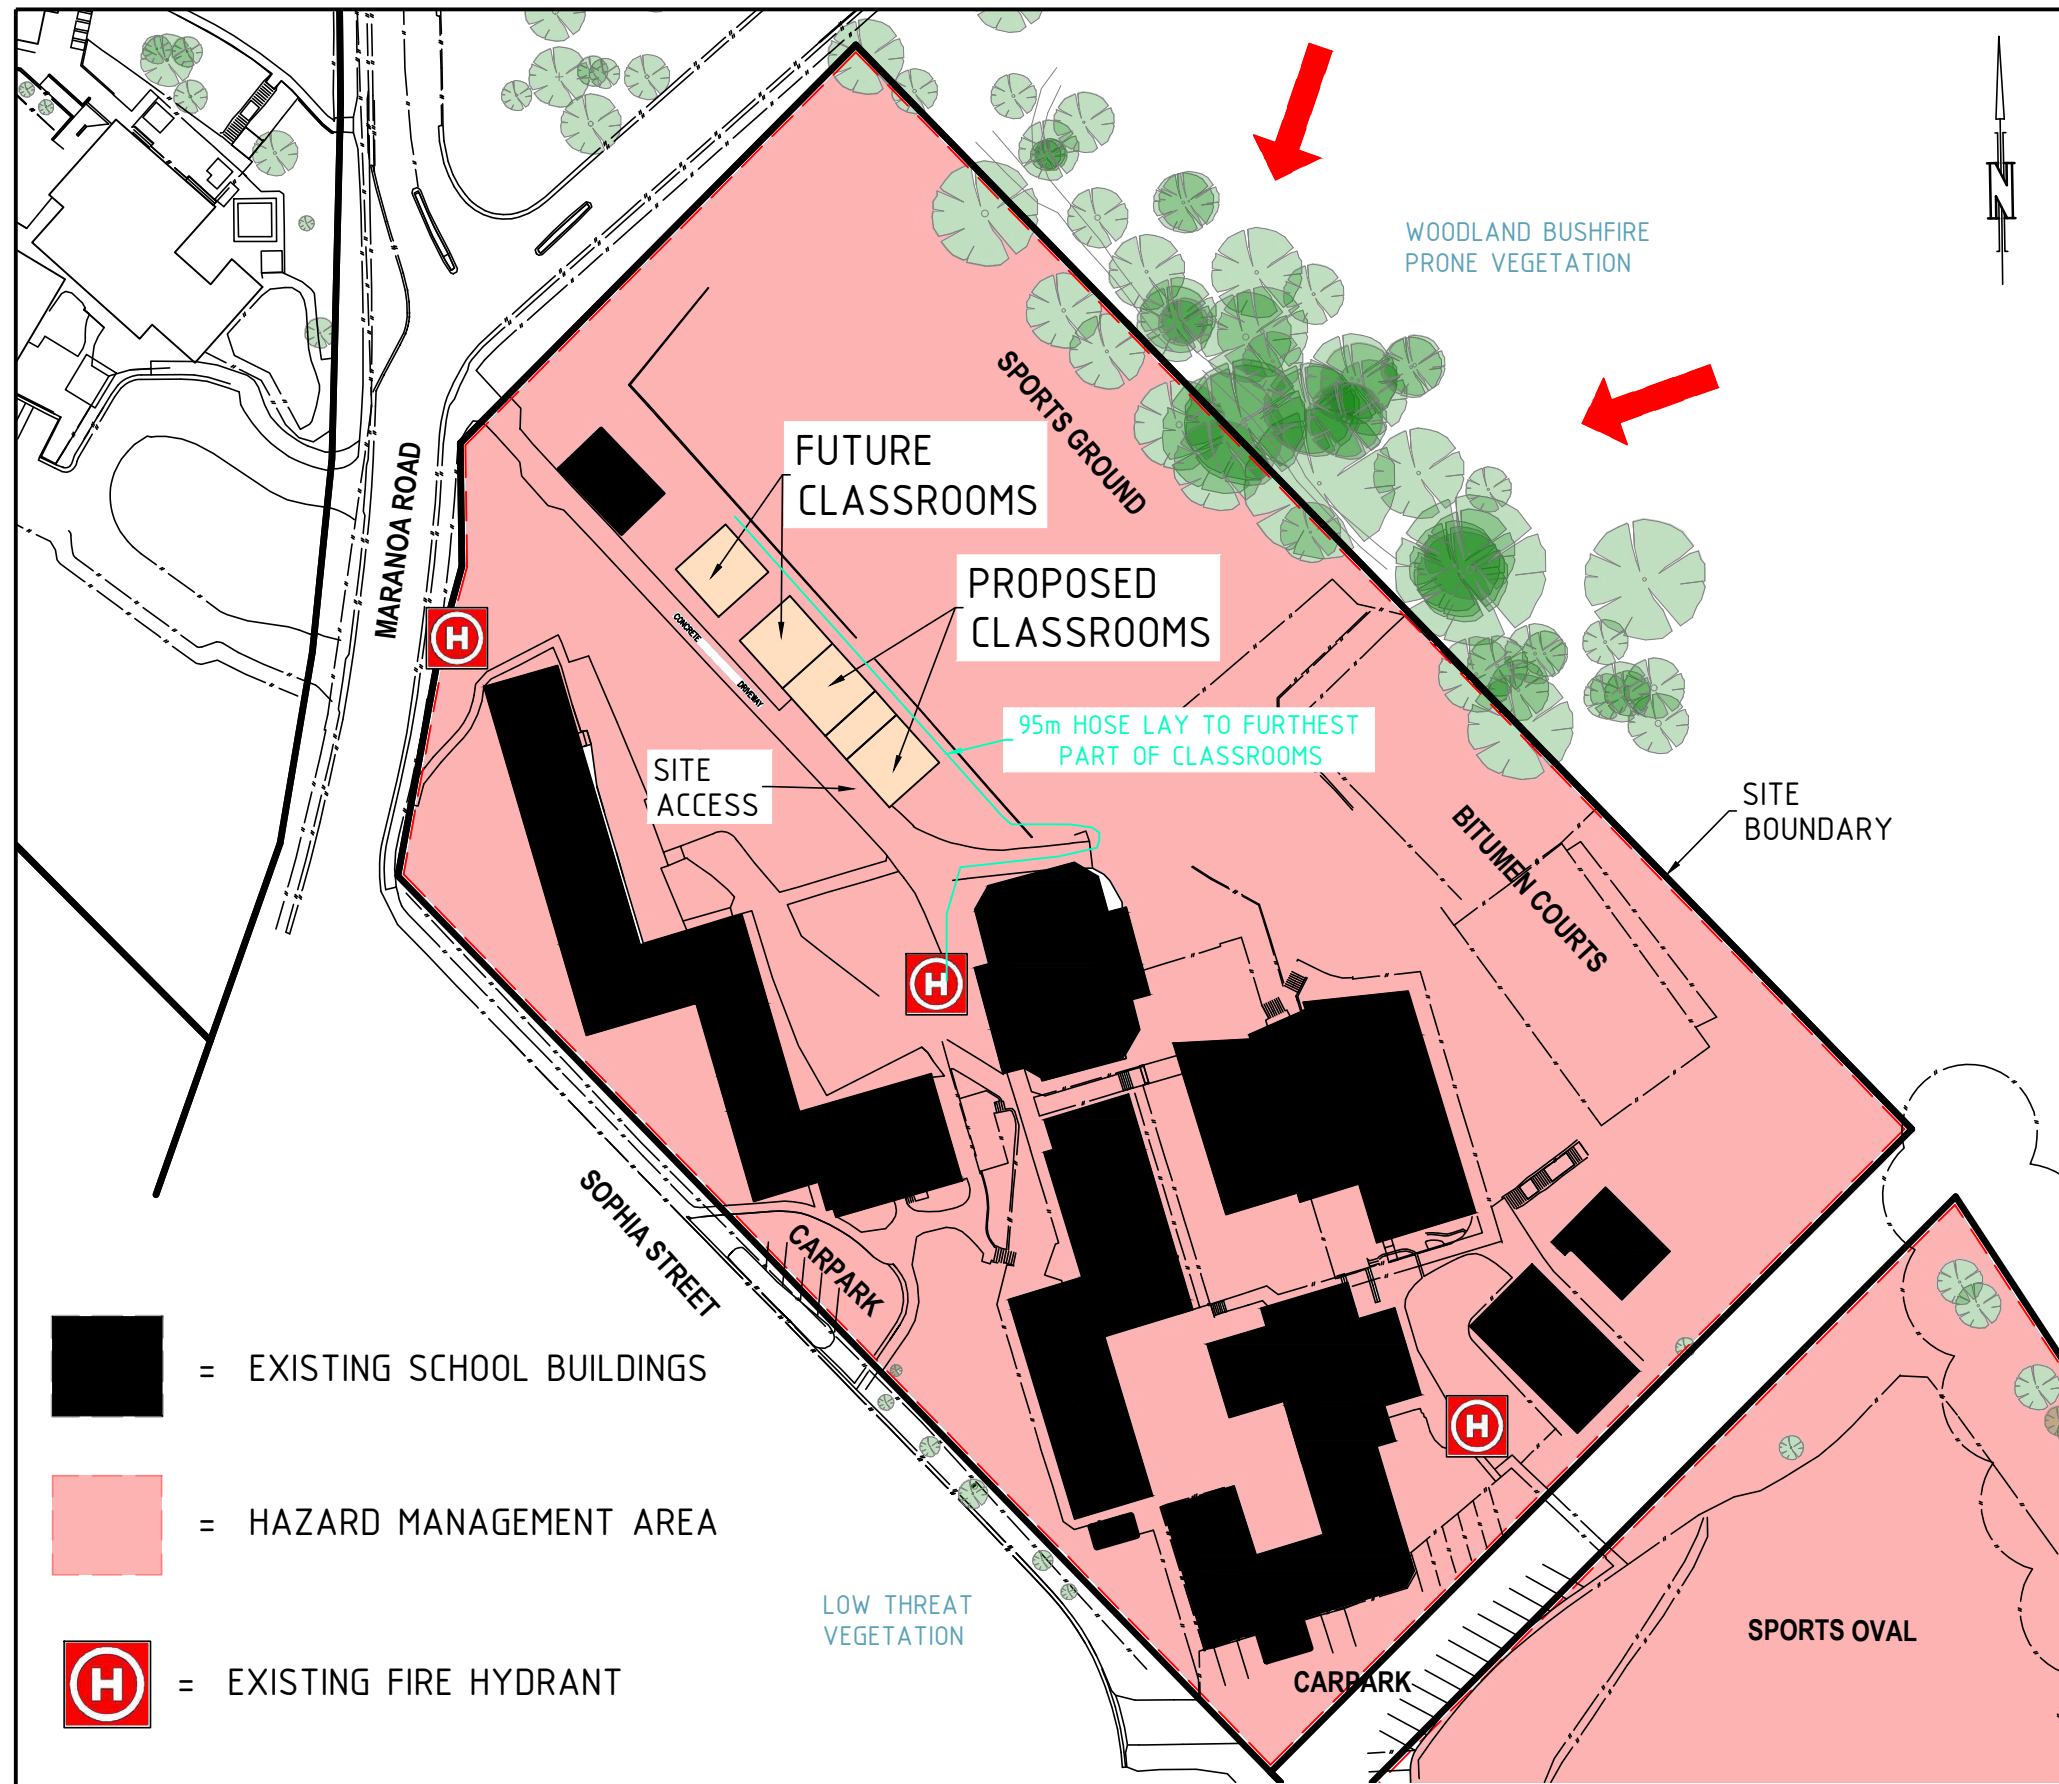
**BUSHFIRE HAZARD MANAGEMENT PLAN**  
SCALE 1:1000

TO SATISFY HMA VEGETATION REQUIREMENTS, GRASS MUST BE REGULARLY MOWN TO A NOMINAL 100mm OR LESS HEIGHT AS PER AS3959 2018 CLAUSE 2.2.3.2(F). EXISTING SHRUBS AND TREES TRIMMED AND MAINTAINED. EXISTING SITE AND VEGETATION CONDITIONS SATISFY LOW THREAT STATUS IN LINE WITH AS3959 2018 CLAUSE 2.2.3.2(D)(E)(F).

MINIMUM SEPARATION DISTANCES ARE TO BE MAINTAINED AS LOW THREAT AND IN ACCORDANCE WITH CLAUSES 2.2.3.2(d)(e)(f) OF AS3959 2018, BHMP AND BUSHFIRE HAZARD ASSESSMENT REPORT.

WE RECOMMEND USE OF LOW FLAMMABILITY PLANTS. EXAMPLES IN THE TASMANIA FIRE SERVICE BOOKLET FIRE RESISTING GARDEN PLANTS FOR THE URBAN FRINGE AND RURAL AREAS, 2017.
