ARBORICULTURAL IMPACT ASSESSMENT

NEW SEWER LINE EXTENSION THROUGH KINGBOROUGH COUNCIL RESERVE (KINGSTON VIEW DRIVE DOG PARK)

10 KINGSTON VIEW DRIVE
KINGSTON 7050

AUGUST 2024

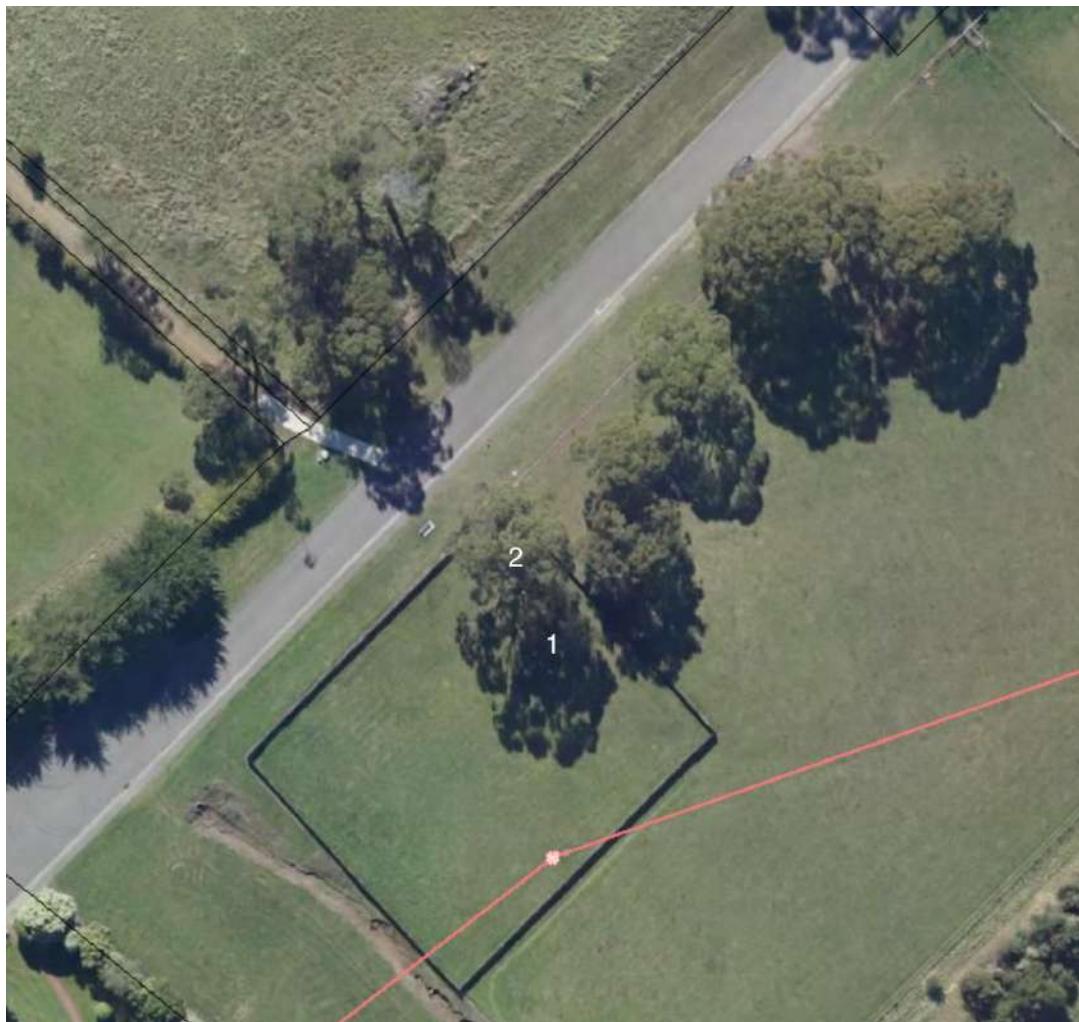
Figure 1: The site with the subject trees & existing sewer line indicated (Source –www.maps.thelist.tas.gov.au)

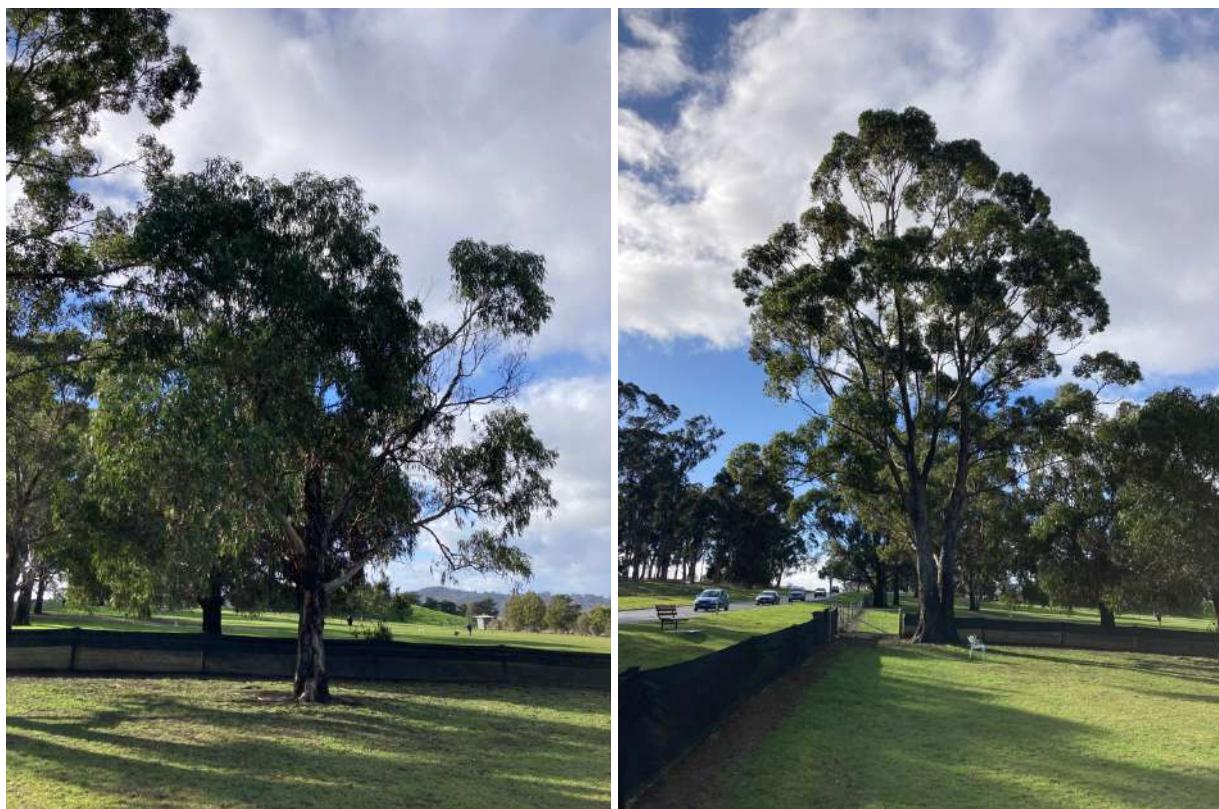
3.0.2 Tree 2 has a large active crack in the basal union of its co-dominant stems. It is likely that the tree has an elevated likelihood of failure and consequent associated risk. Accordingly A detailed Tree Risk assessment should be conducted on this tree.

3.1.2 **Tree 2** also has a sufficiently large trunk diameter (DBH) to be ascribed a “High/Very High Conservation Value” (HCV) as described in Kingborough Council Policy 6.10 “Biodiversity Offset Policy” (Section A1.5 in **Appendix 4**). Accordingly this tree is also considered to have ‘Moderate Priority Biodiversity Values’ as set out in Table “E10.1- Priority Biodiversity Values” of The Scheme and should be retained and protected wherever practicable as prescribed in “E10.0 - Biodiversity Code” of The Scheme.

Figure 2: The Subject trees located in the Council dog park. Tree 1 is on the left & HCV tree2 is on the right

5.3.3 Council should conduct a Tree Risk Assessment of tree 2

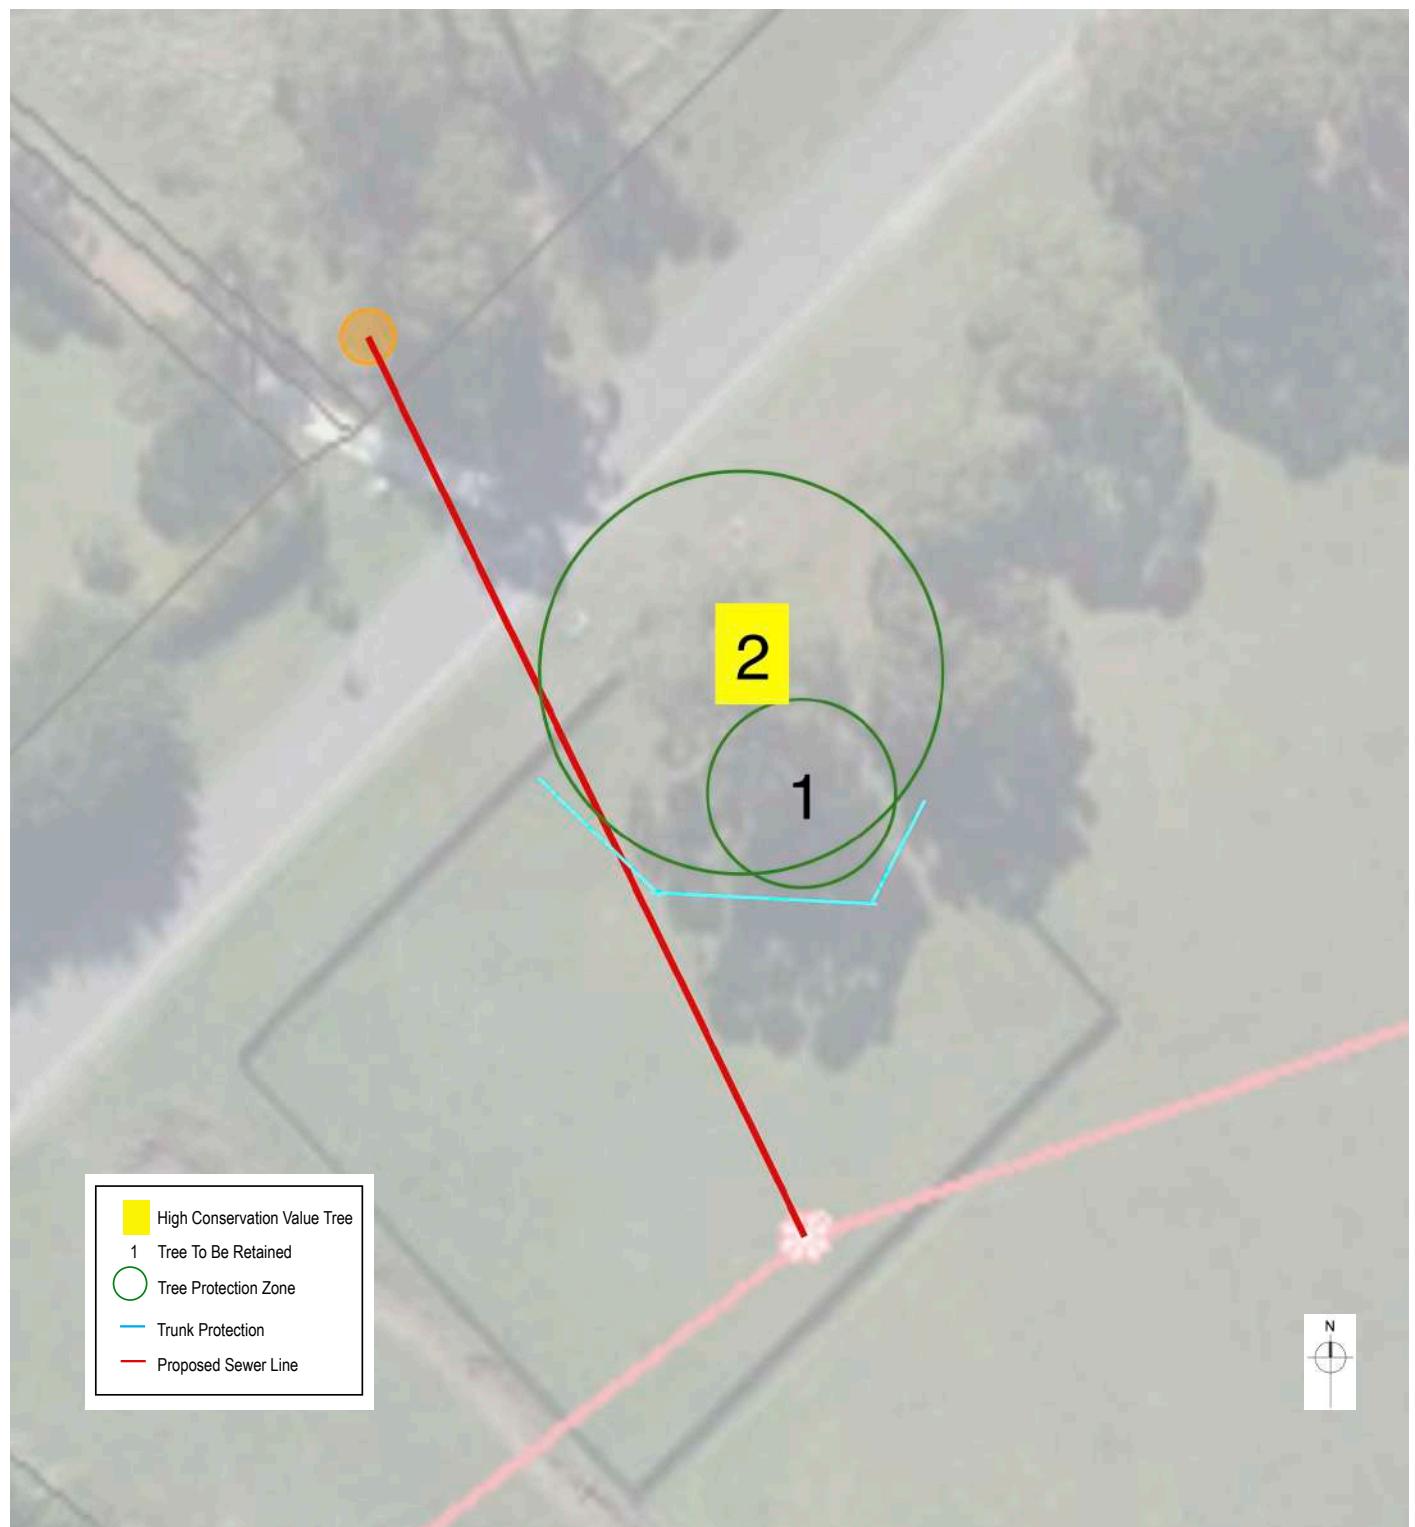
TREE PROTECTION PLAN: 87 KINGSTON VIEW DRIVE KINGSTON

5.2.2.1 Open trenching for the new sewer line installation will result in an **acceptable** (<10%) encroachment on the TPZ area of **tree 2**. Although this level of encroachment will have minimal adverse impact on the tree the new sewer line should be relocated entirely outside the TPZ of tree 2 in order to ensure no unforeseen impact on the tree due to the proposed works.

5.2.2.2 The proposed works are located outside the TPZ of tree 1 & as such there will be no impact on this tree.

5.3.1 Retain trees 1 & 2 and protect them accordance with the Tree Protection Specification in Section 6.

5.3.2 Relocate the alignment of the new sewer line to be entirely outside the TPZ of both subject trees
