DOYLE **SOIL** **CONSULTING**

SITE AND SOIL EVALUATION REPORT FOUNDATION, WINDLOADING AND LANDSLIDE RISK ASSESSMENT

13 Steen Court, Blackmans Bay

January 2026

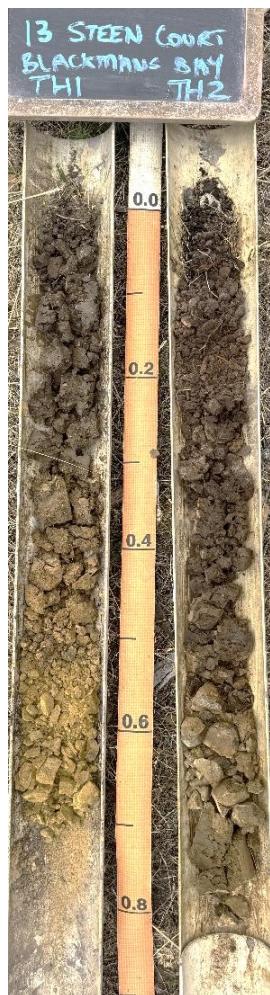
SOIL PROFILES – Test Hole 1

Depth (m)	Horizon	Description and field texture grade	USCS Class
0 - 0.3	A1	Greyish brown (2.5YR 5/2), Silty Light Clay , strong medium angular blocky structure, dry stiff consistency	CH
0.3 – 0.5	B2 ₁	White yellowish brown (2.5YR 6/4) Silty Light Clay , strong medium angular body structure, dry very stiff consistency	CH
0.5 – 0.7	Cw	Platy sandy mudstone bedrock Refusal	GW
