Public Toilet Strategy

Kingborough Council

Council Approved 27 February 2017

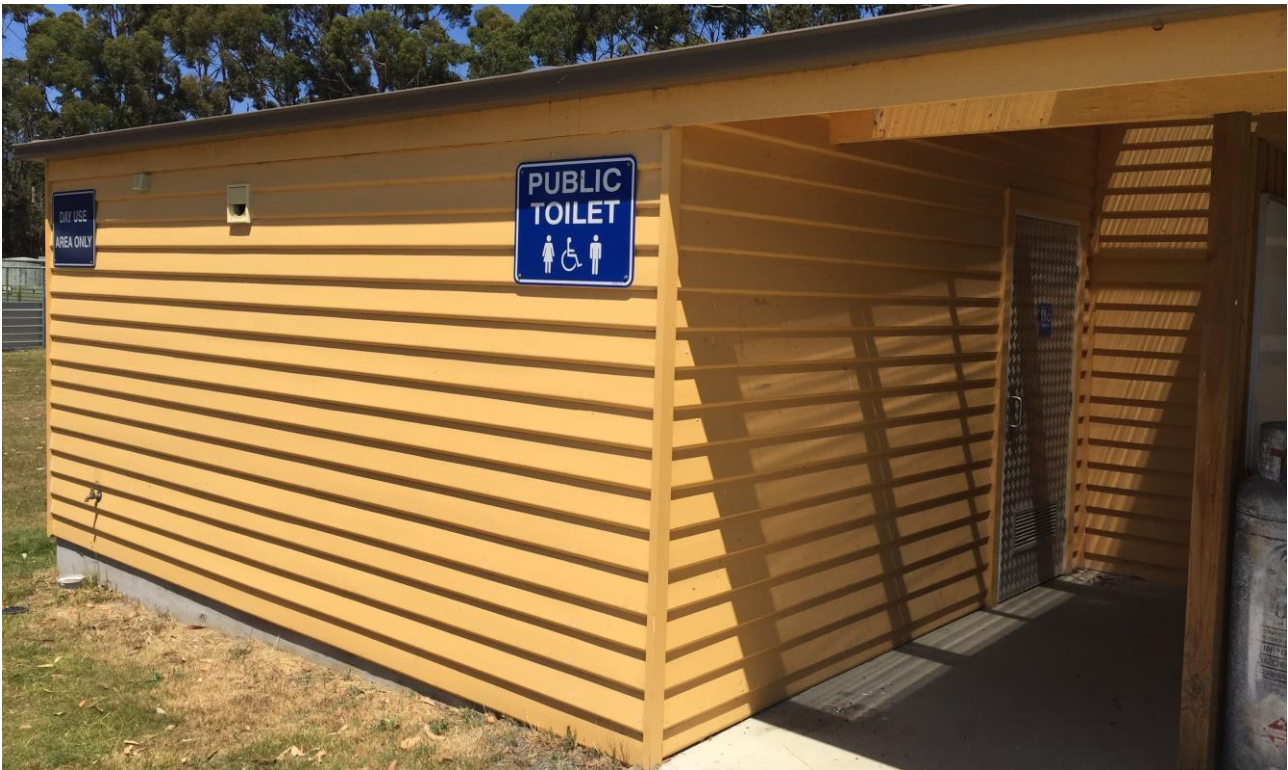
6.1 *Adventure Bay Hall*

Description – Recently upgraded facilities in excellent condition. Good natural lighting, with modern fittings and fixtures.

Accessibility – Fully compliant disability access. External access paths are in good condition.

1. Landscaping around building.

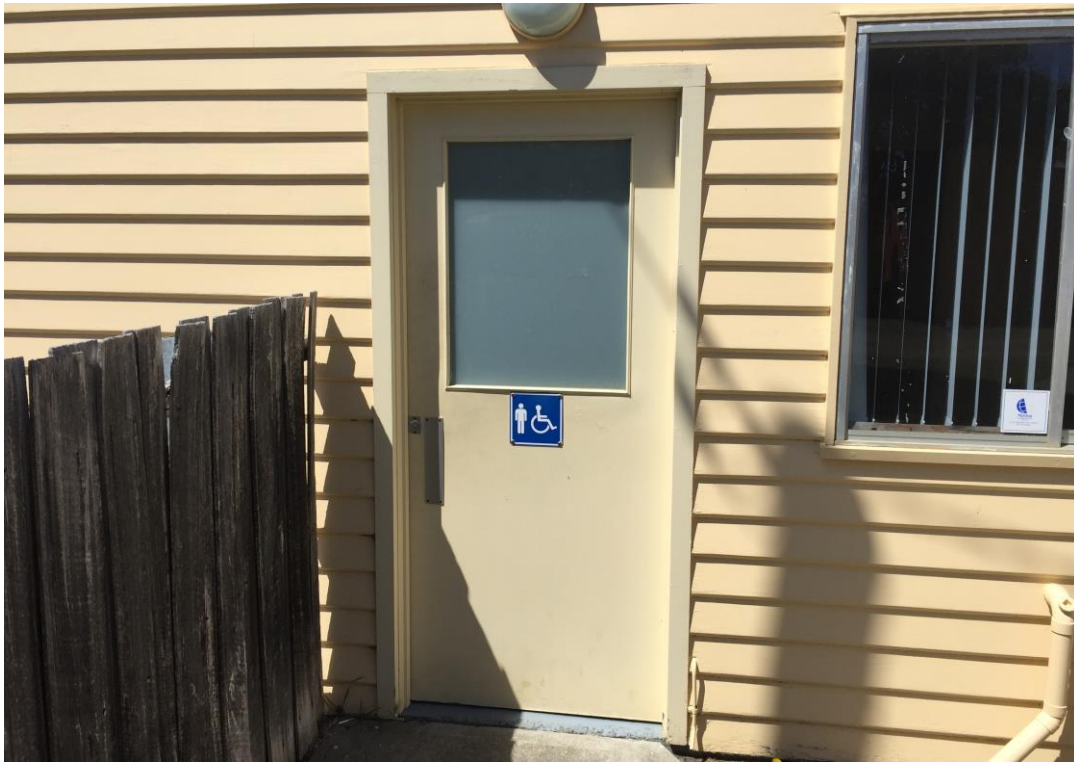
6.2 Alonnah Service Centre

Description – Single unit cubicles located at rear of Service Centre. Older style in fair condition.

Accessibility – Signage indicates that the facility is accessible to people in wheelchairs but it does not meet standards in terms of door width, handrails and manoeuvring space. The concrete access paths to the facility are in poor condition.

1. Remove accessibility signage.
2. Install spring loaded taps.
3. Update fittings and fixtures.

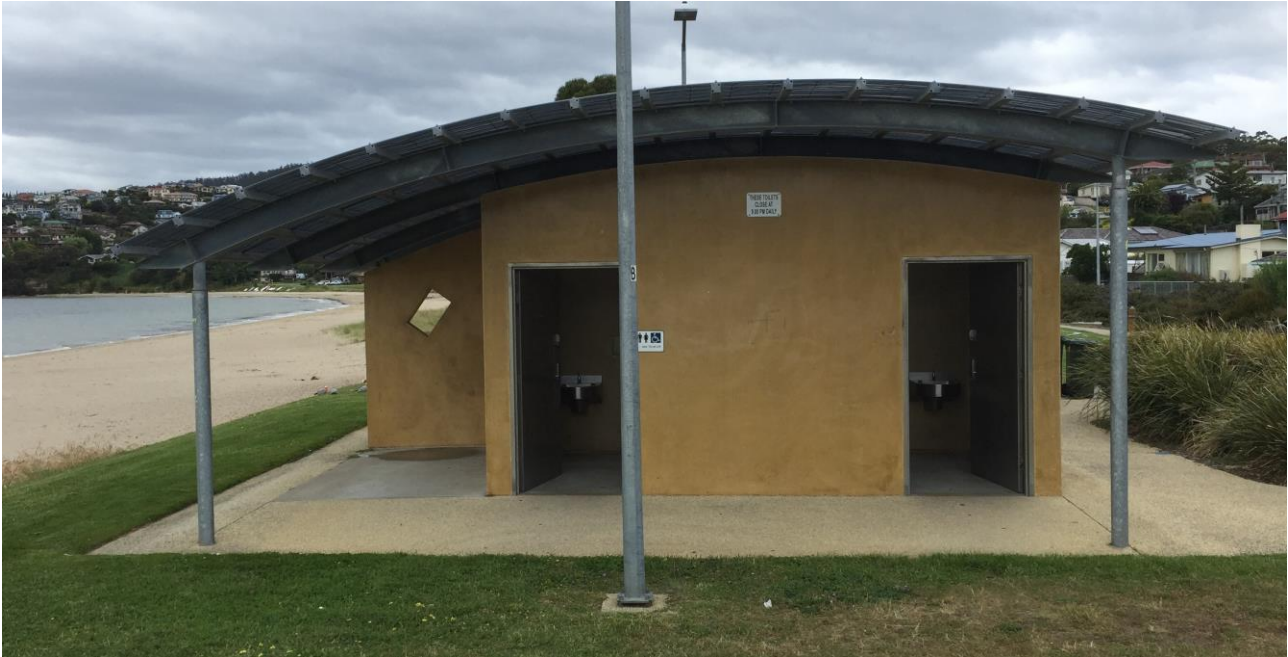
6.3 Blackmans Bay Beach

Description – Four unisex disabled access toilets and external showers. Relatively modern design in good condition. Well lit and ventilated.

Accessibility – All cubicles are disability access compliant. External access paths are in good condition.

Issues – The facility is showing signs of corrosion due to the salty air environment in which it is located, as well as evidence of vandalism. In general however, it is in good condition and meets the needs of the community for the foreseeable future.

1. Install spring loaded taps.
2. Address corrosion issues.
3. Install vandal proof shower heads.
4. Improve directional signage from the road.
5. Refurbish internally.

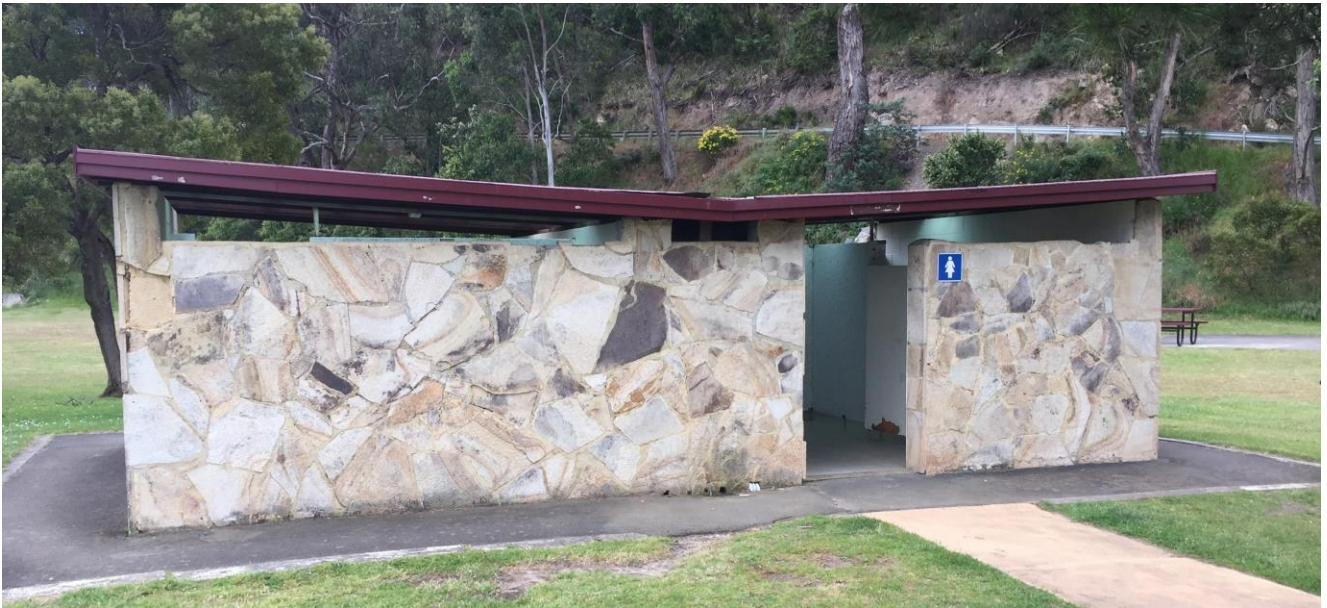
6.4 Christopher Johnson Park

Description – Older style facility in fair condition. Structurally sound but fittings are dated. Well ventilated with adequate levels of natural lighting.

Accessibility – Could be made compliant with minor work. The concrete access paths to the facility are in average condition.

1. Replace roof, barge boards and flashing.
2. Fix stone tiling.
3. Update fittings and fixtures.
4. Improve disability access.
5. Refurbish internally.

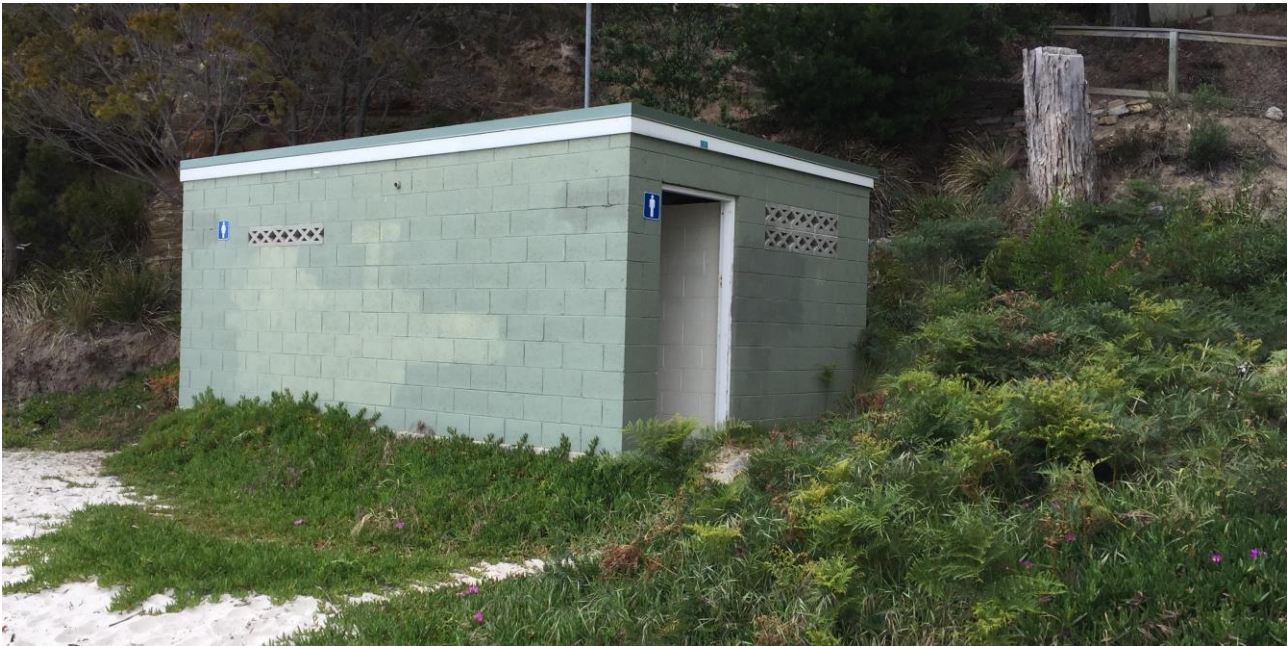
6.5 Coningham Beach

Description – Older style concrete block facility in poor condition. Poor natural lighting and ventilation. No artificial lighting.

1. The existing toilet block be demolished and replaced with a disability compliant, unisex facility located in the vicinity of the carpark.
2. Details of the design and location of the facility to be determined in consultation with the Coningham and Lower Snug Community Association.

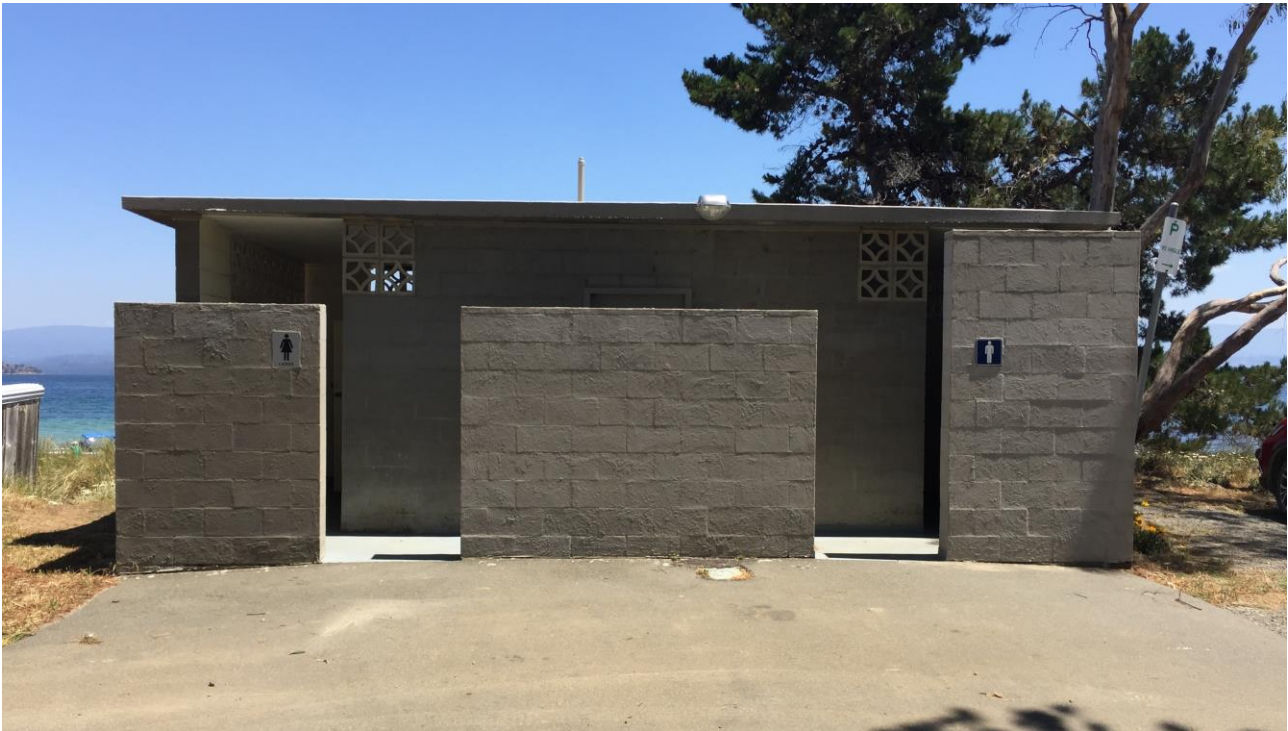
6.6 Dennes Point

Description – Standard older style concrete block facility in good condition with adequate natural lighting and ventilation.

Construction – Concrete block on slab with concrete roof. The external blockwork has recently been rendered and the floors sealed. Fittings and fixtures have recently been replaced.

1. Improve disability access.
2. Refurbish internally.

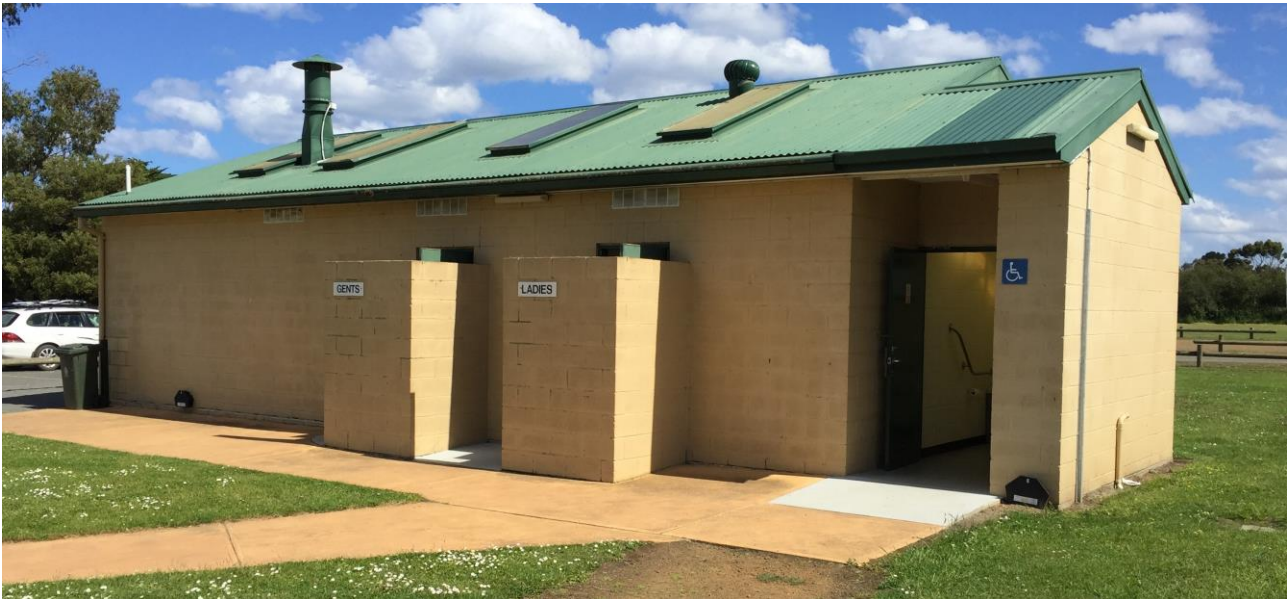
6.7 Dru Point (Kiosk)

Description – Sandstone block facility in average condition.

Accessibility – Standalone disability access facility. External access paths in good condition.

Issues – The building is structurally sound and in reasonable condition. With some minor maintenance and paintwork to improve its presentation, the facility can continue to meet the needs of users of the Dru Point Reserve.

1. Update fittings and fixtures.
2. Seal external block work.
3. Repaint internally.

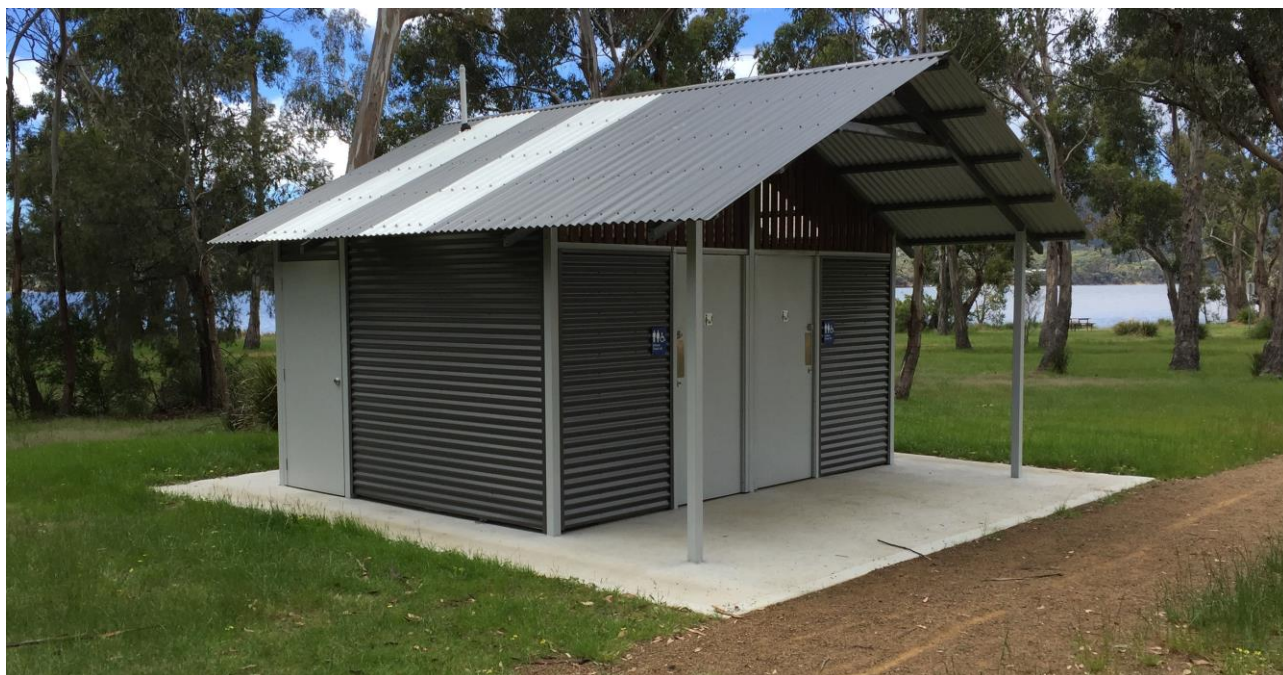
6.8 Dru Point (Park)

Description – Two unisex disabled access cubicles. Contemporary design in excellent condition. Well ventilated with good natural light.

1. Install concrete access path from the carpark.

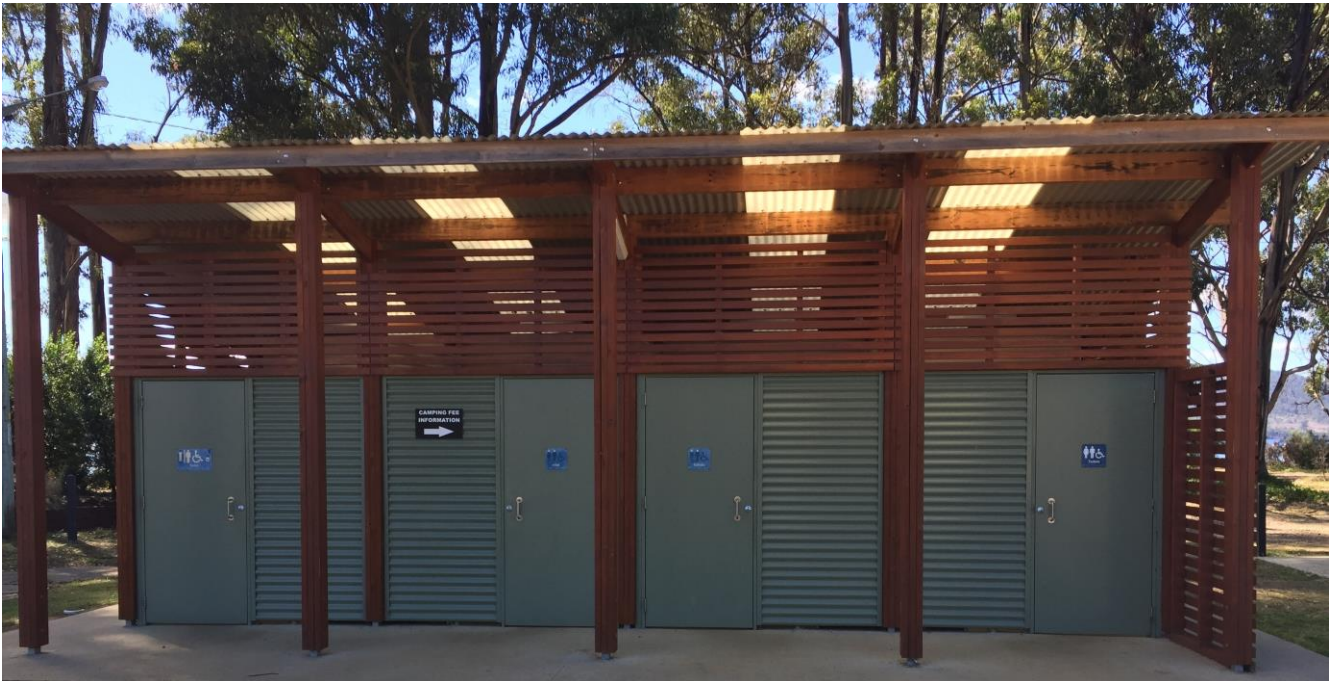
6.9 Gordon Oval

Description – Four unisex cubicles (two with disability access) in excellent condition. Contemporary design with good natural light and ventilation.

1. Install spring loaded taps.
2. Oil timber cladding.

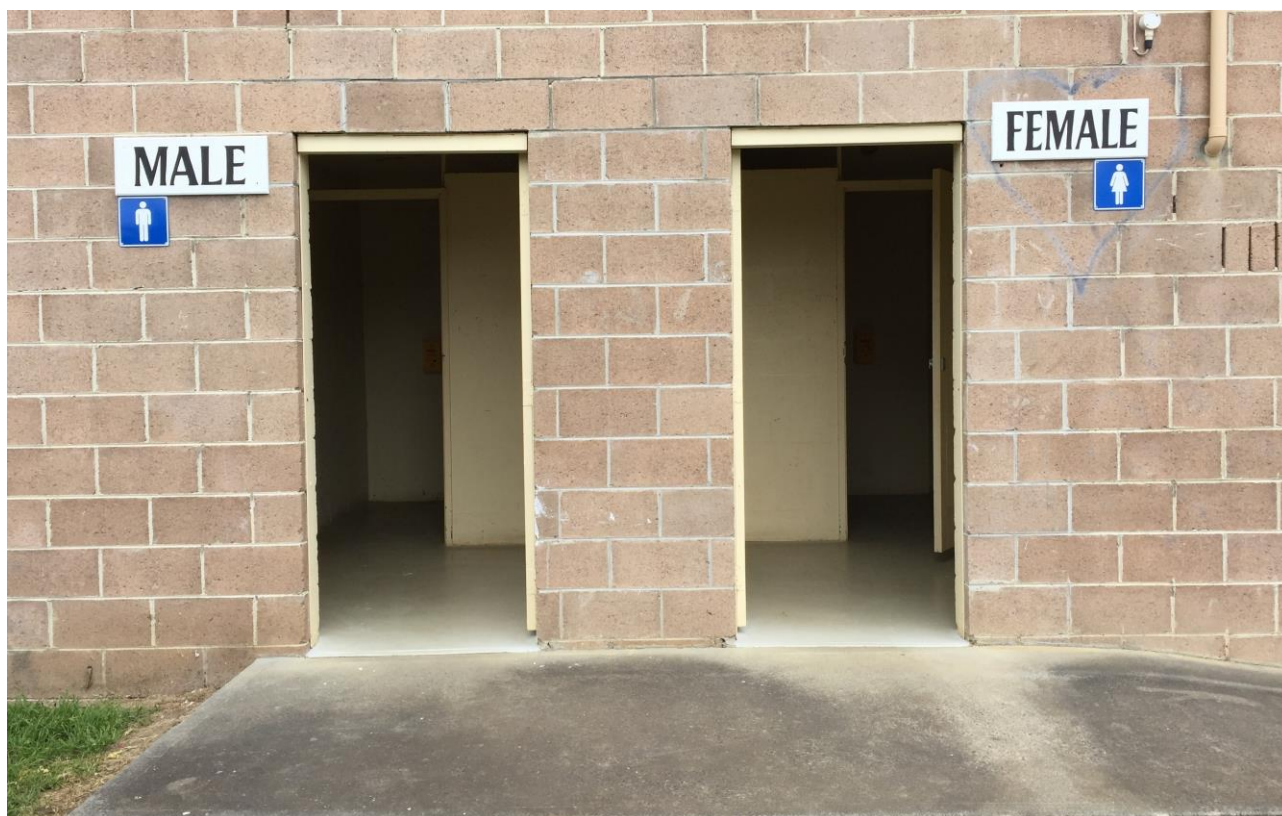
6.10 Kettering Oval

Description – Older style facility located underneath Kettering Hall. Single male and female cubicles.

Issues – The building is structurally sound and in reasonable condition. Whilst it is of simplistic design, the facility serves its purpose and with a minor upgrade is sufficient to meet the needs of the community for the foreseeable future.

1. Install spring loaded taps.
2. Update fittings and fixtures.
3. Modifications to meet accessibility requirements.

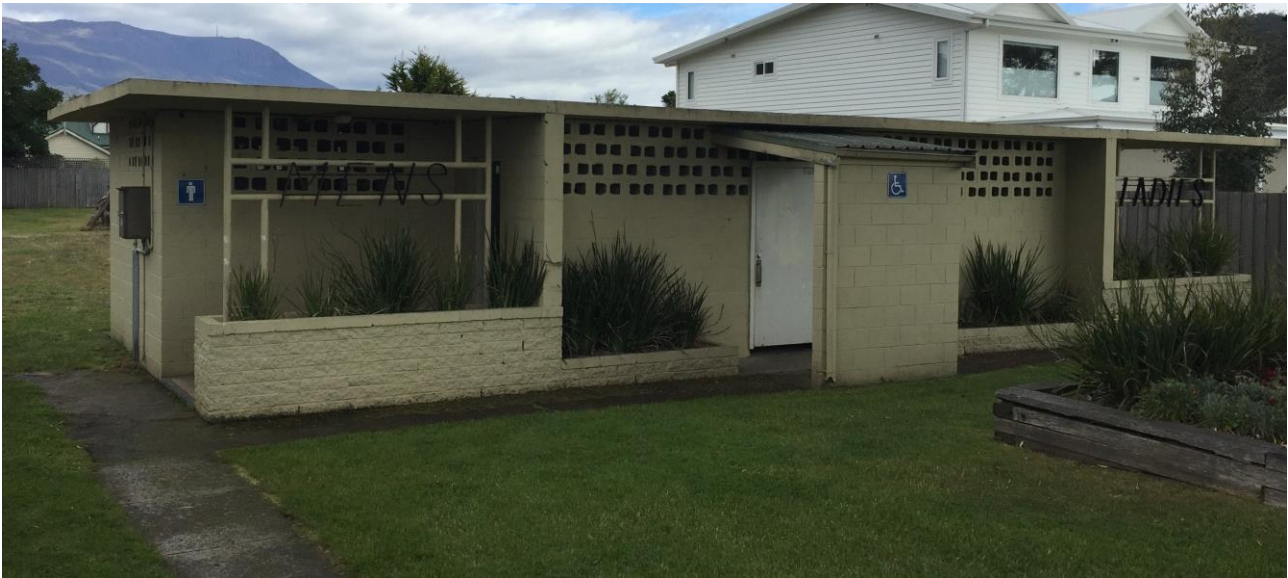
6.11 Kingston Beach

Description – Older style facility in poor condition.

Accessibility – Standalone disability access facility that does not meet standards. Access paths are in poor condition.

Issues – This facility is clearly a priority for replacement given its high level of usage and poor condition. It is in a prominent location and any new facility should incorporate an aesthetically pleasing design with the full suite of high quality fixtures and fittings. Negotiations with a private developer and the Kingston Beach Surf Life Saving Club are continuing in relation to the replacement of this facility.

1. Facility to be demolished and replaced.

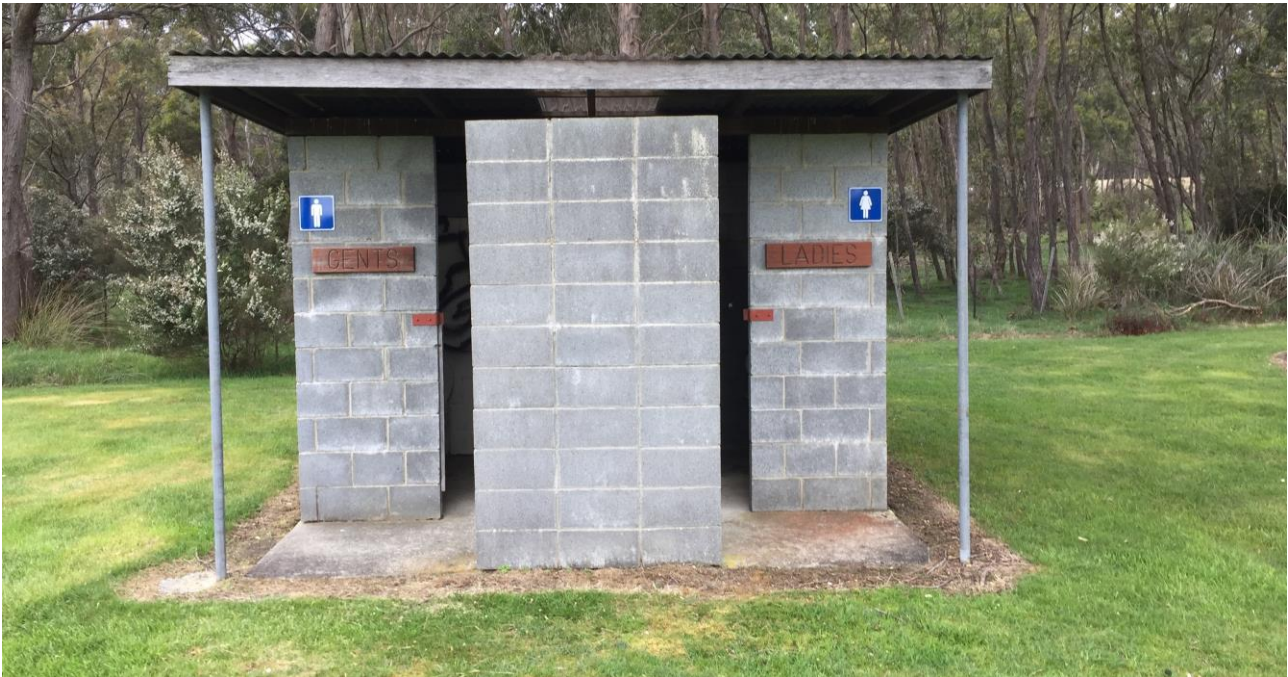
6.12 Leslie Vale Oval

Description – Old style facility in poor condition.

1. Usage of the facility to be monitored to determine future requirements.

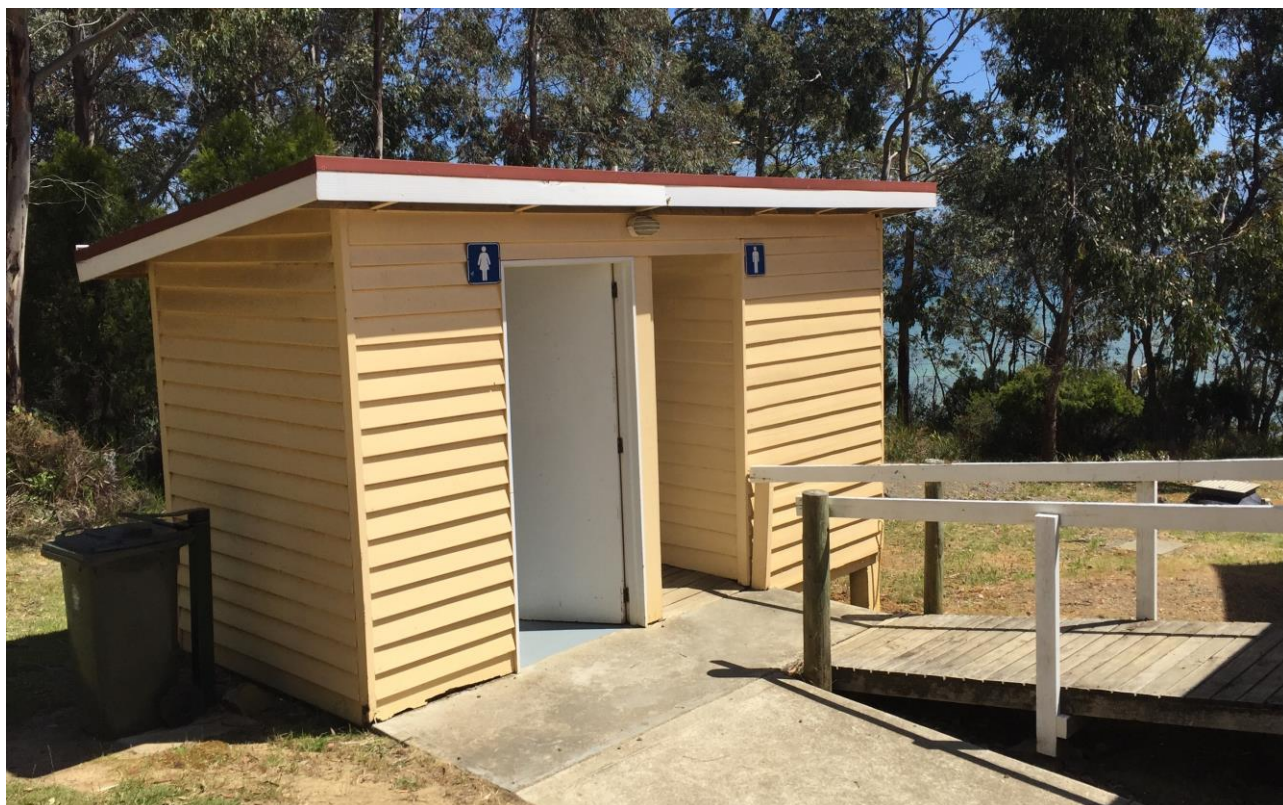
6.13 Lunawanna Hall

Description – Single unit older style facility in average condition.

Accessibility – Does not meet access standards. External access paths in good condition.

Issues – The building is structurally sound but its design is dated. It is the only facility available for users of the adjacent Lunawanna Hall and is well used by visitors travelling to the south of Bruny Island. Given its condition and level of usage, it is recommended that it be replaced with contemporary style facility, with the final design and location to be determined in consultation with the Lunawanna Hall Management Committee.

1. Existing building to be demolished and replaced.

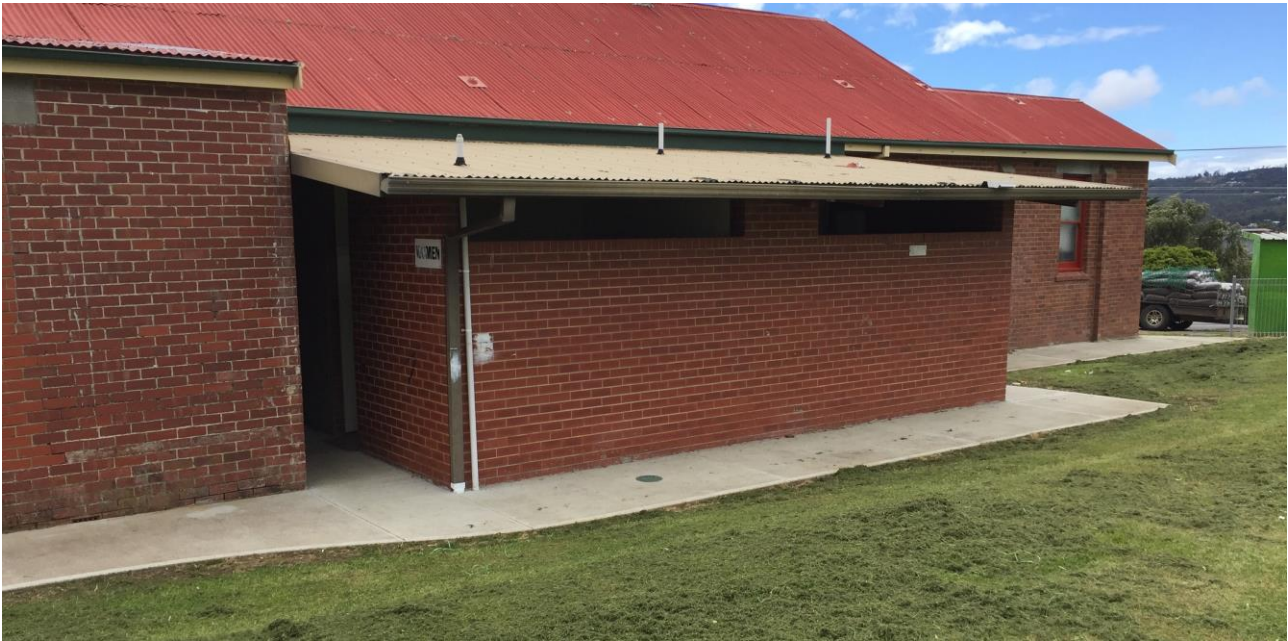
6.14 Margate Hall

Description – Older style brick facility at rear of Margate Hall in average condition. Poor natural light levels.

1. Replace fittings and fixtures (including spring loaded taps).
2. Improve natural lighting.
3. Repaint internally.
4. Investigate options for provision of an accessible unisex facility.
5. Install directional signage at front of hall.

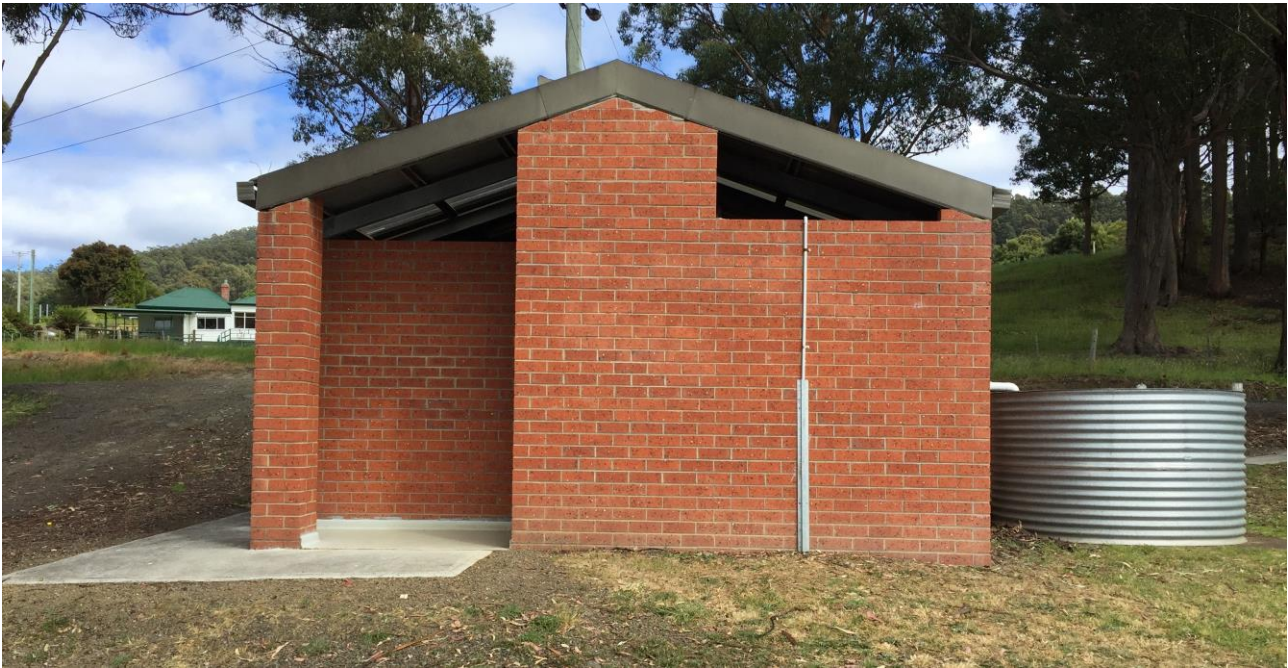
6.15 Middleton

Description – Brick facility in average condition with poor natural lighting.

Issues – The steel frame of the building is showing signs of corrosion, along with the roof and gutters. It is noticeably dark inside and has poor disability access. Minor maintenance will ensure that the facility is adequate to meet the needs of users in the short term but ultimately, it should be replaced with a facility that is fully accessible and of contemporary design.

1. Install spring loaded taps.
2. Replace alsynite roof sheets to improve lighting.
3. Replace galvanised tank with larger poly tank.
4. Update fittings and fixtures.

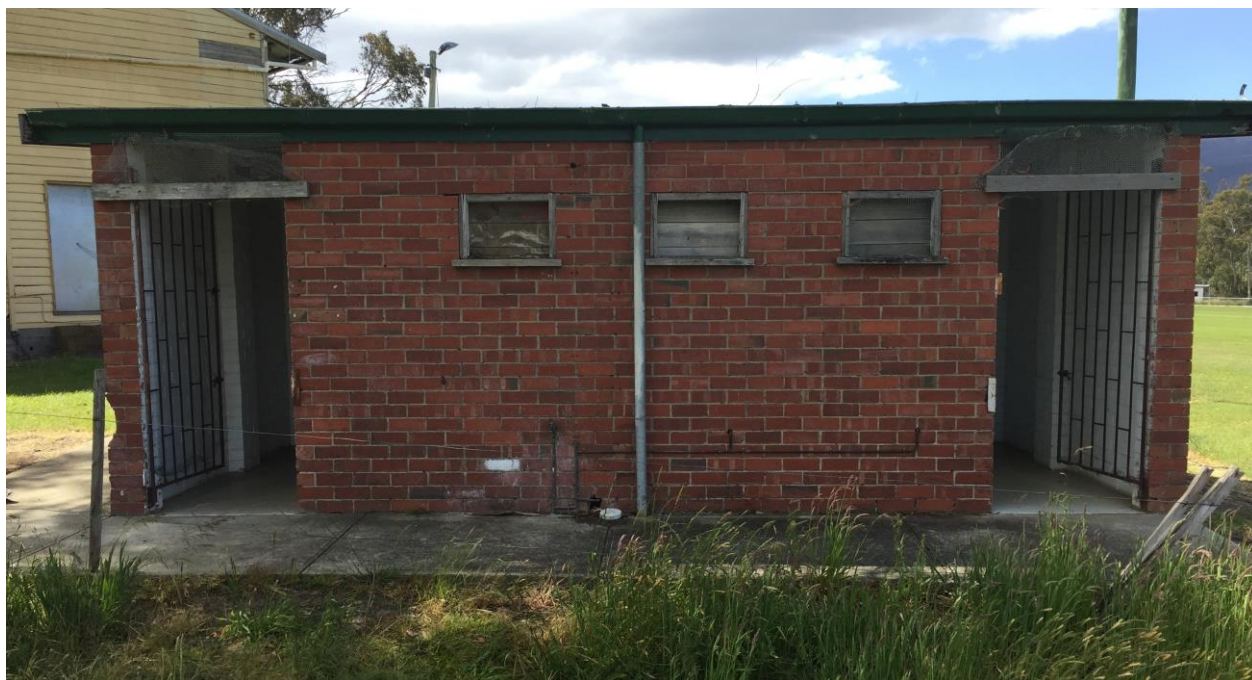
6.16 Sandfly Oval

Description – Very old style brick facility in poor condition.

Accessibility – Non-compliant. External access paths in average condition.

Issues – The building is in very poor condition and presents poorly both inside and out. It is predominantly used when there is sport being played on the oval and in this regard but nonetheless requires an upgrade.

1. Repaint.
2. Refurbish internally

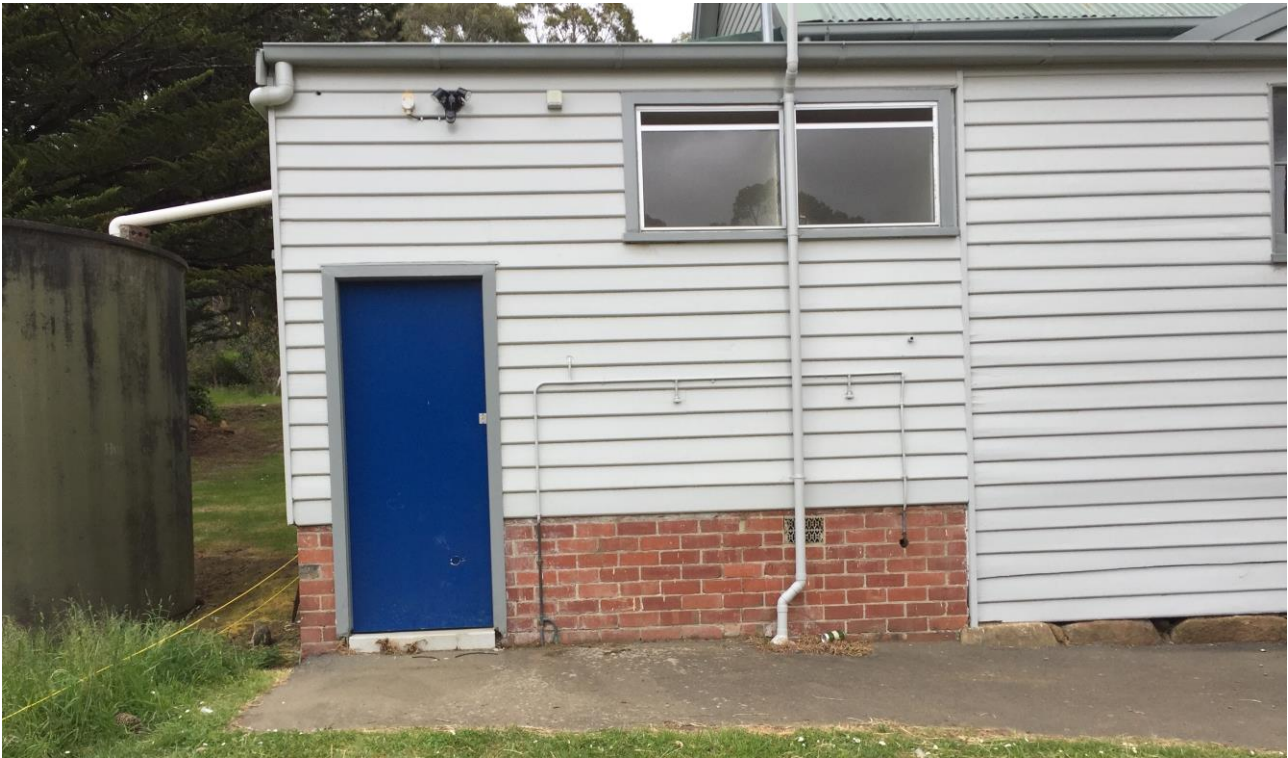
6.17 Sandfly Hall

Description – Weatherboard facility adjoining Sandfly Hall. Male toilet only is externally accessible.

Accessibility – Non compliant. Concrete access path in reasonable condition but there is stepped entry into the facility.

Issues – The most pressing issue is the septic system which has failed due to collapsed absorption trenches. There is insufficient land available to install an effective septic or alternate wastewater treatment system and hence the only available option is a holding tank that is pumped out as required.

1. Replace failing septic system as a matter of urgency.
2. Internal modifications to improve accessibility.
3. Restrict access to the facility to when the hall is in use.

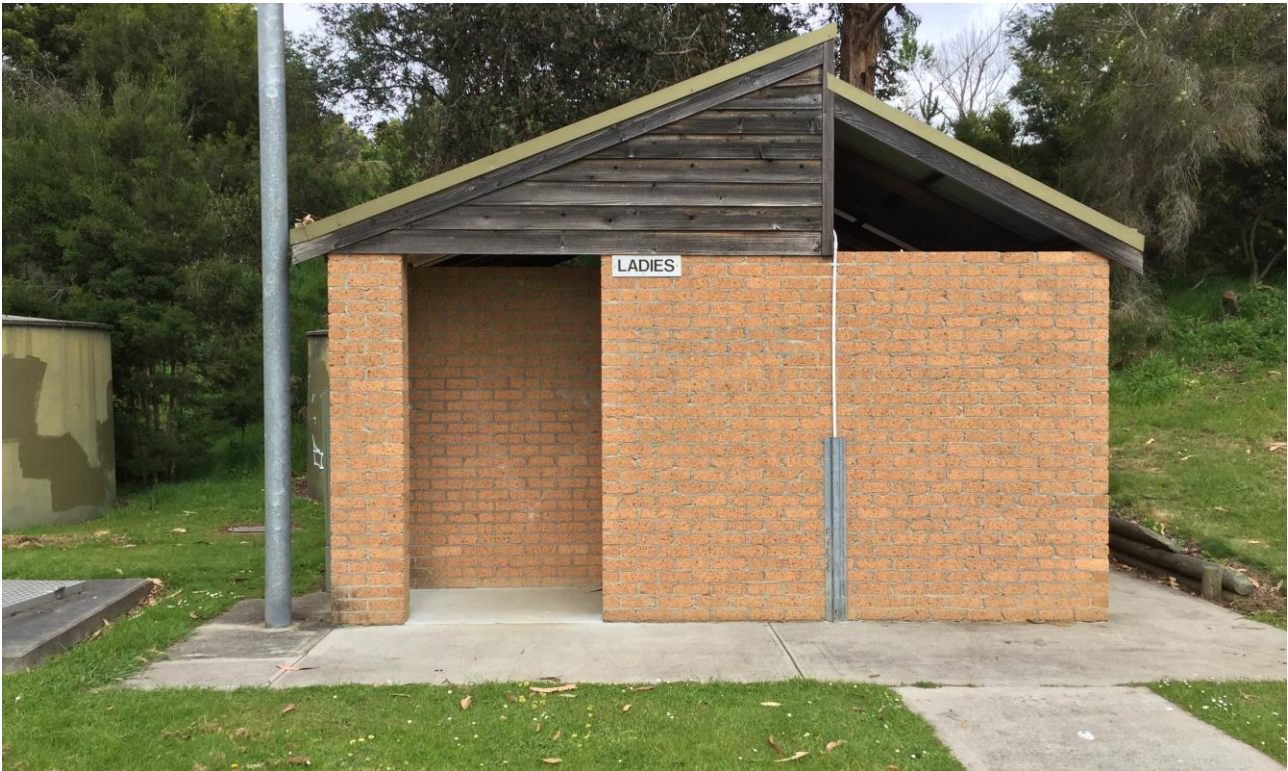
6.18 Silverwater Park

Description – Older style brick facility in fair condition. Well ventilated but poor natural light levels.

Accessibility – Non compliant. Concrete access paths in average condition.

Issues – With some minor maintenance, the facility can continue to operate effectively to meet the needs of the community in the short term. However, its design is dated and it is non-compliant in terms of disability access. It is therefore recommended that it be replaced with a fully accessible facility of contemporary design.

1. Install spring loaded taps.
2. Replace alsynite roof sheets to improve lighting.
3. Replacement or major refurbishment in the longer term.

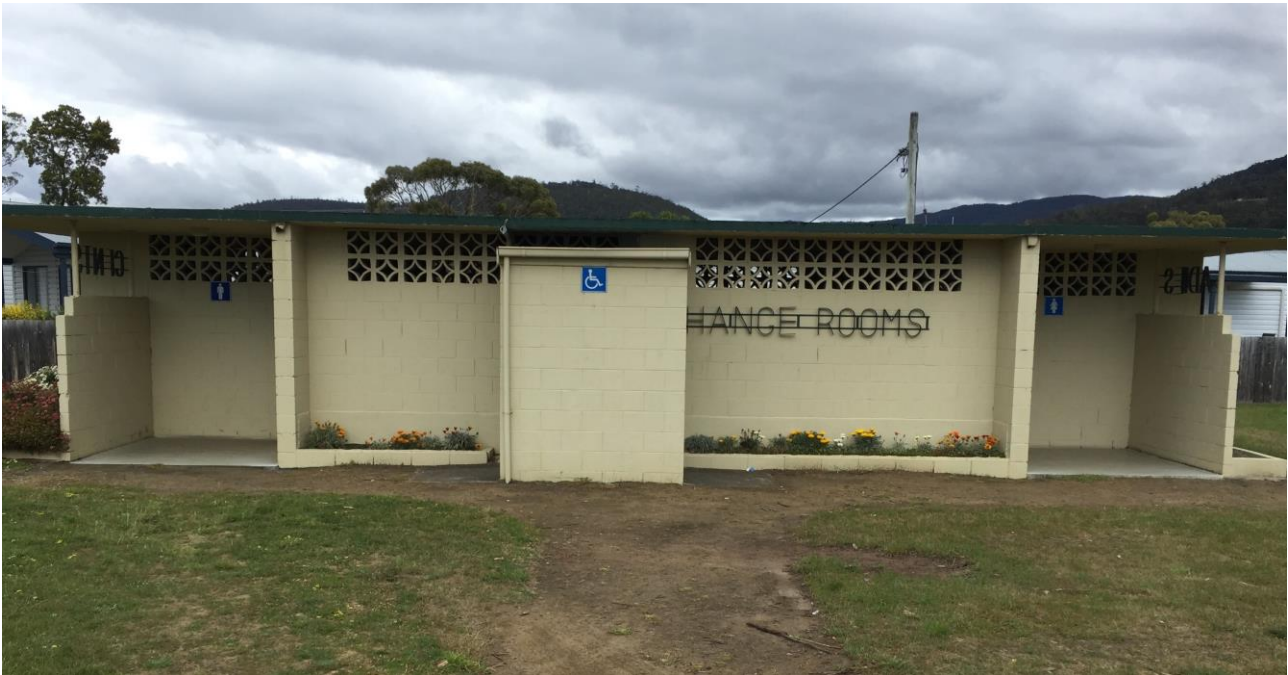
6.19 Snug Beach

Description – Older style concrete block facility in average condition. Includes changerooms and separate disabled access facility.

Accessibility – Access paths to the facility are gravel only and in poor condition. The accessible cubicle does not meet standards.

Issues – The building is showing signs of age and presents poorly. On account of the level of usage of the facility, its current condition and lack of accessibility, it is recommended that it be listed for replacement with a fully accessible facility of modern design.

1. Install spring loaded taps.
2. Replacement or major refurbishment in the medium term.

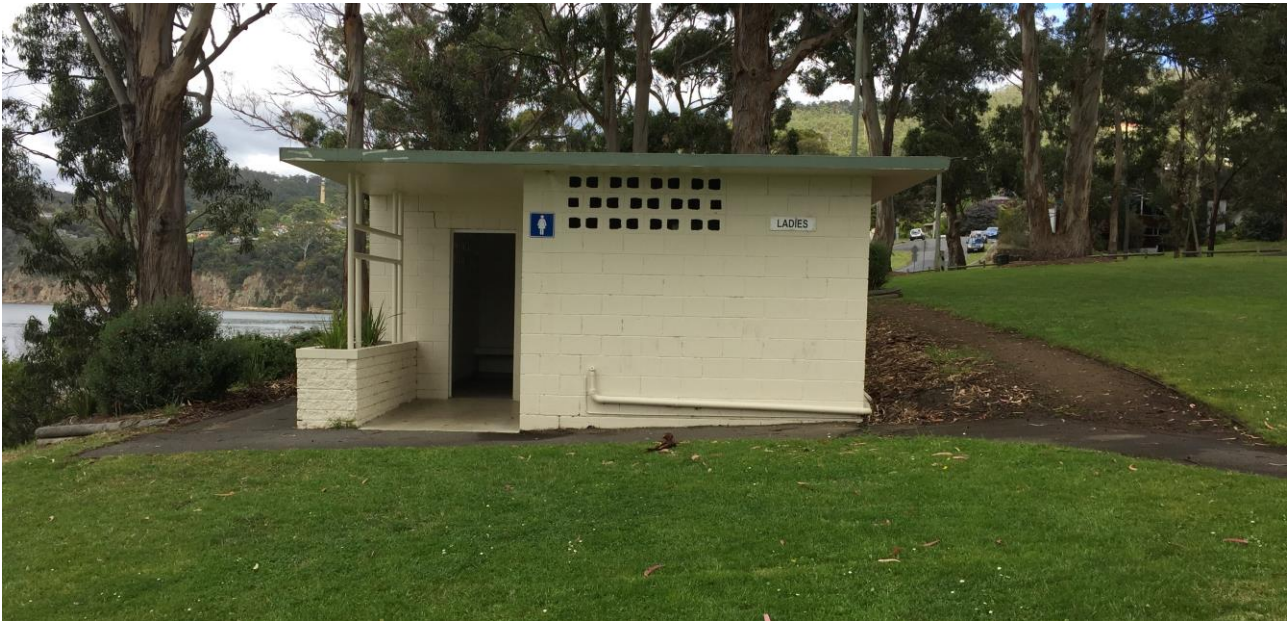
6.20 Taroona Beach

Description – Older style concrete block facility in average condition. Includes disused changerooms.

Accessibility – There is no dedicated disability access facility and the main block does not meet standards. Access paths are in poor condition.

Issues – The facility is dated and presents poorly. It is dark internally and has a considerable amount of disused space. It is functional in the short term but should be listed for replacement with a fully accessible, modern facility.

1. Install spring loaded taps.
2. Replacement or major refurbishment in the longer term.

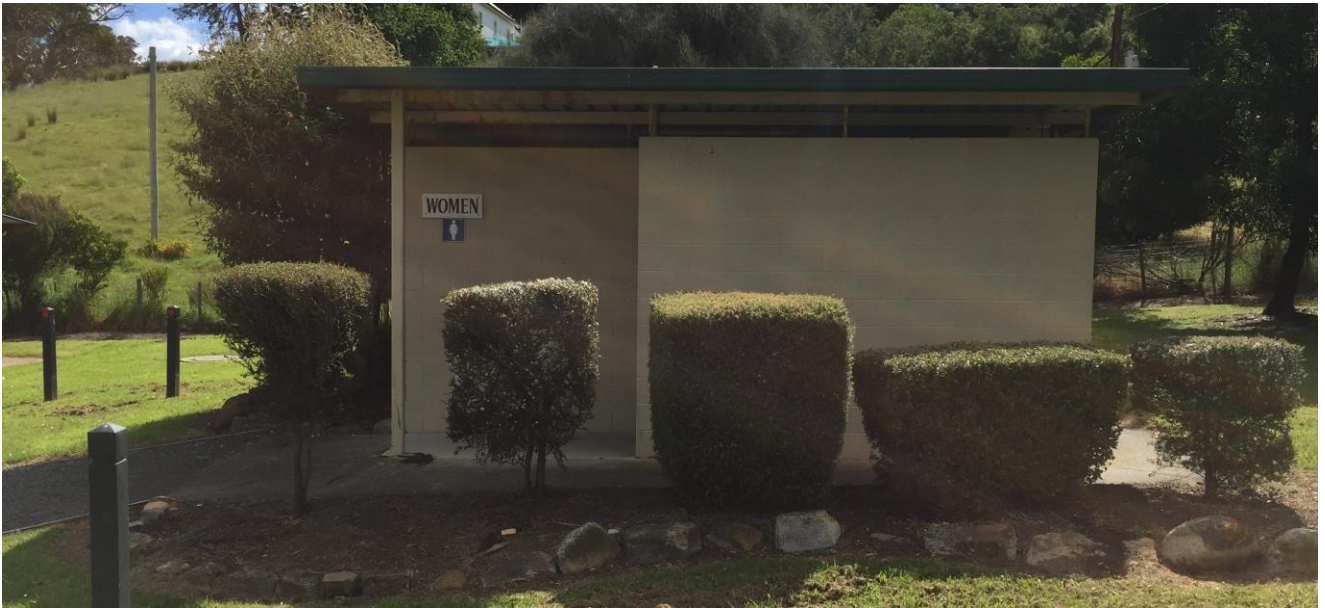
6.21 *Tinderbox*

Description – Small but functional older style facility in reasonable condition.

Accessibility – No disability access facility and main block does not meet standards. Concrete access paths from the carpark are in good condition.

1. Install spring loaded taps.
2. Update fittings and fixtures.

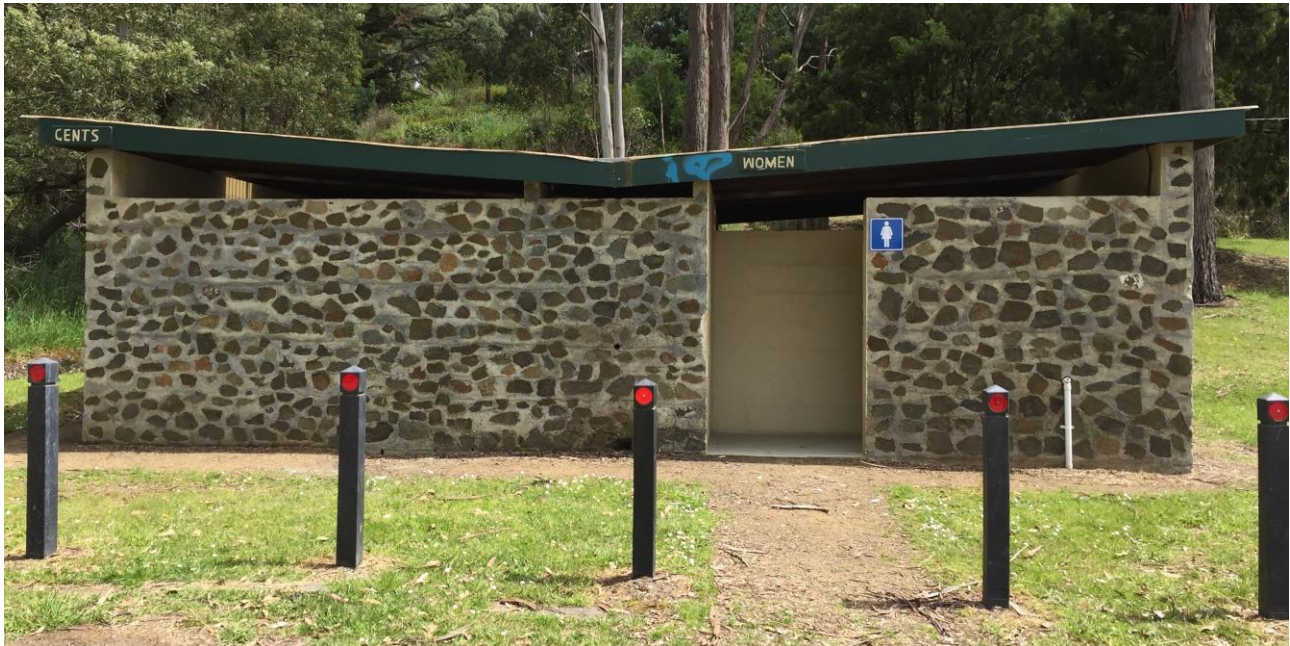
6.22 Trial Bay

Description – Old style stone facility in average condition.

Construction – Timber framing with rock cladding on concrete slab. Iron roof with valley gutters in poor condition.

Accessibility – No separate disability access facility and main block does not meet standards. Gravel paths providing access to the facility are in average condition.

Issues – The facility is located next to a well-used picnic area and is close to the popular Trial Bay Boat Ramp. The stone walls present slightly better than the concrete block style facilities but the v-shaped roof design and valley gutters are unsuitable given the large trees surrounding the building. Ventilation inside the facility is good but natural lighting is poor and there are no artificial lights. On account of the level of usage of the facility, its current condition and lack of accessibility, it is recommended that it be listed for replacement with a fully accessible facility of modern design.

1. Install spring loaded taps.
2. Replace alsynite roof sheets to improve lighting.
3. Demolish and replace in longer term.
