Public Toilet Strategy

Kingborough Council

Council Approved 27 February 2017

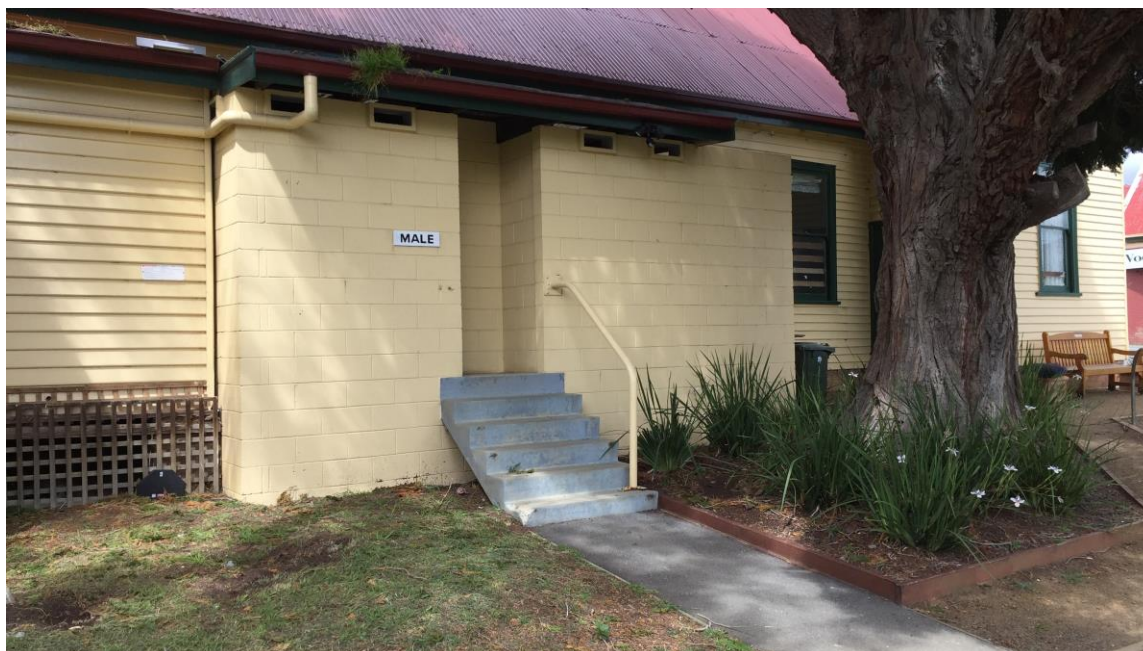
6.23 Woodbridge Hall

Description – Small, single cubicle facility adjoining Woodbridge Hall. Dark, with poor ventilation and dated fittings and fixtures.
