# Kingborough

## COUNCIL MEETING AGENDA

NOTICE is hereby given that an Ordinary meeting of the Kingborough Council will be held in the Kingborough Civic Centre, 15 Channel Highway, Kingston on  
Monday, 1 February 2021 at 5.30pm

## 66 Summerhill Road, West Hobart

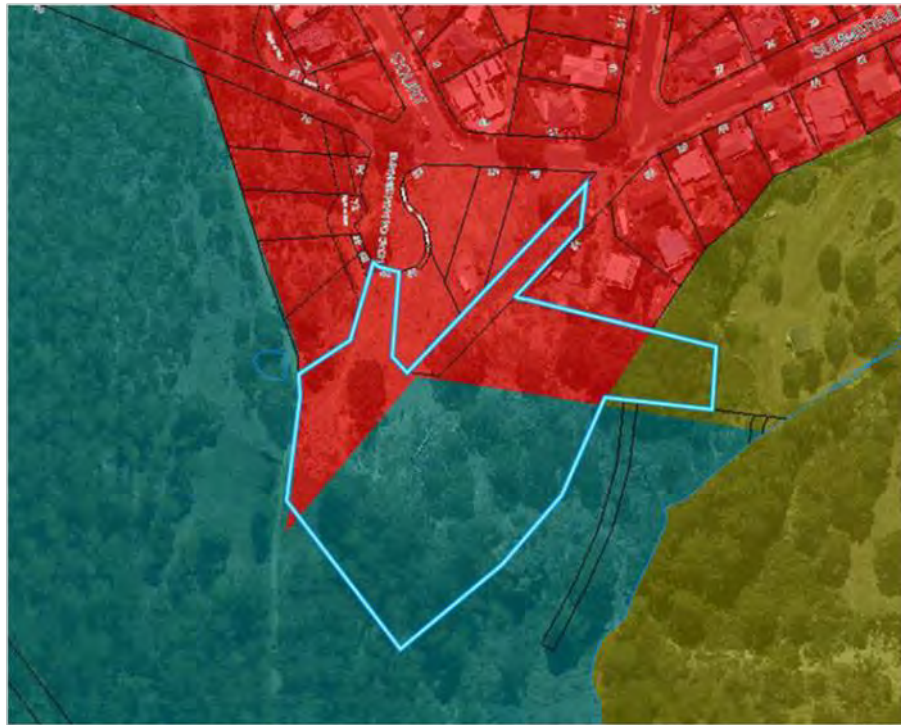
**Figure 1: Subject site showing existing zoning (Council GIS)**

- 4.8. The site is currently partly zoned General Residential, Environmental Living and Environmental Management.
- 4.9. It is noted that the zoning maps of the Council's GIS overlays (see Figure 1) align differently with the underlying property boundaries compared to the State Government's LISTmap property boundaries (see Figure 2).

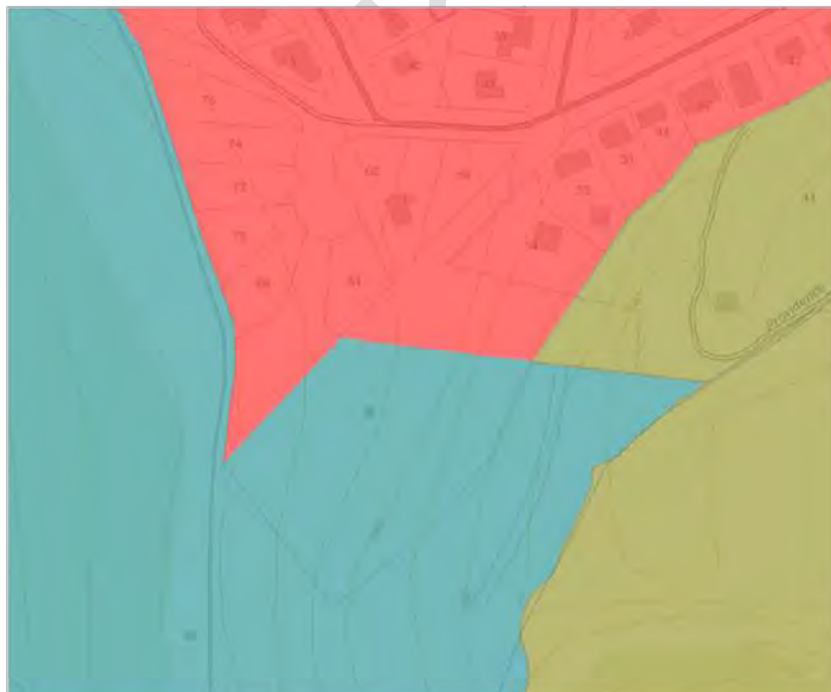
**Figure 2: Subject site showing existing zoning (LISTmap)**

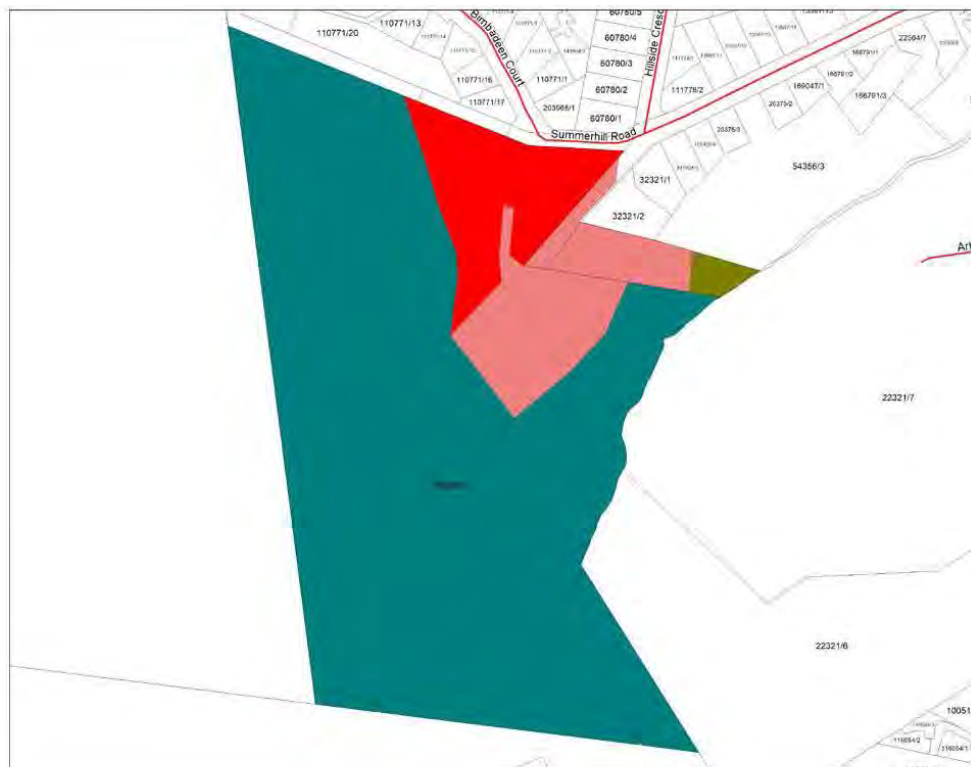
**Figure 1:** Proposed rezoning of the subject site.

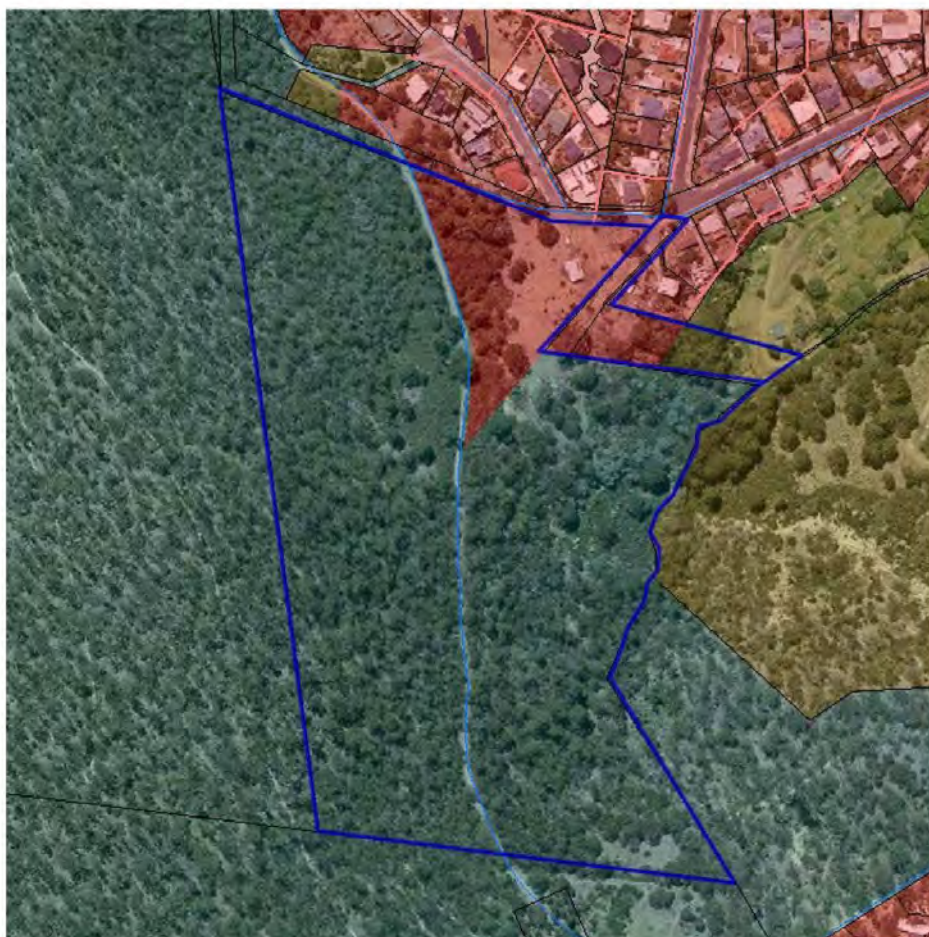
Figure 3: The properties are currently zoned General Residential at the Summerhill Road end, Environmental Management for the remainder of the larger lot, and Environmental Living on half of the smaller lot to the east. (source: [www.maps.thelist.tas.gov.au](http://www.maps.thelist.tas.gov.au)).

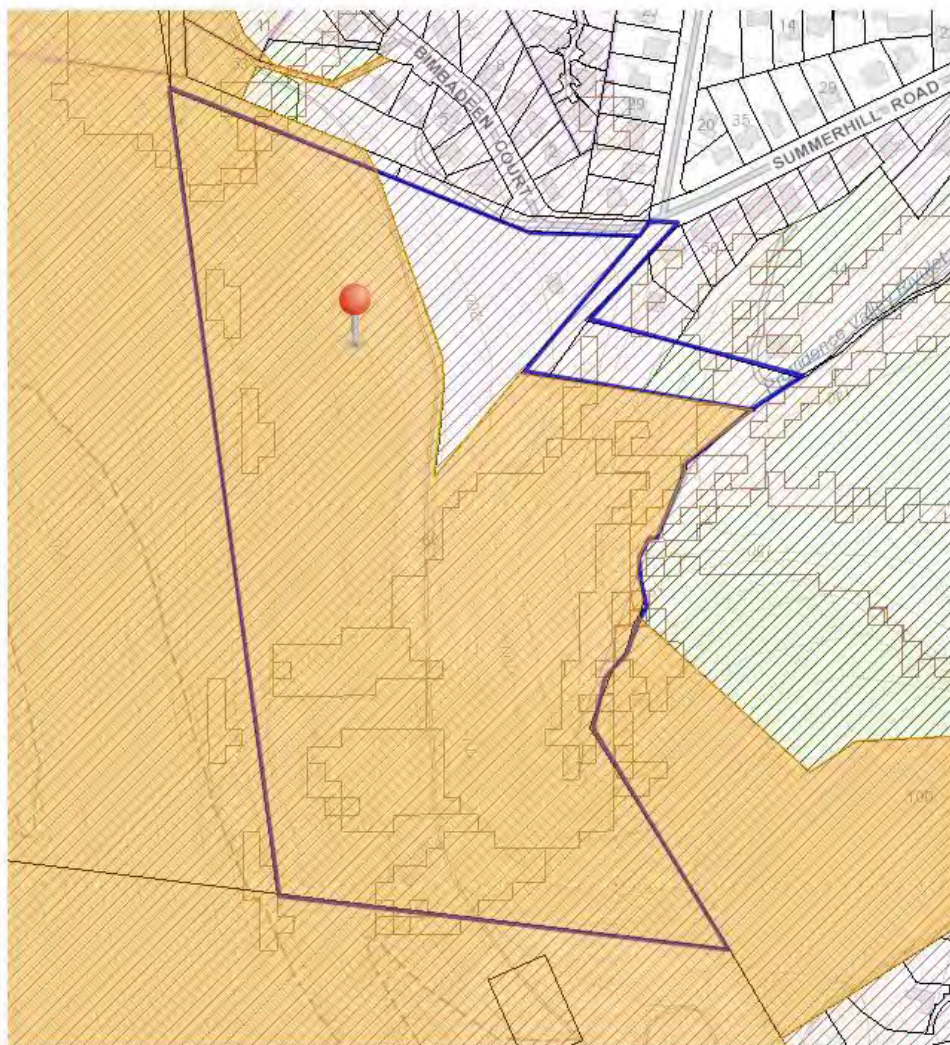
Figure 4: The Biodiversity protection area as it applies to the site. The section it doesn't apply to includes the existing General Residential zone.

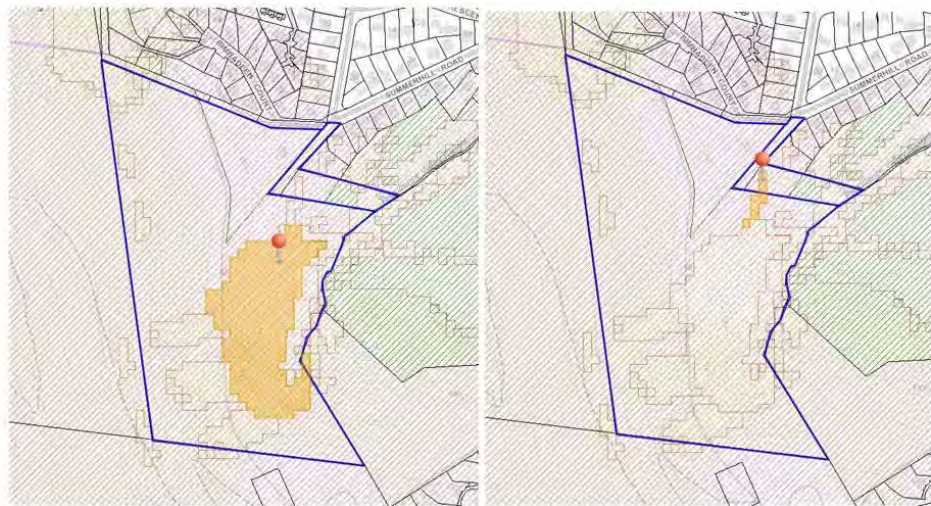
Figure 5: The Medium landslide hazard area applies to the sections shown above.

The Landslide Hazard overlay as shown in Figure 5 below, includes the medium level landslide hazard risk area. It is considered that the future size of the lots facilitated by the proposed rezoning will provide opportunities for development outside of these overlay areas. If necessary, at the subdivision stage supporting geotechnical reports can be provided to demonstrate safe building sites for future development.

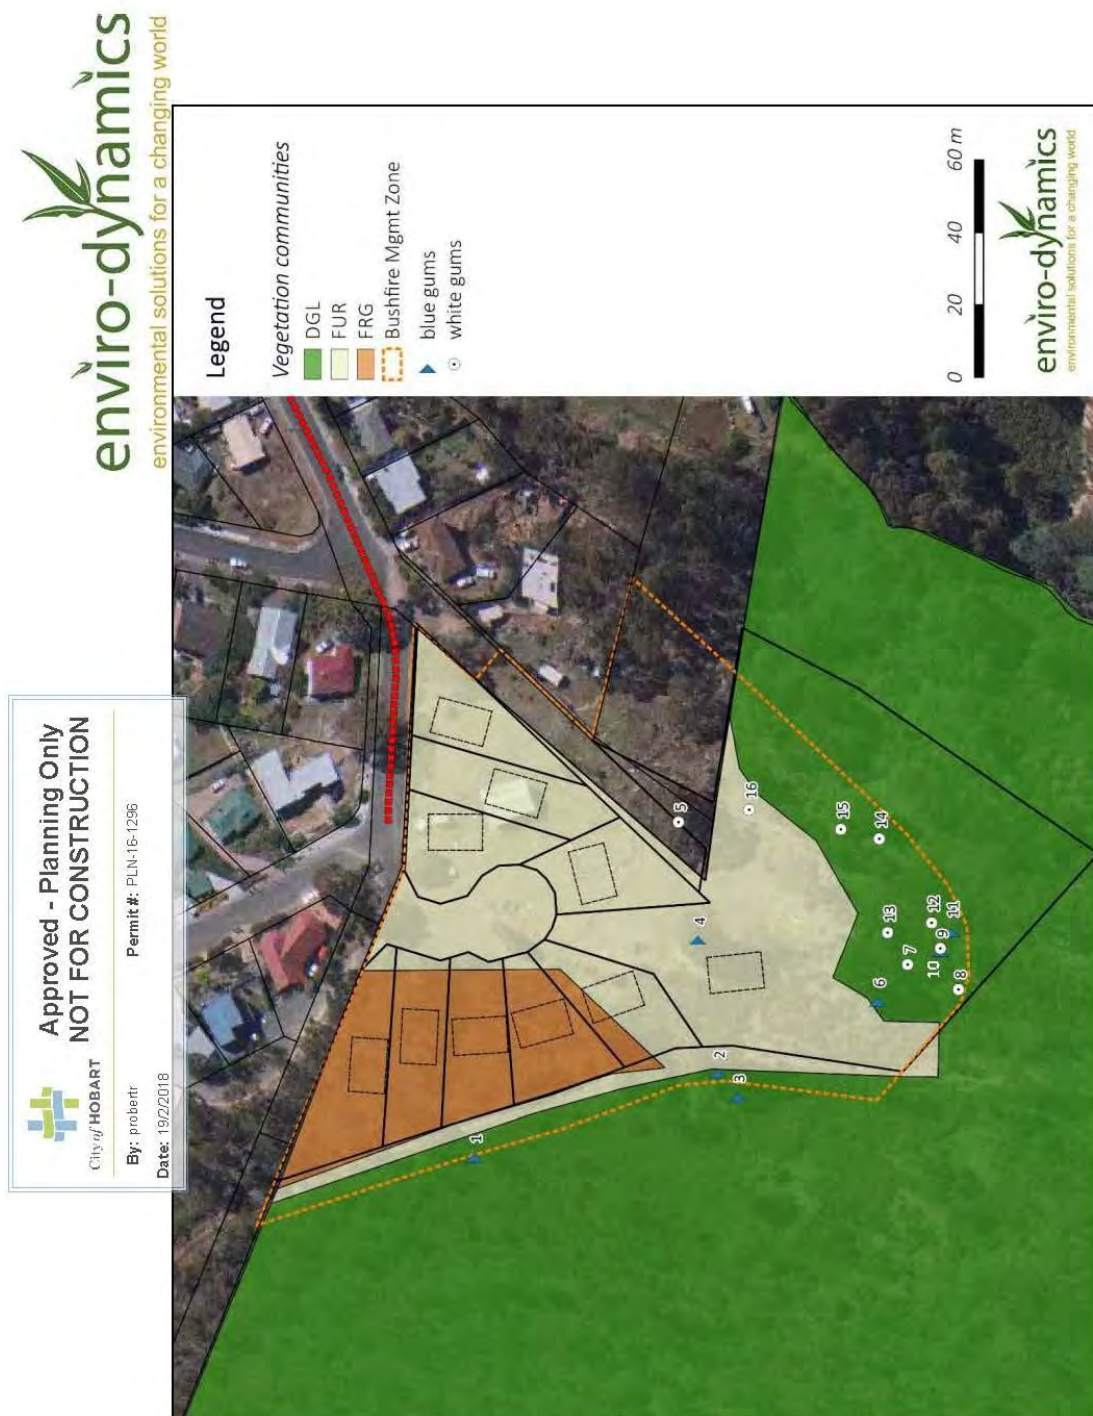
Figure 1 – location of mature trees within bushfire hazard management area.

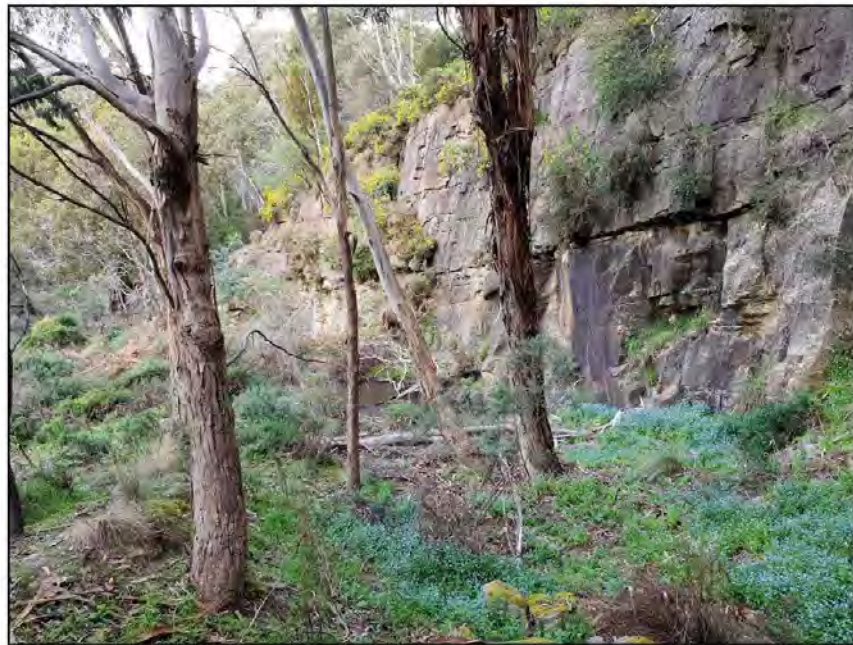
Figure 2 – quarried area downslope with eucalypt over storey and weedy understorey.

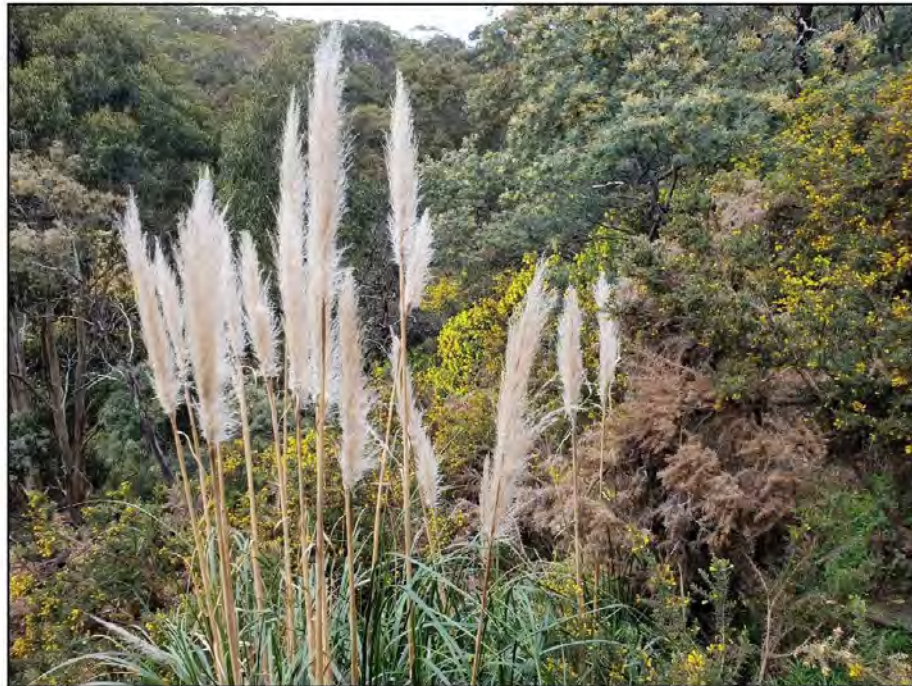
*Figure 3 – Vegetation broadly classified as DGL with understorey dominated by woody weeds.*

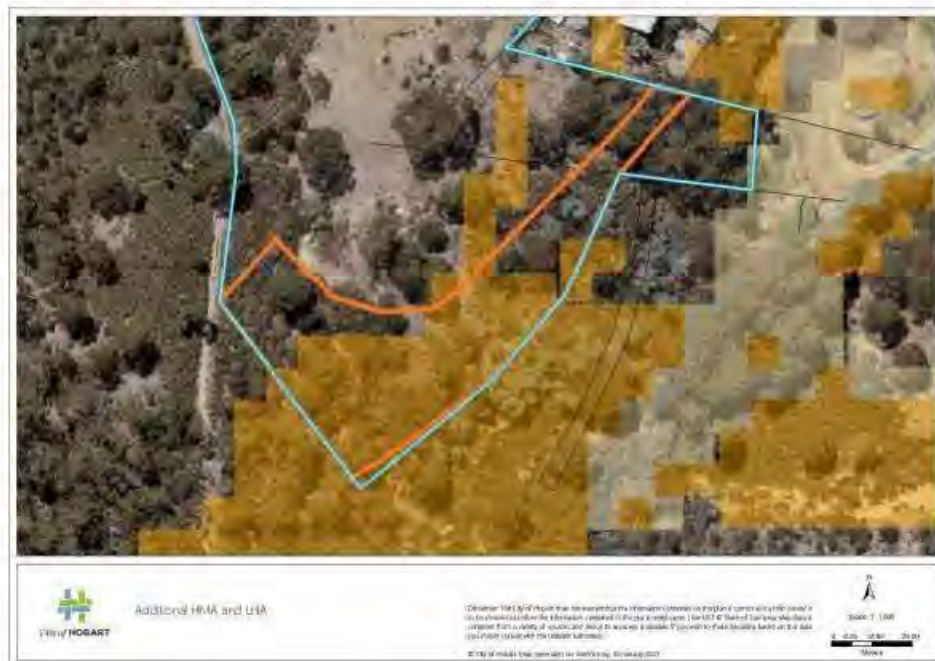
**Figure 1** – extract of landslide hazard area and proposed vegetation removal

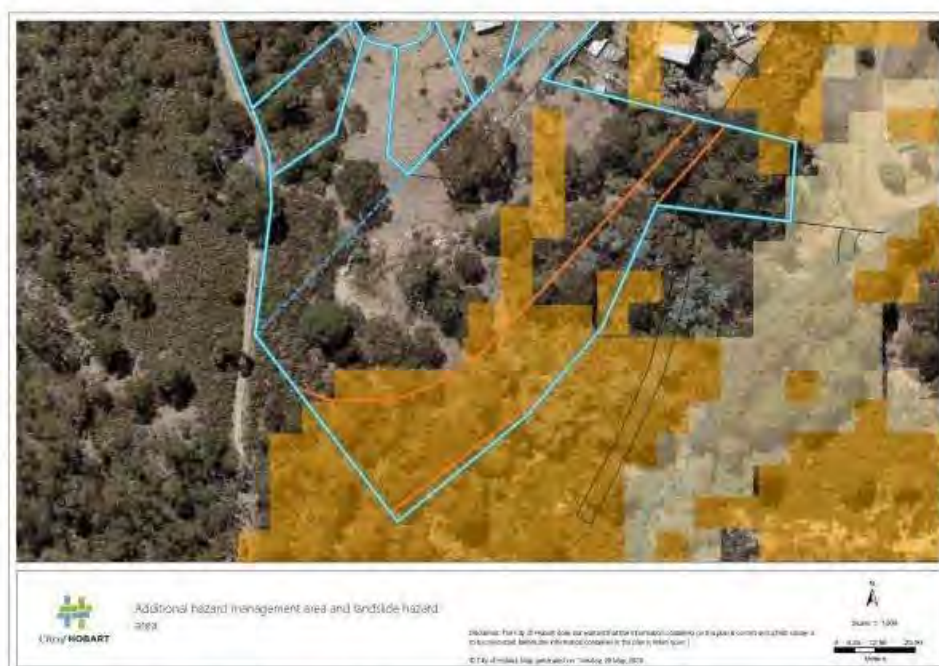
Figure 1: Additional area required for hazard management area (between orange lines)

The additional area of the lot that would be required as a bushfire hazard management area (HMA) beyond that approved for the existing subdivision, based on the indicative building envelope for future dwellings is shown in Figure 1 below.

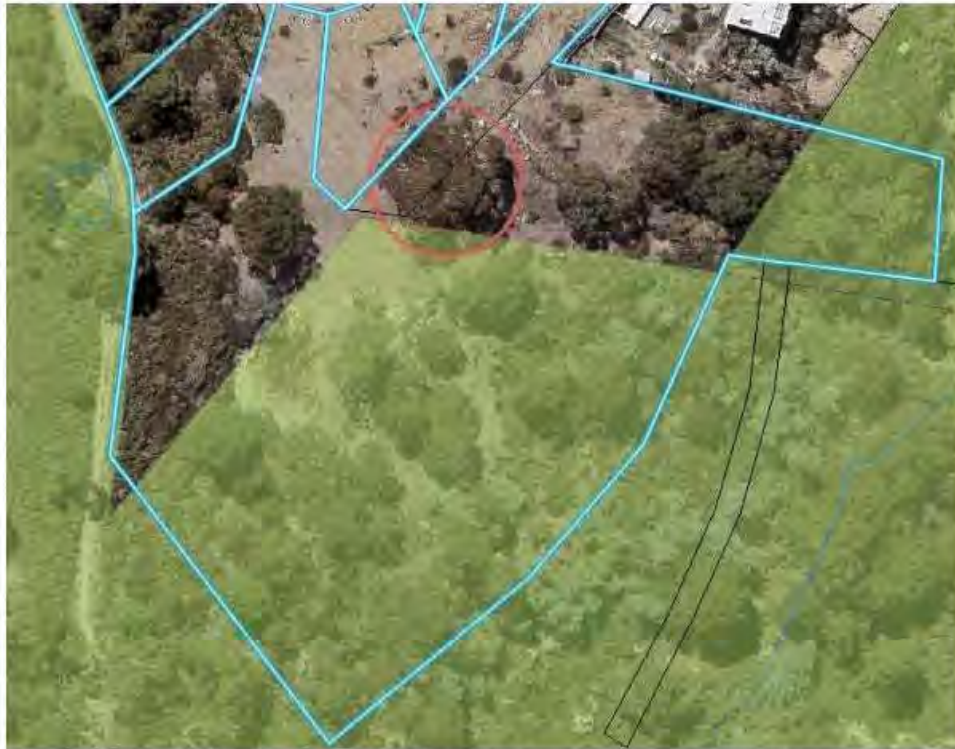
Figure 5: Extent of Biodiversity Protection Area on lot and location of large White Gum with hollows

It should be noted that the white gum and blue gums referred to are not currently within a biodiversity protection area, however they are on, or at least partially on, the land proposed for rezoning.

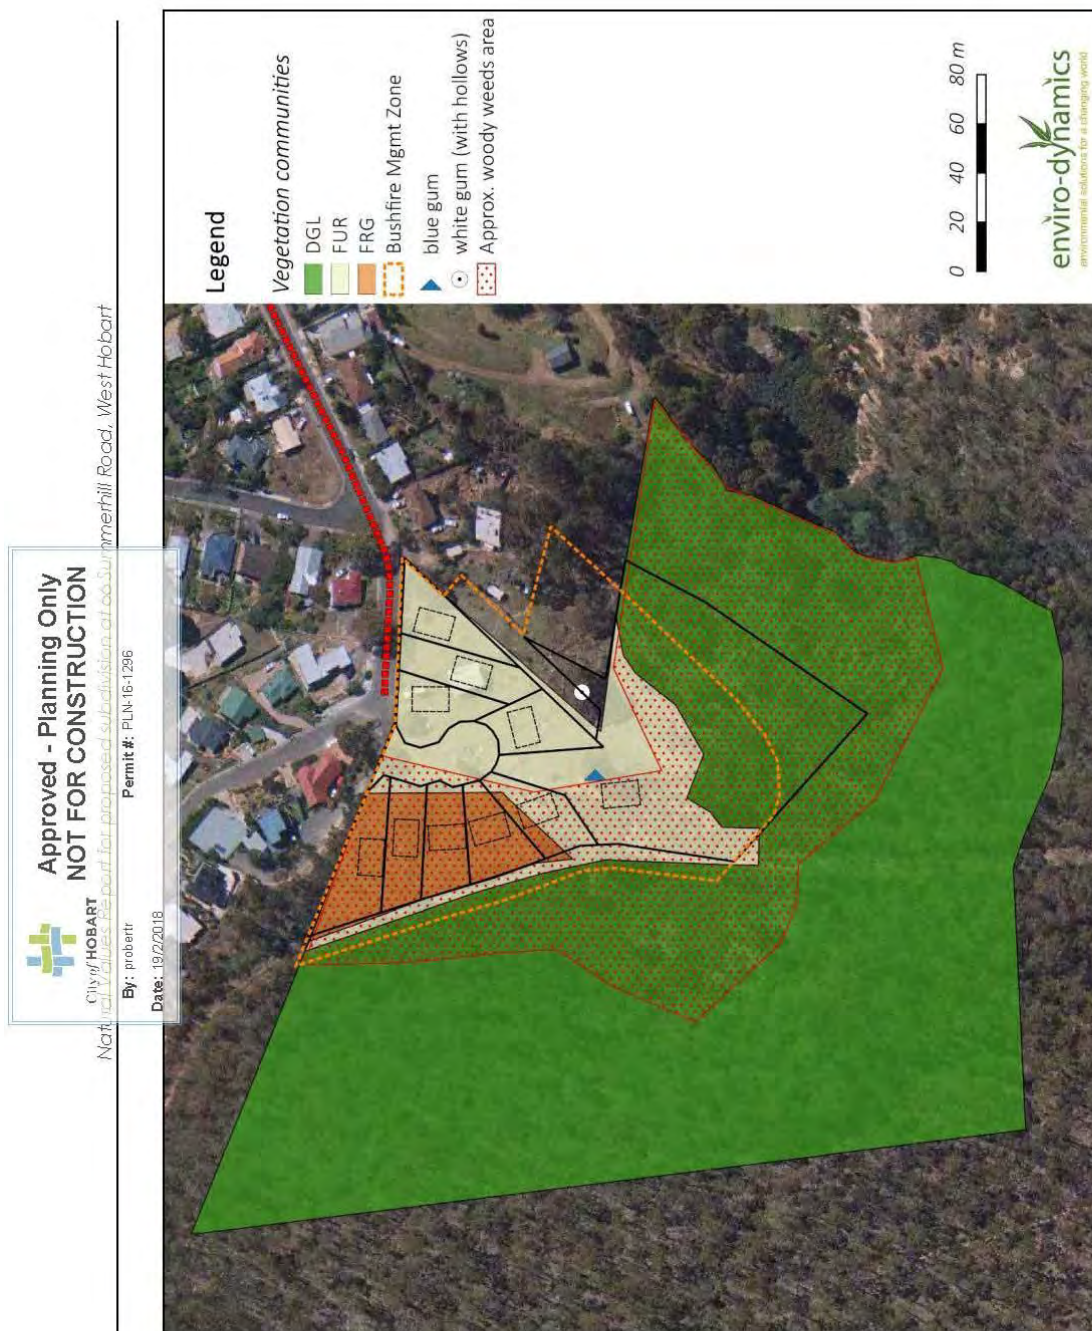
Figure 2 - Distribution of vegetation communities, threatened flora and weeds across site.

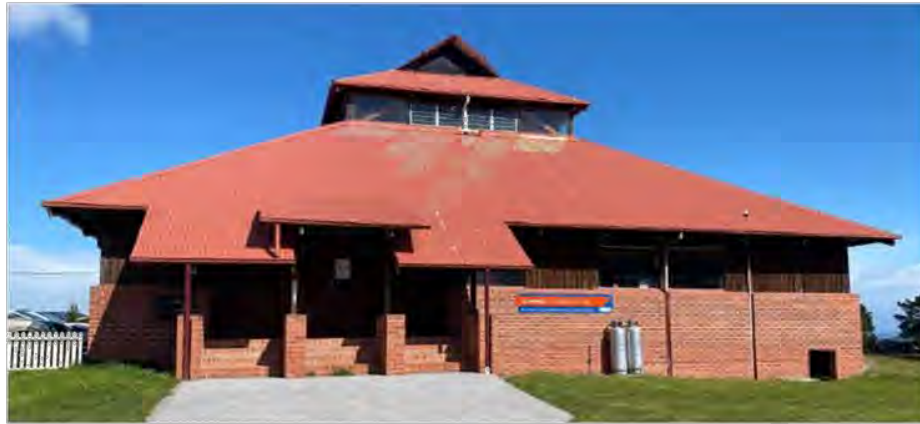
**9.2 Bruny Island Community Centre (Alonnah)**

**Description** – Architecturally designed building constructed in 1975 with brick and timber and colorbond roof.

**Current Condition** – The facility is rated as being good to very good and has recently been upgraded via a state government grant.

1. Address the maintenance items as per Optimus Building Surveyors report (doors and walls)
2. Re-oil external timber walls
3. Relocate cleaning supply cupboard
4. Repair leaks in roof and guttering

1. Upgrade toilet facilities to meet disability access standards.

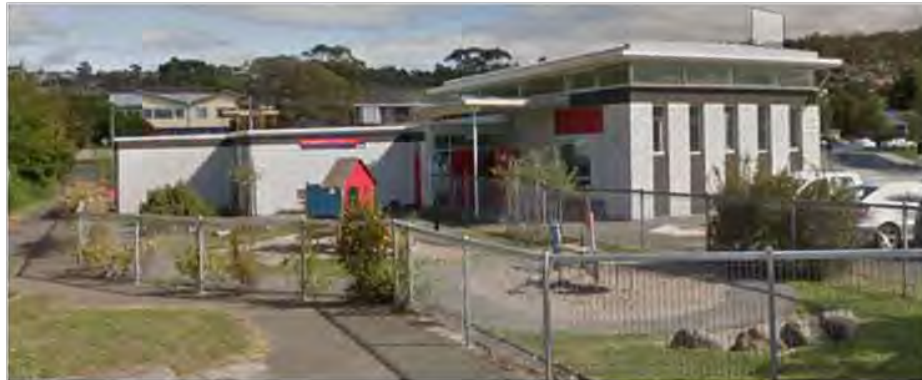
**9.3 Blackmans Bay Hall**

**Description** – Concrete block building with corrugated iron roof. Contains a main hall, stage, kitchenette and meeting room.

**Current Condition** – Most elements of the building are rated in either fair or poor condition.

**Issues** – the building is showing signs of age with cracking to the block work, subsidence to the floor in the stage area and water damage to the carpet and floor of the meeting room.

1. Address the subsidence issues pending outcome of investigations
2. Roof replacement

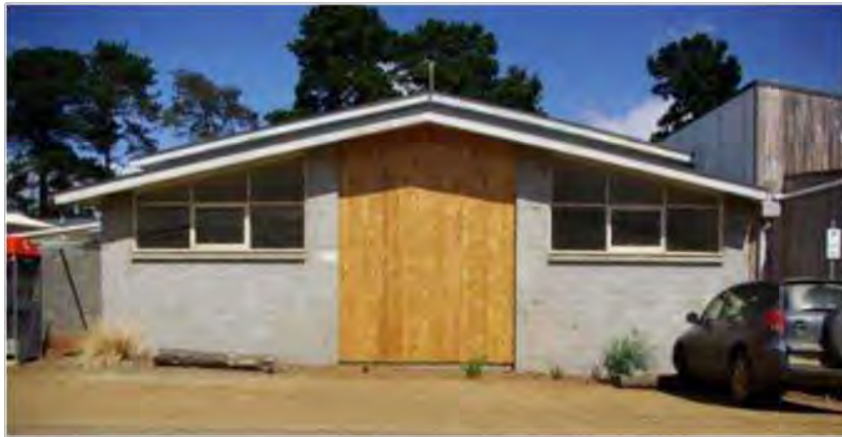
**9.4 Dennes Point Hall**

**Description** – Main hall is block with a corrugated iron roof. Attached to the hall is a café and gift shop constructed of timber.

**Current Condition** – The majority of the building elements are rated in good condition.

1. Upgrade of side entrance

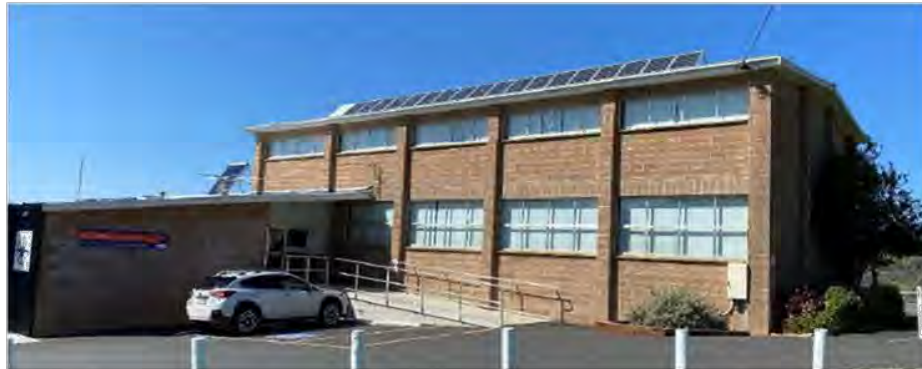
### 9.5 Kettering Hall

**Description** – Brick building with corrugated iron roof constructed in 1940 and contains a main hall, stage, kitchen and meeting room

**Current Condition** – most elements of the building are rated as either good or very good.

1. Compliant disability access toilet inside the hall
2. Kitchen upgrade
3. Floor replacement

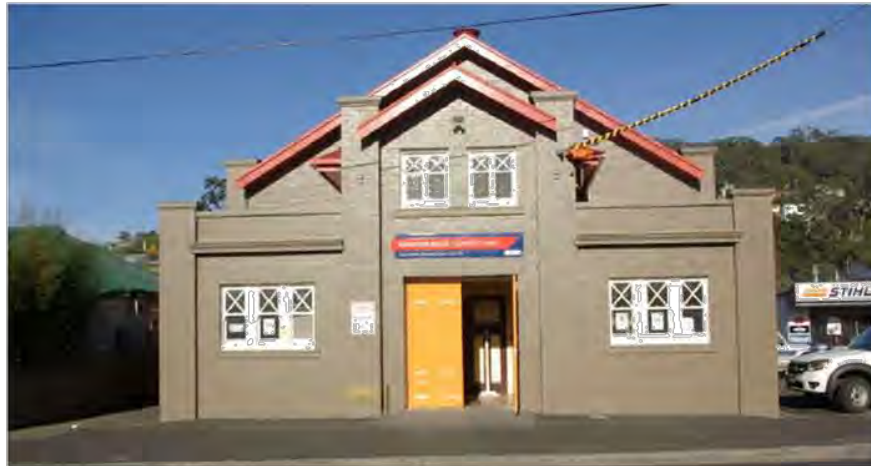
#### 9.6 Kingston Beach Hall

**Description** – Brick building with corrugated iron roof contains main hall, stage, kitchen, meeting rooms and gallery.

**Current Condition** – The building is rated as being in good condition except for windows, doors, and toilets that are rated fair.

**Issues** – The disability access toilet is non-compliant, the front ticket room is currently used for storage but is in poor condition and better use could be made of this space.

1. Compliant disability access toilet
2. Upgrade of ticket room
3. Disability access to gallery space

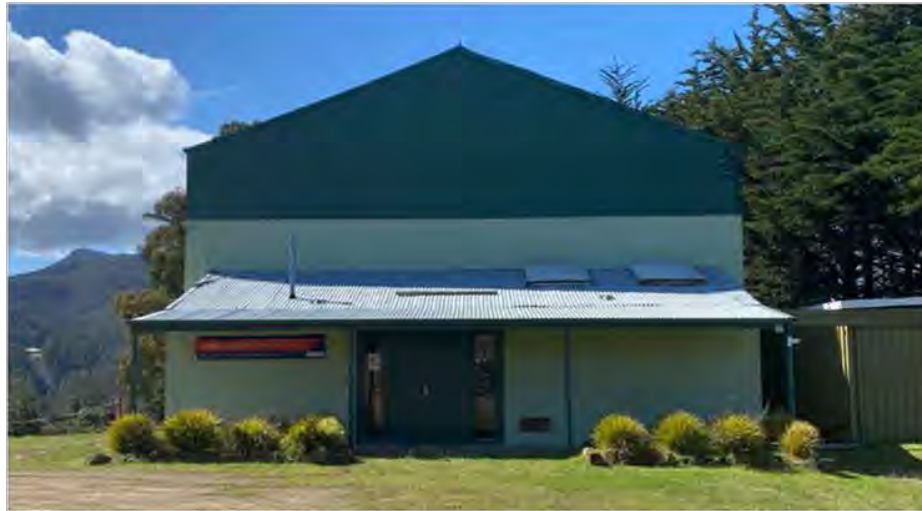
#### 9.7 Lower Longley Hall

**Description** – Weatherboard building with corrugated iron roof contains main hall, kitchen, meeting room and mezzanine floor.

**Current Condition** – the building is rated as being in fair condition with some elements being rated as poor (ceilings and external paths).

**Issues** – the hall is dated and it is questionable as to whether its design is suitable for the current and future needs of the community. However, there is currently no consensus as to whether the facility should be refurbished or replaced.

1. Refurbishment or replacement pending further consultation with the Hall Management Committee and local community.

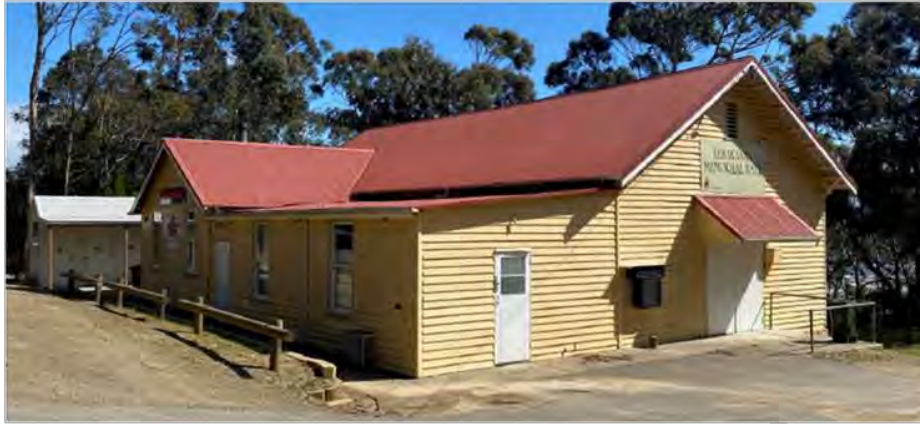
**9.8 Lunawanna Hall**

**Description** – timber building constructed in 1920 with a corrugated iron roof contains main hall, stage, kitchen and meeting room. External toilets (renewed in 2019).

**Current Condition** – The building is rated as being in good condition.

1. Sealing of the carpark
2. Construction of a deck on the water side

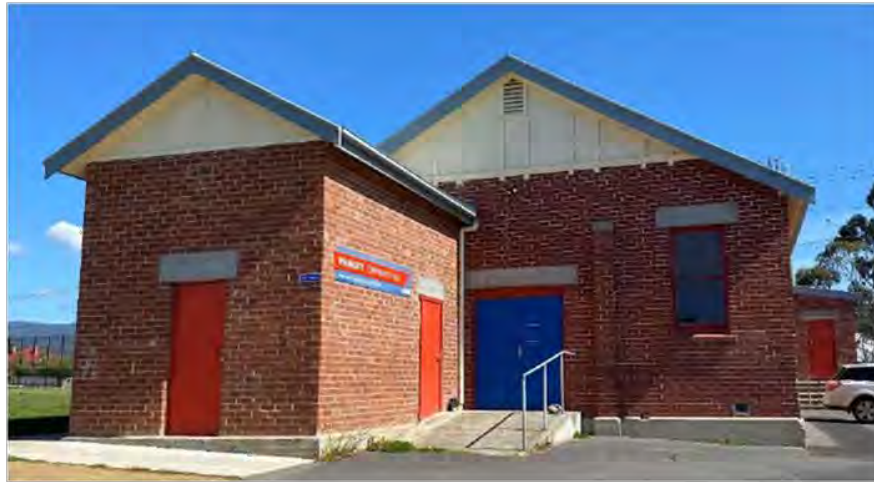
#### 9.9 Margate Hall

**Description** – Brick building constructed in 1930 with a new colorbond roof contains main hall, stage, kitchen and meeting room.

**Current Condition** – Most elements of the building are rated as being in good condition with the exception of windows, doors and the stage floor.

**Issues** – The toilets are in poor condition and there is no compliant disability access facility. The external ramp to the hall is also non-compliant.

1. Toilet upgrade as per Toilet Strategy
2. Main entrance access ramp

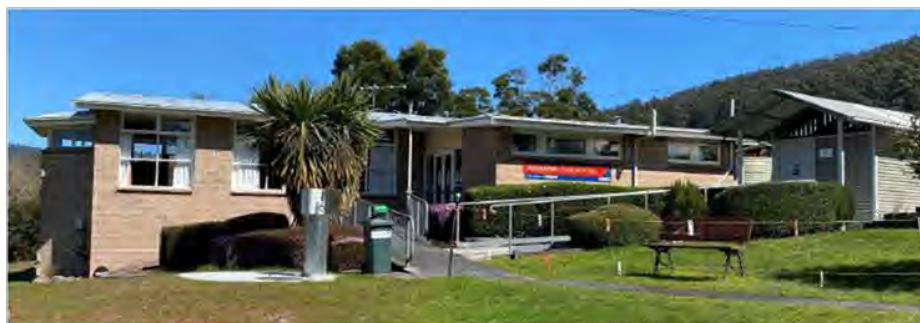
**9.10 South Channel Community Hall (Middleton)**

**Description** – Concrete block building constructed in 1972 with a corrugated iron roof contains main hall, kitchen and meeting room.

**Current Condition** – The building is rated as being in good condition with the exception of some minor maintenance required on doors and walls.

1. Upgrade of internal toilet facilities

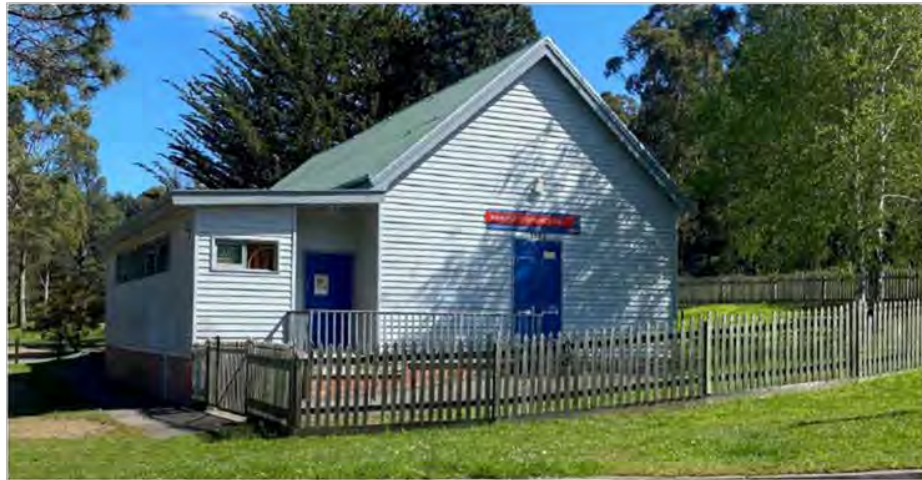
#### 9.11 Sandfly Hall

**Description** – Weatherboard building with a corrugated iron roof contains hall, stage, kitchen and meeting room.

**Current Condition** – The building is rated as fair and good condition with some elements rated as poor.

1. Roof, sub floor/foundations
2. Toilet facilities
3. External access
4. Kitchen upgrade

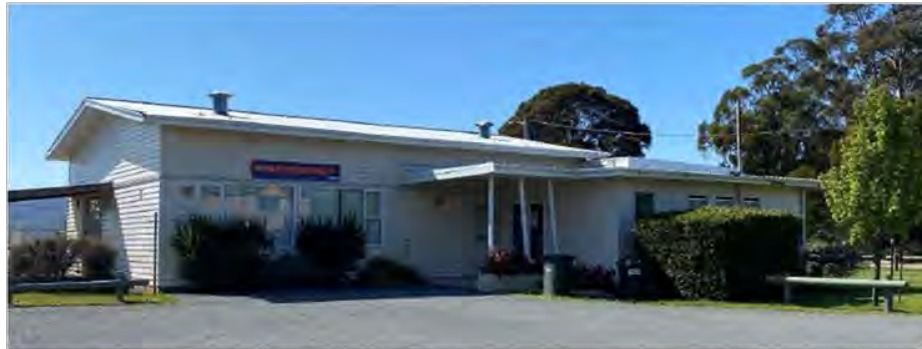
#### 9.12 Snug Hall

**Description** – Weatherboard building with a corrugated iron roof contains main hall and kitchen.

**Current Condition** – Most of the elements of the building are rated in fair condition.

**Issues** – Most elements of this facility require upgrading. The Hall Management Committee has requested that Council give consideration to solar panels and replacement of the heating system. The roof is scheduled for replacement in the 2020/21 financial year.

1. Kitchen upgrade
2. Heating system upgrade

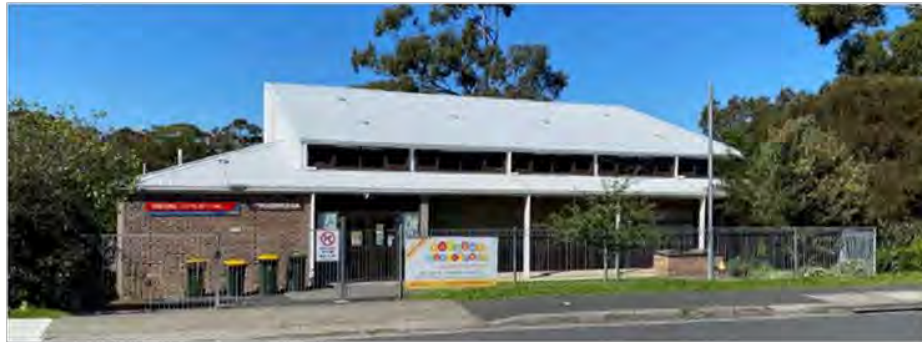
**9.13 Tarooma Hall and Cottage**

**Description** – Brick building with corrugated roof contains main hall, stage, kitchen and RSL Office. Adjoining Cottage is a weatherboard building with a corrugated iron roof and contains several meeting rooms.

**Current Condition** – Overall the facilities are rated as being in good condition with some general maintenance required on windows and doors. There are some cracks evident in the brick work that have been assessed by an Engineer and found to be of minor concern.

1. As identified in Tarooma Hall Masterplan.

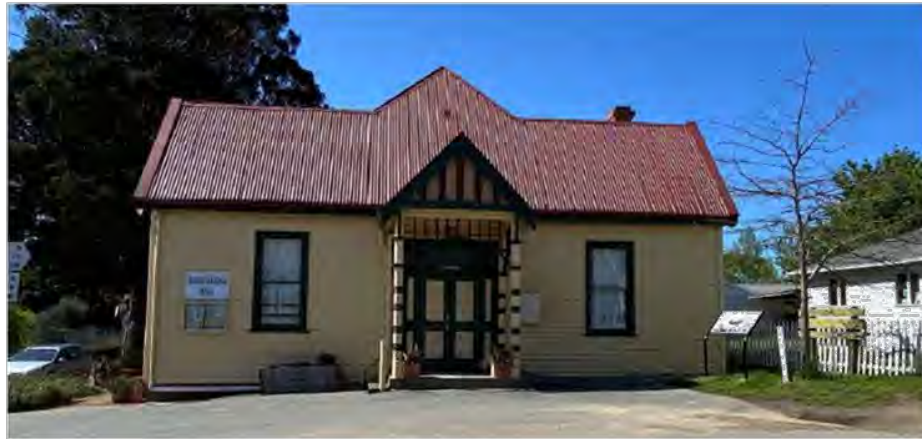
**9.14 Woodbridge Hall**

**Description** – Weatherboard building constructed in 1983 with a corrugated roof contains main hall, stage, kitchen and meeting room.

**Current Condition** – Overall the building is rated as being in fair condition except apart from the kitchen which was recently upgraded. An upgrade of the toilets and front porch is being undertaken in the current financial year along with the replacement of the roof.

1. Heating upgrade
2. Deck on the northern side (subject to tree removal)

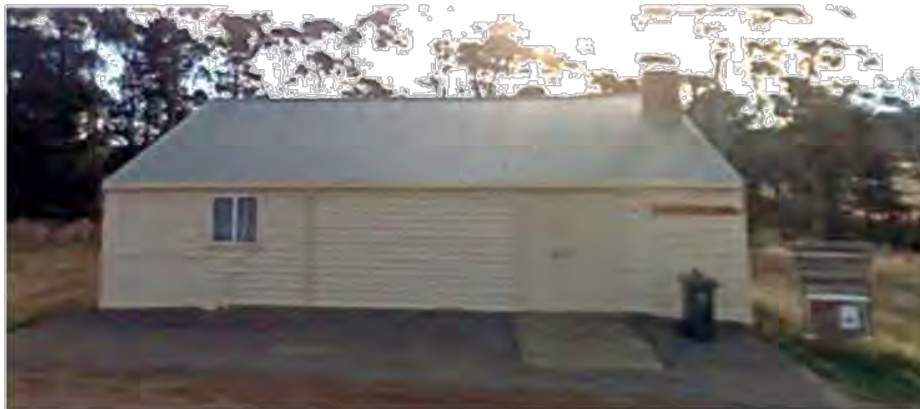
**9.15 CWA Barnes Bay Hall**

**Description** – Weatherboard building constructed in 1974 with a corrugated iron roof.

**Current Condition** – Overall the facility is rated in good condition.

**Issues** – Current lease conditions state that if the building is not properly maintained, then Council reserves the right to sell it.

1. Address the maintenance items as per Optimus Building Surveyors report (general maintenance schedule) in accordance with lease conditions.

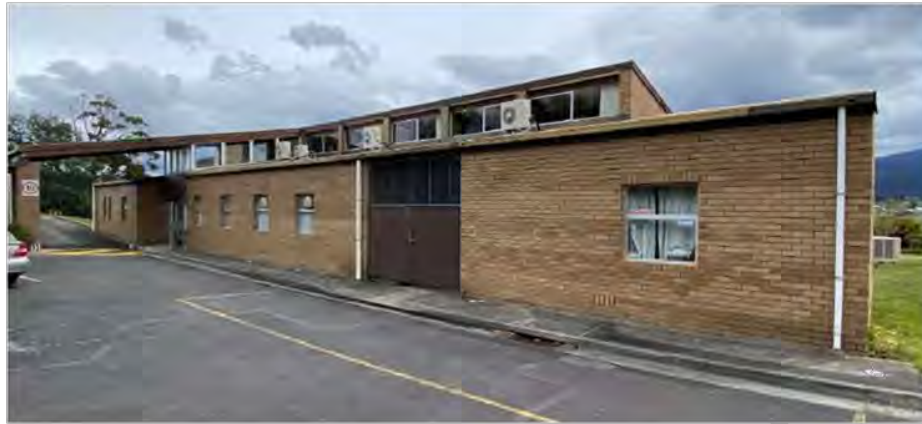
**9.16 Kingborough Community Centre (Senior Citizens Club)**

**Description** – Brick building constructed in 1978 with a corrugated iron roof contains main hall, kitchen and meeting rooms. Meals on Wheels is also located in part of the building.

**Current Condition** – Overall the facility is rated in good condition.

1. Address the maintenance items as per Optimus Building Surveyors report (facias, walls, ceiling in kitchen and areas in the Meals on Wheels room) in accordance with lease conditions.

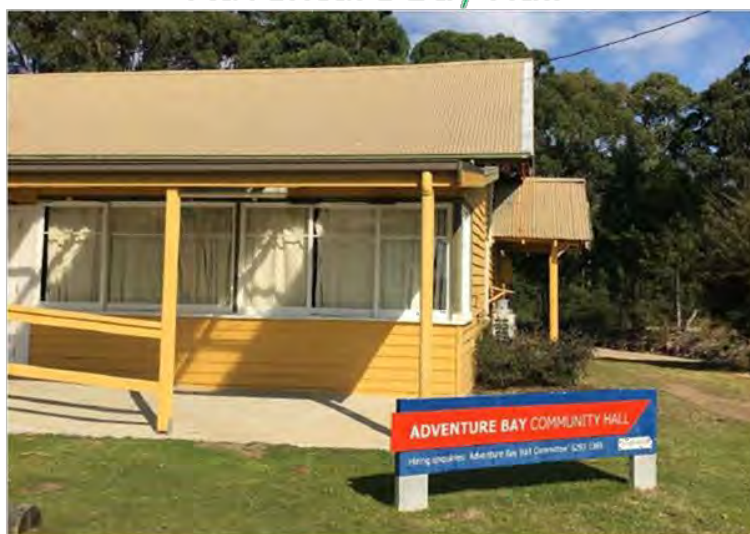
## Adventure Bay Hall

It appeared that the lean-to and entrance porch had been fitted with new gutters and downpipes recently and these were still in good condition. The condition at the rear of the building was poor and repair will be required. The roof to the rear of the building was in poor condition with some dips in the sheeting which may lead to future problems.

The shingles to the side of the building above the exit door were in poor condition and require replacement.

Internal paint was in fair condition and showing signs of normal wear and tear.

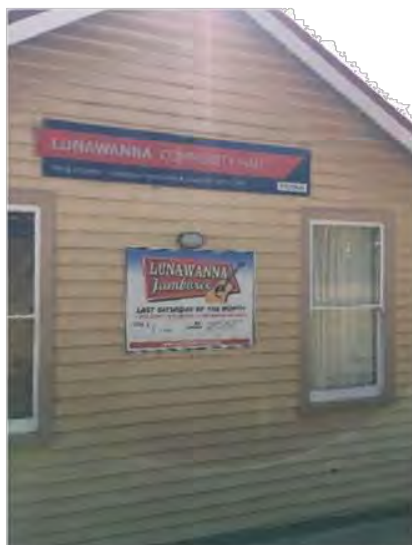
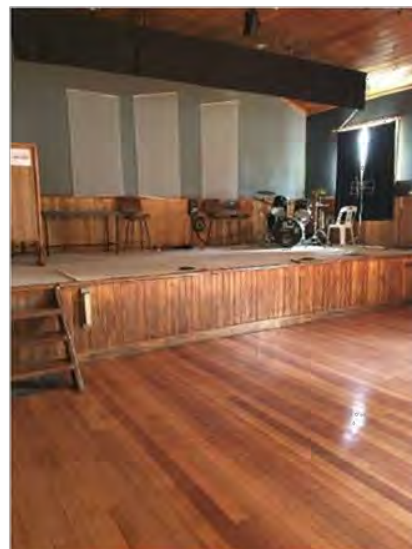
## Lunawanna Hall

Good condition, no works required other than general maintenance.

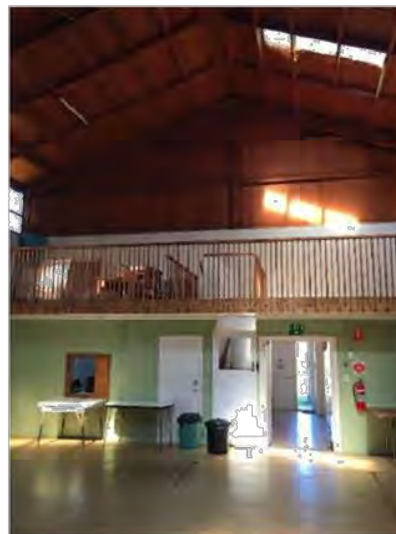
Address: 9 Hovingstons Road Lower Longley

The roof was in good condition and repair will not be required in the near future. General maintenance recommended.

Blockwork around the perimeter of the building was in good condition however it is recommended that general maintenance is carried out as moss was starting to grow on the far side of the building. Some minor cracking was evident in the mortar lines of the blockwork, however more significant cracking was evident from the internal kitchen area. The areas of cladding also require general maintenance.

The rear exit door lead to a concrete landing which had deteriorated and will require replacement, this exit was unsafe and should not be used. The path from this exit to the front of the building was uneven natural ground.

The internal surfaces were in good condition aside from the ceiling linings, water damage is evident to these areas, particularly the lean-to area. The main hall ceiling was coated with an unknown product. The floor and walls were in good condition and showing signs of normal wear and tear.

There were two doors from the building, the front main exit and the side exit door. Exits had been fitted with compliant door furniture which will require repair as the doors did not freely operate from the closed position. The lock to the main door will also require repair.

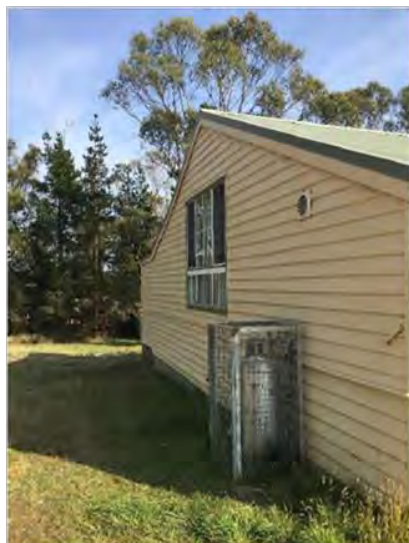
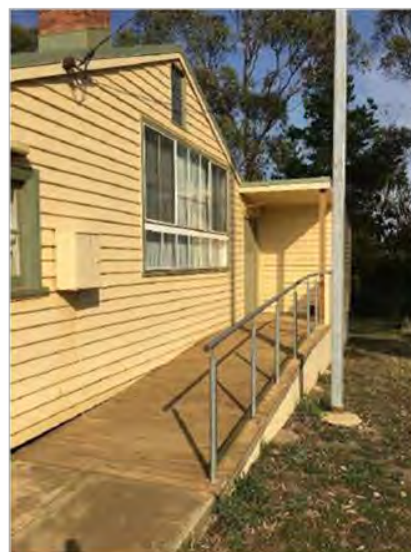
Address: 680 Bruny Island Main Road Barnes Bay

The roof, gutters and facias all appeared to be in good condition for the age of the building. General maintenance is recommended.

Weatherboards to the exterior of the building were in good condition with only minor damages. General maintenance is recommended.

Internal surfaces had been well maintained and were in good condition. Some walls and the floor are uneven but as expected for the age of the building. The building appeared to be frequently used.

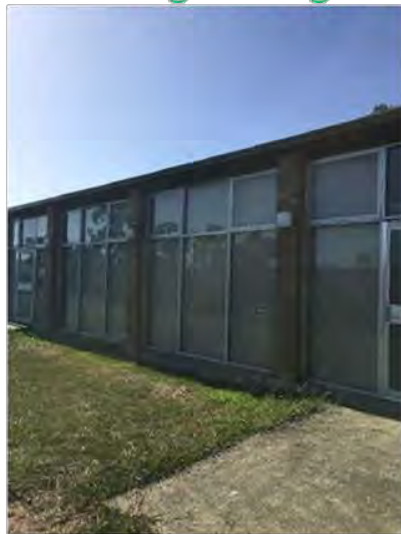
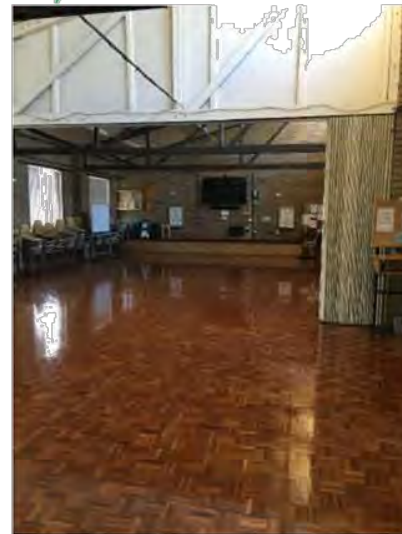
Address: 35 Redwood Road Kingston

The roof was in good condition. Upkeep maintenance is recommended with no significant work expected in the near future. Some water damage to the ceiling inside was present indicating a leak. Further investigation may be required.

External brickwork to the perimeter of the building was in very good condition and did not appear to be showing signs of defects. General maintenance is recommended.

Ceiling and walls were also in good condition throughout the building with exception to the storage area nearest the commercial kitchen and cleaners room where the ceiling will need repairing.

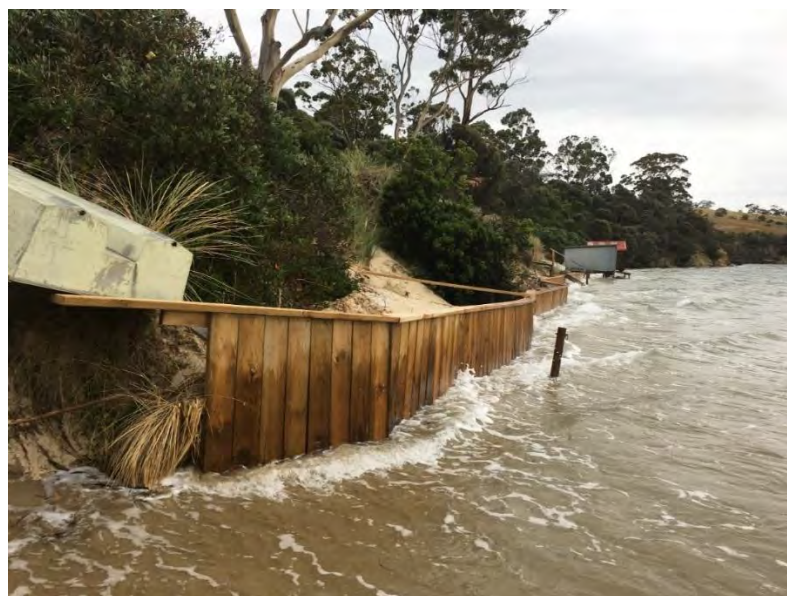
*Image of Nebraska Beach erosion mitigation works.*

Council has retained the services of Chris Sharples (Consultant Geoscientist) to further research the coastal erosion vulnerability status of Nebraska Beach on Bruny Island as well gaining a better understanding of the multiple unapproved coastal defence structures constructed in front of foreshore dwellings over many years. Chris recently completed his PhD focussed on coastal erosion with case study sites on Bruny Island, including Nebraska Beach. The issue of coastal defence structures installed without adequate planning approvals and structural design considerations is of concern to council staff ongoing.

It is hoped, that as part of the project, conceptual designs may be able to be developed demonstrating works / structures that might offer long term erosion protection to this entire section of coastline. The current component of the project should be completed by July 2021.
