APPENDIX A. GLOSSARY

Appendix B

APPENDIX C. SENSITIVITY FLOOD MAPPING

APPENDIX D. FLOOD IMPACT MAPPING

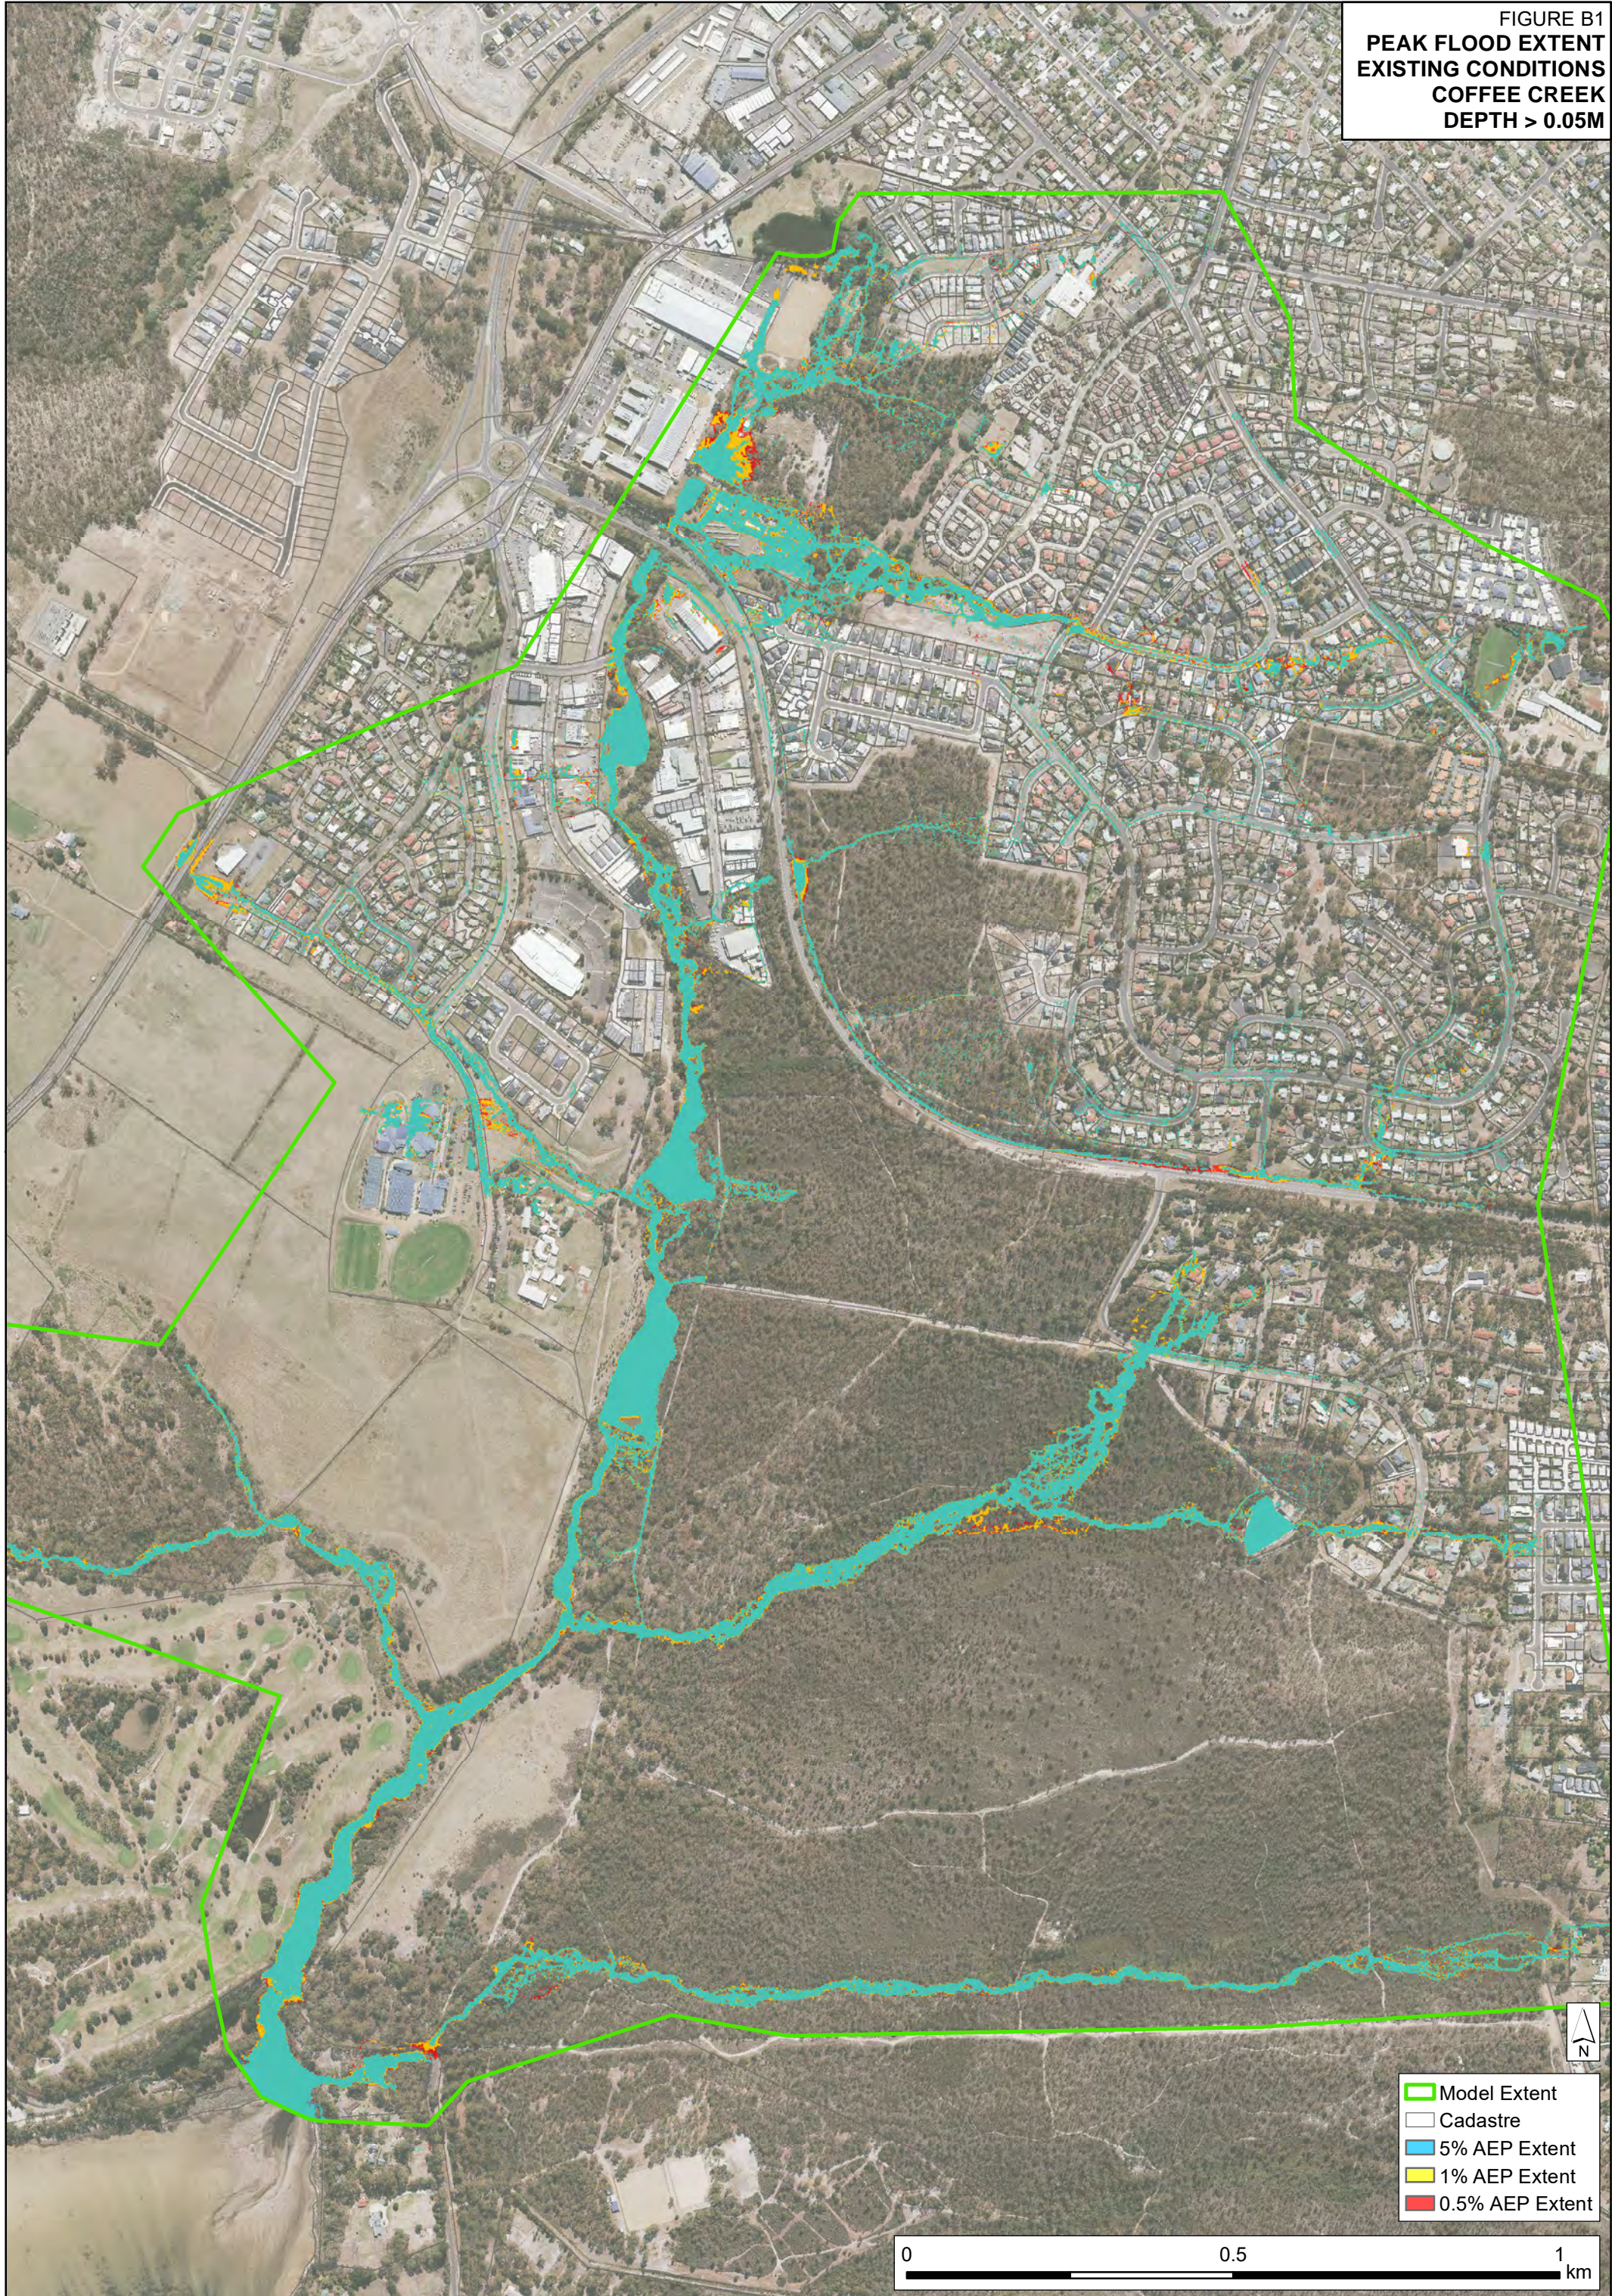
FIGURE B1
PEAK FLOOD EXTENT
EXISTING CONDITIONS
COFFEE CREEK
DEPTH > 0.05M

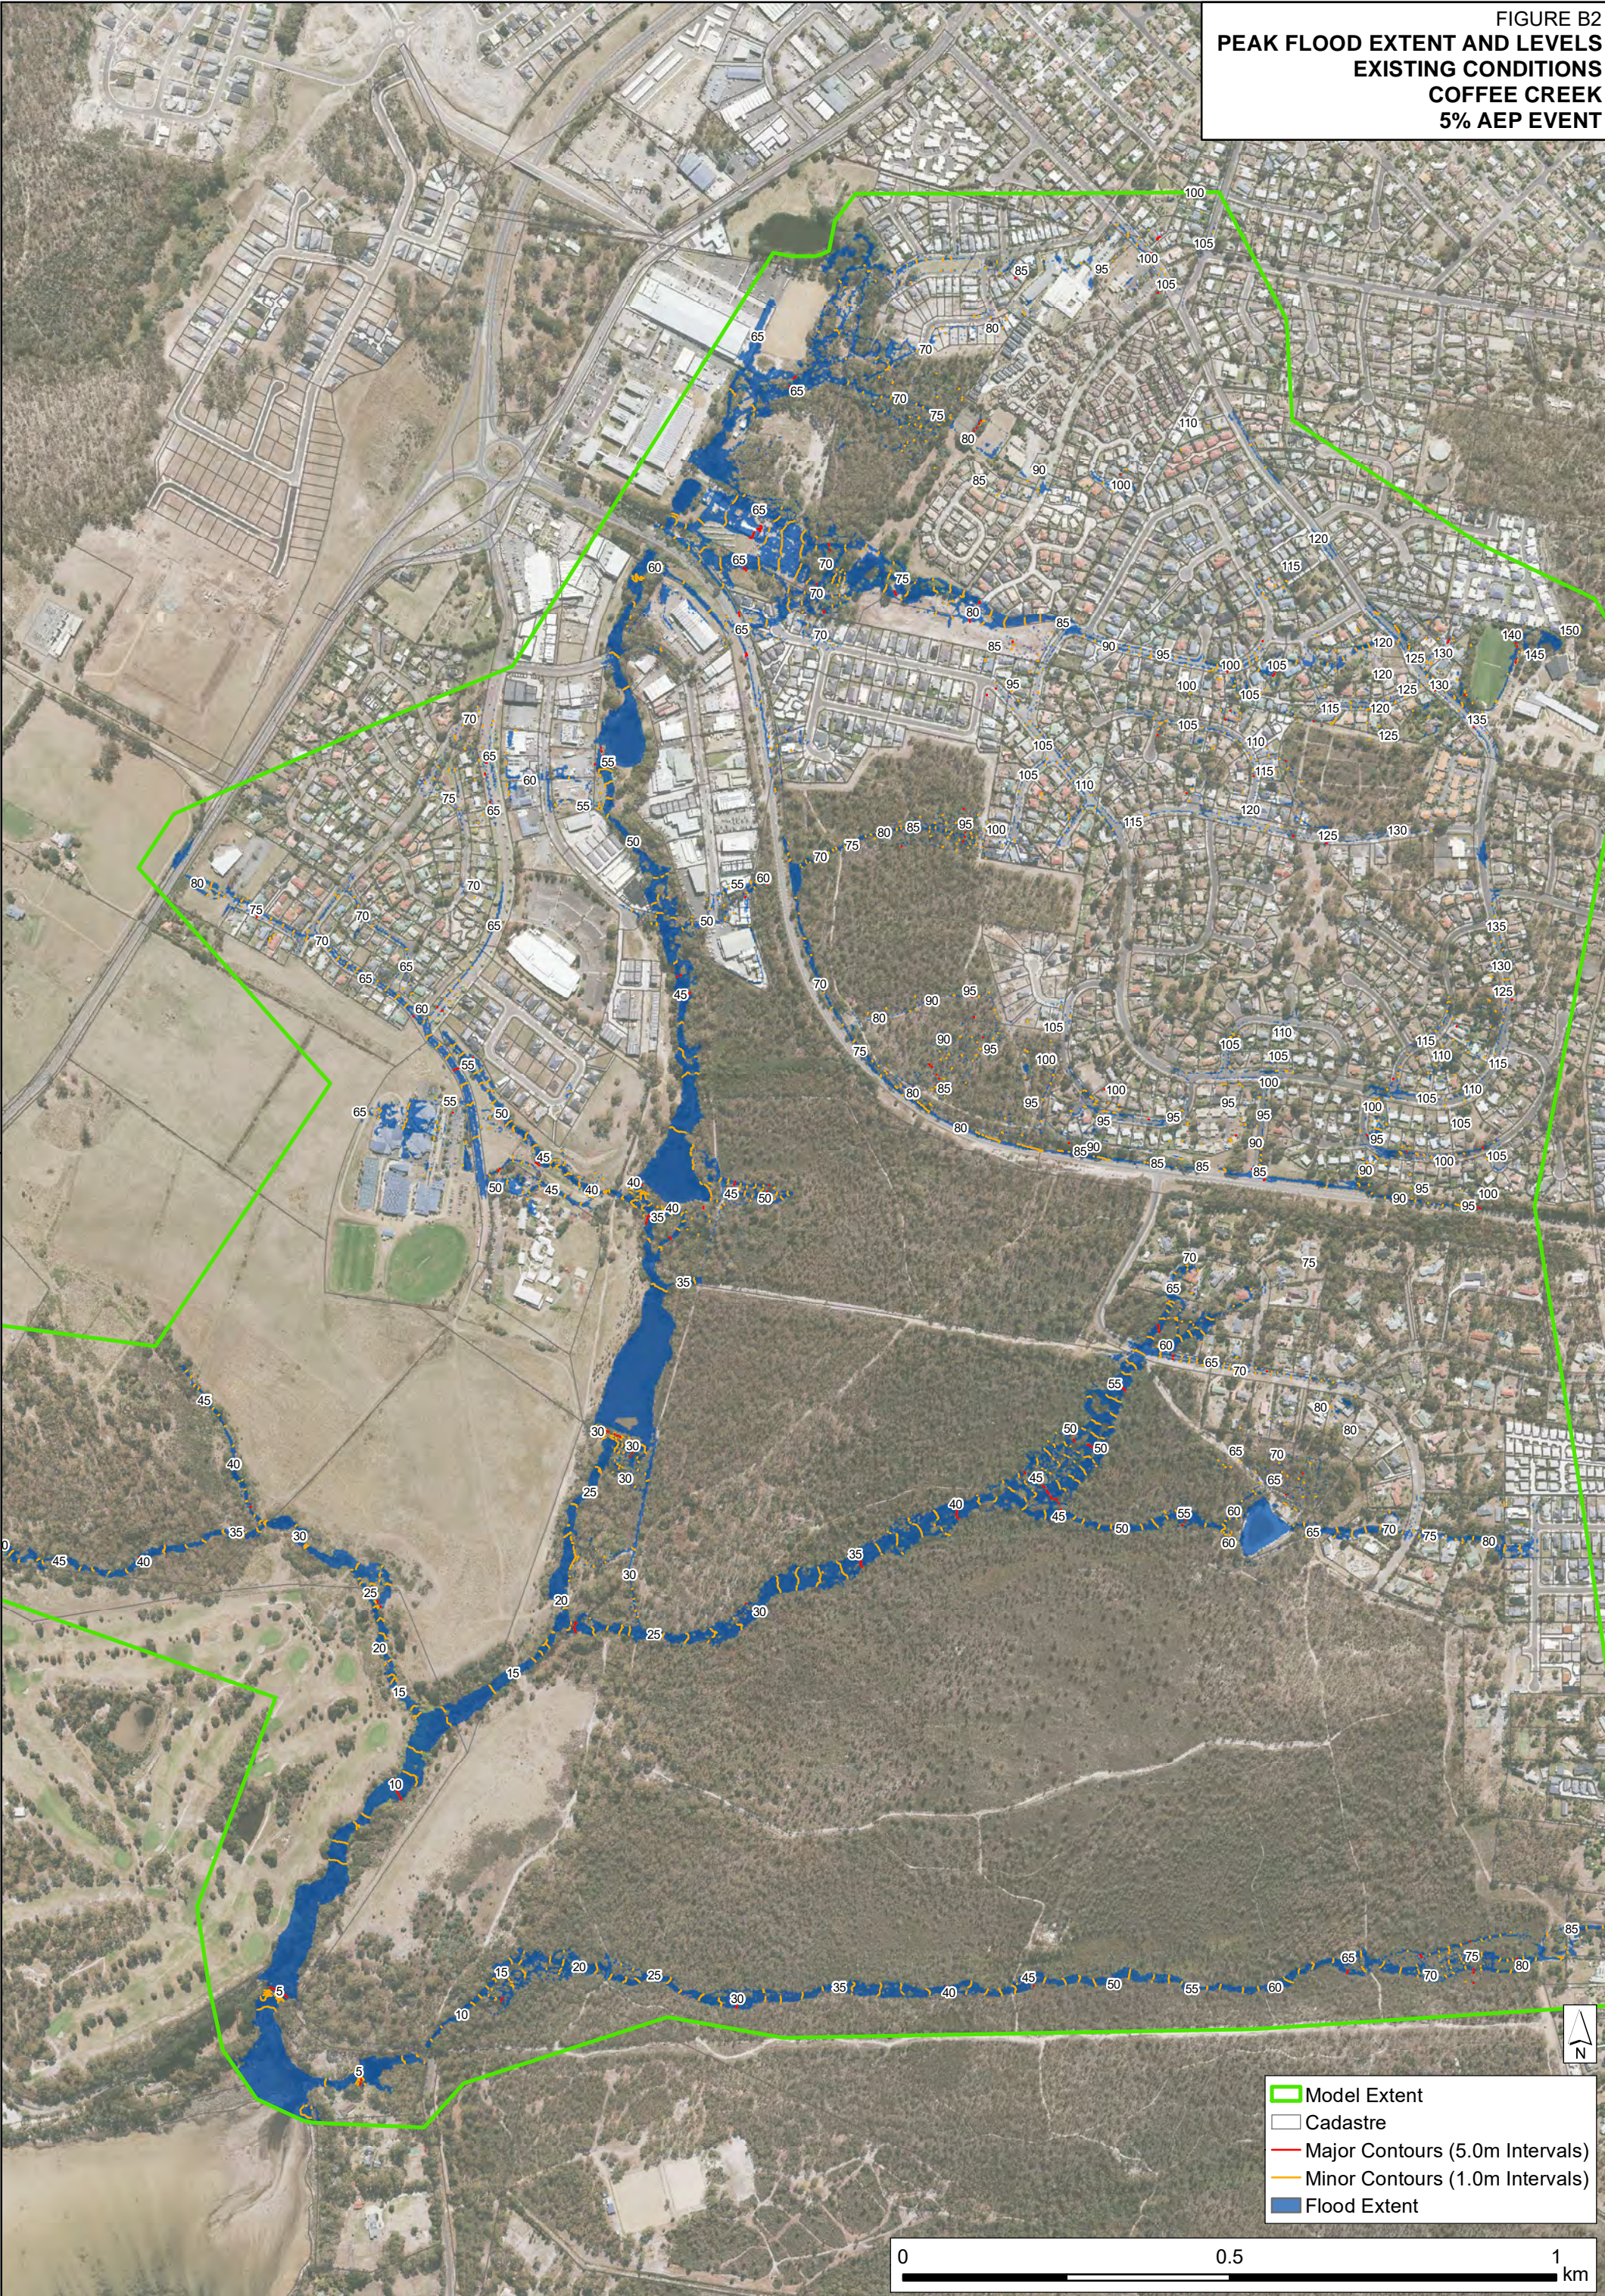
FIGURE B2
PEAK FLOOD EXTENT AND LEVELS
EXISTING CONDITIONS
COFFEE CREEK
5% AEP EVENT

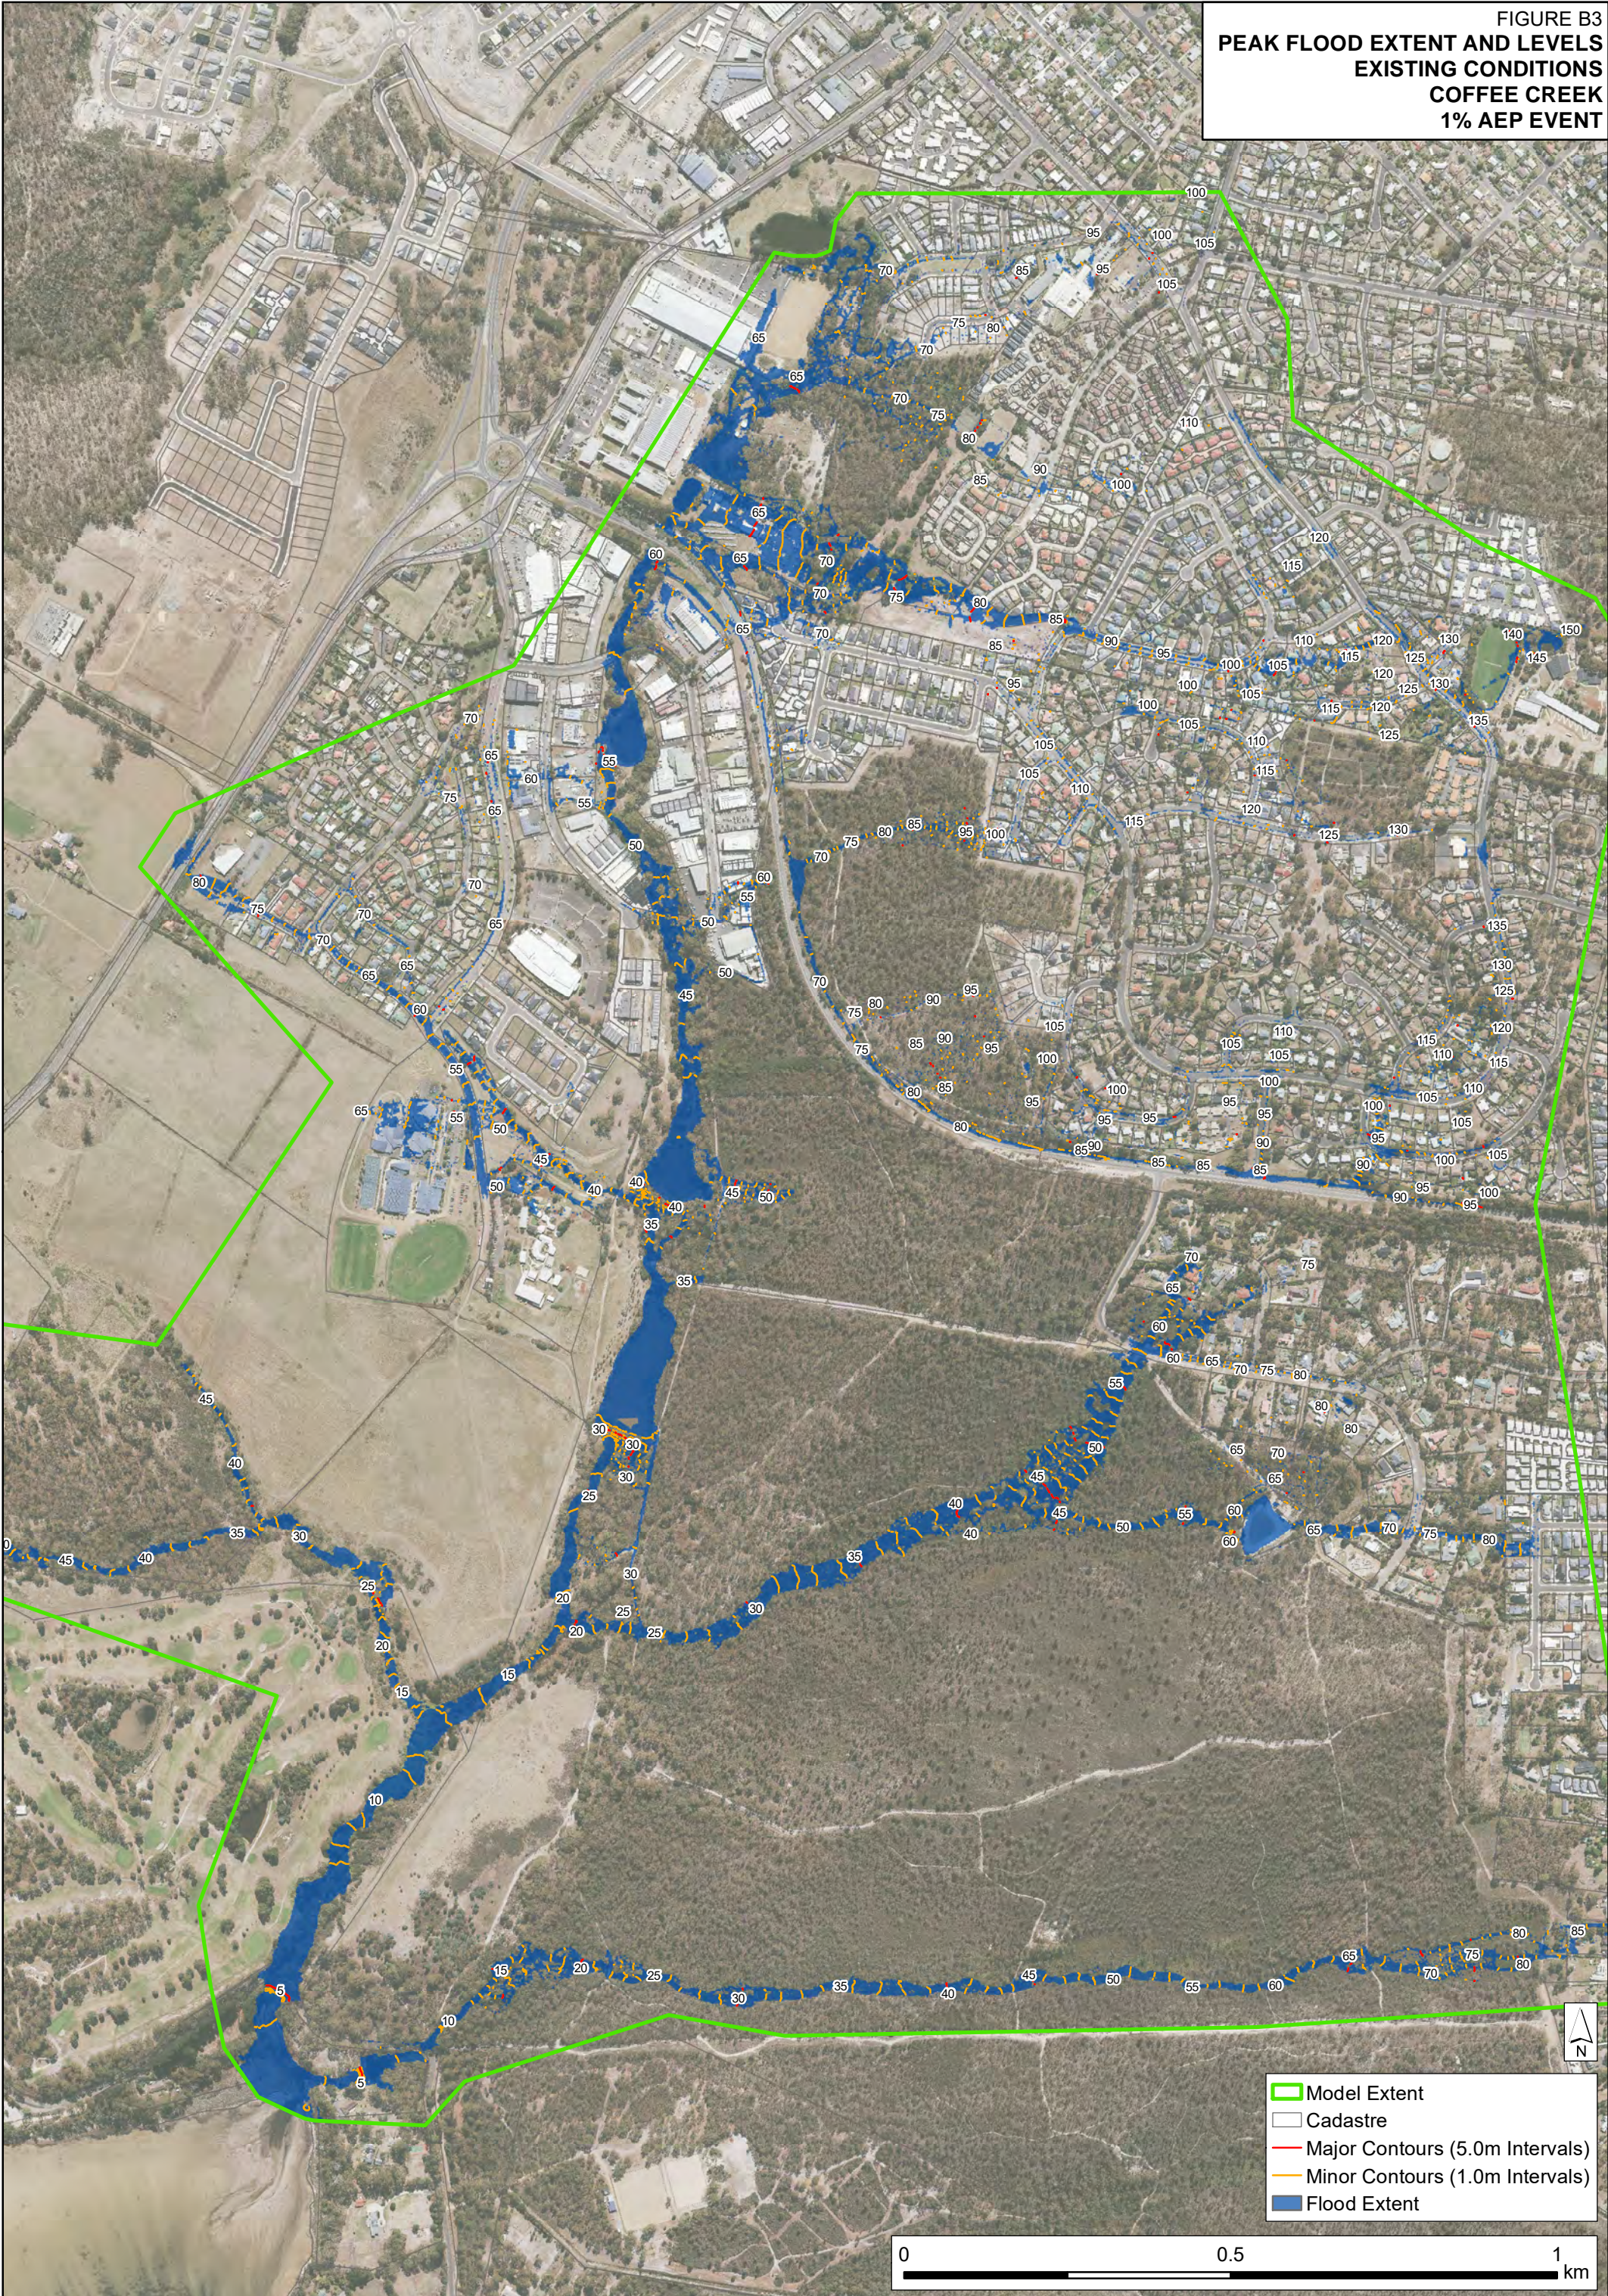
FIGURE B3
PEAK FLOOD EXTENT AND LEVELS
EXISTING CONDITIONS
COFFEE CREEK
1% AEP EVENT

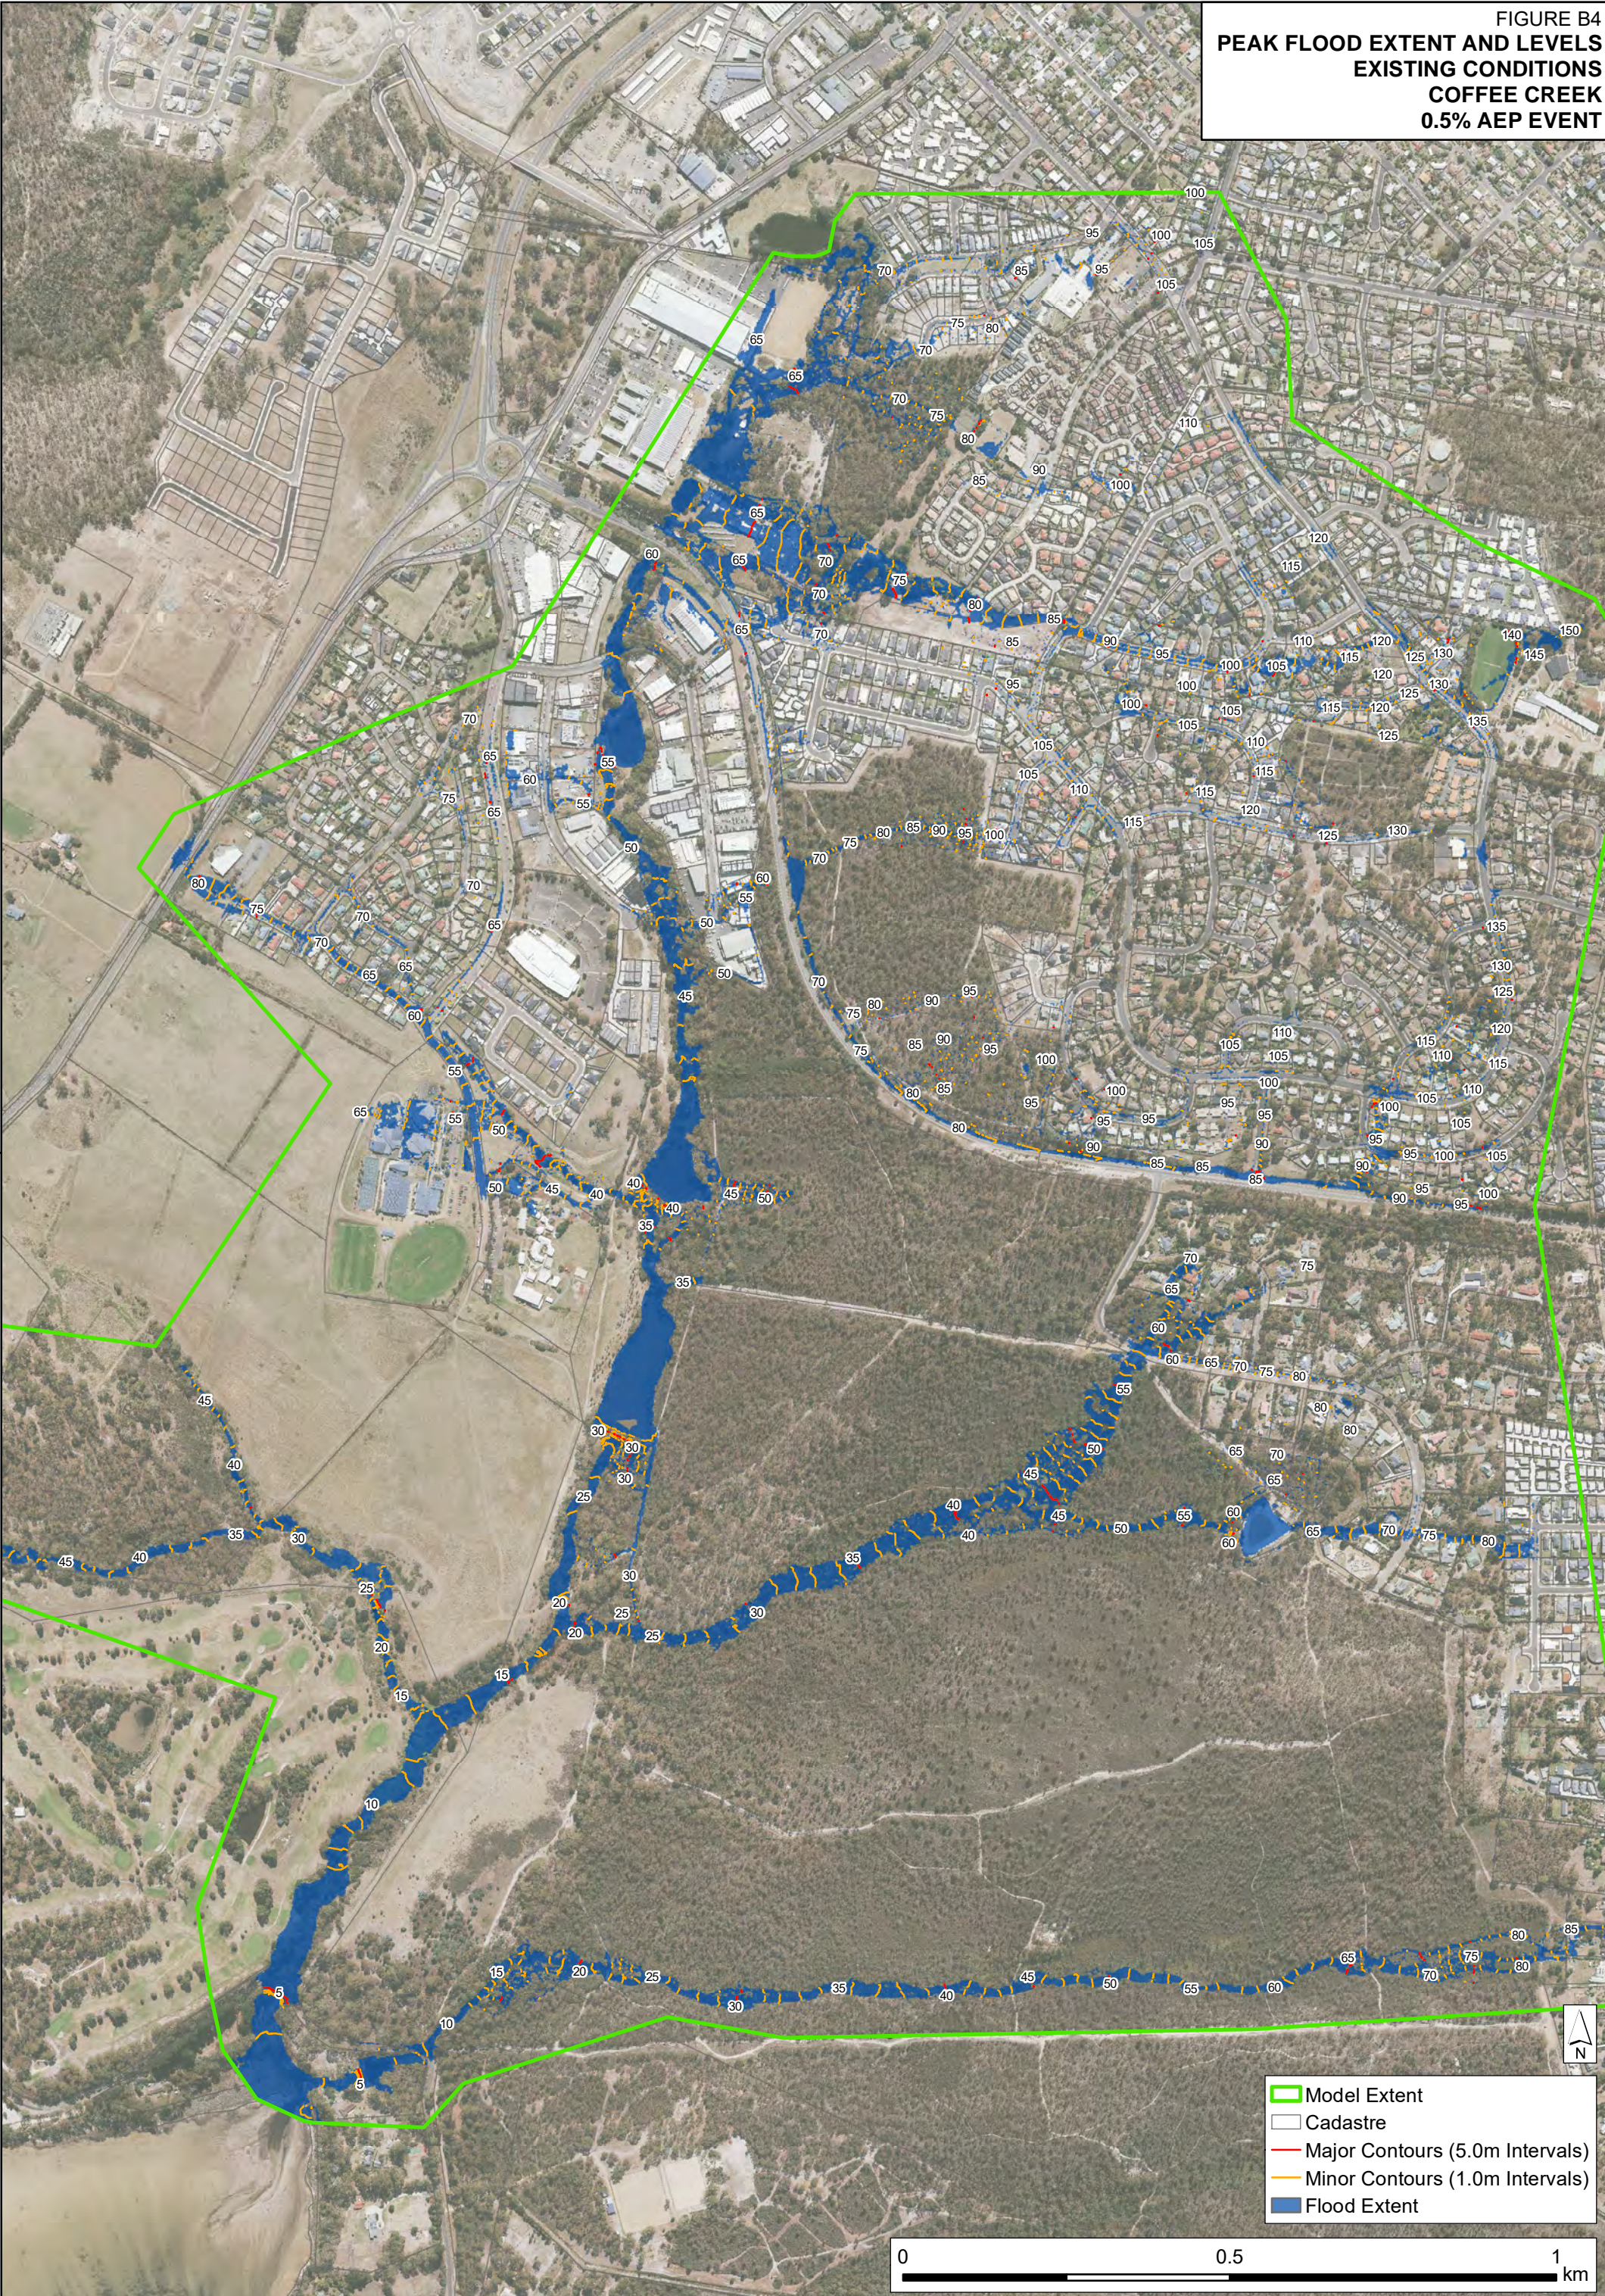
FIGURE B4
PEAK FLOOD EXTENT AND LEVELS
EXISTING CONDITIONS
COFFEE CREEK
0.5% AEP EVENT

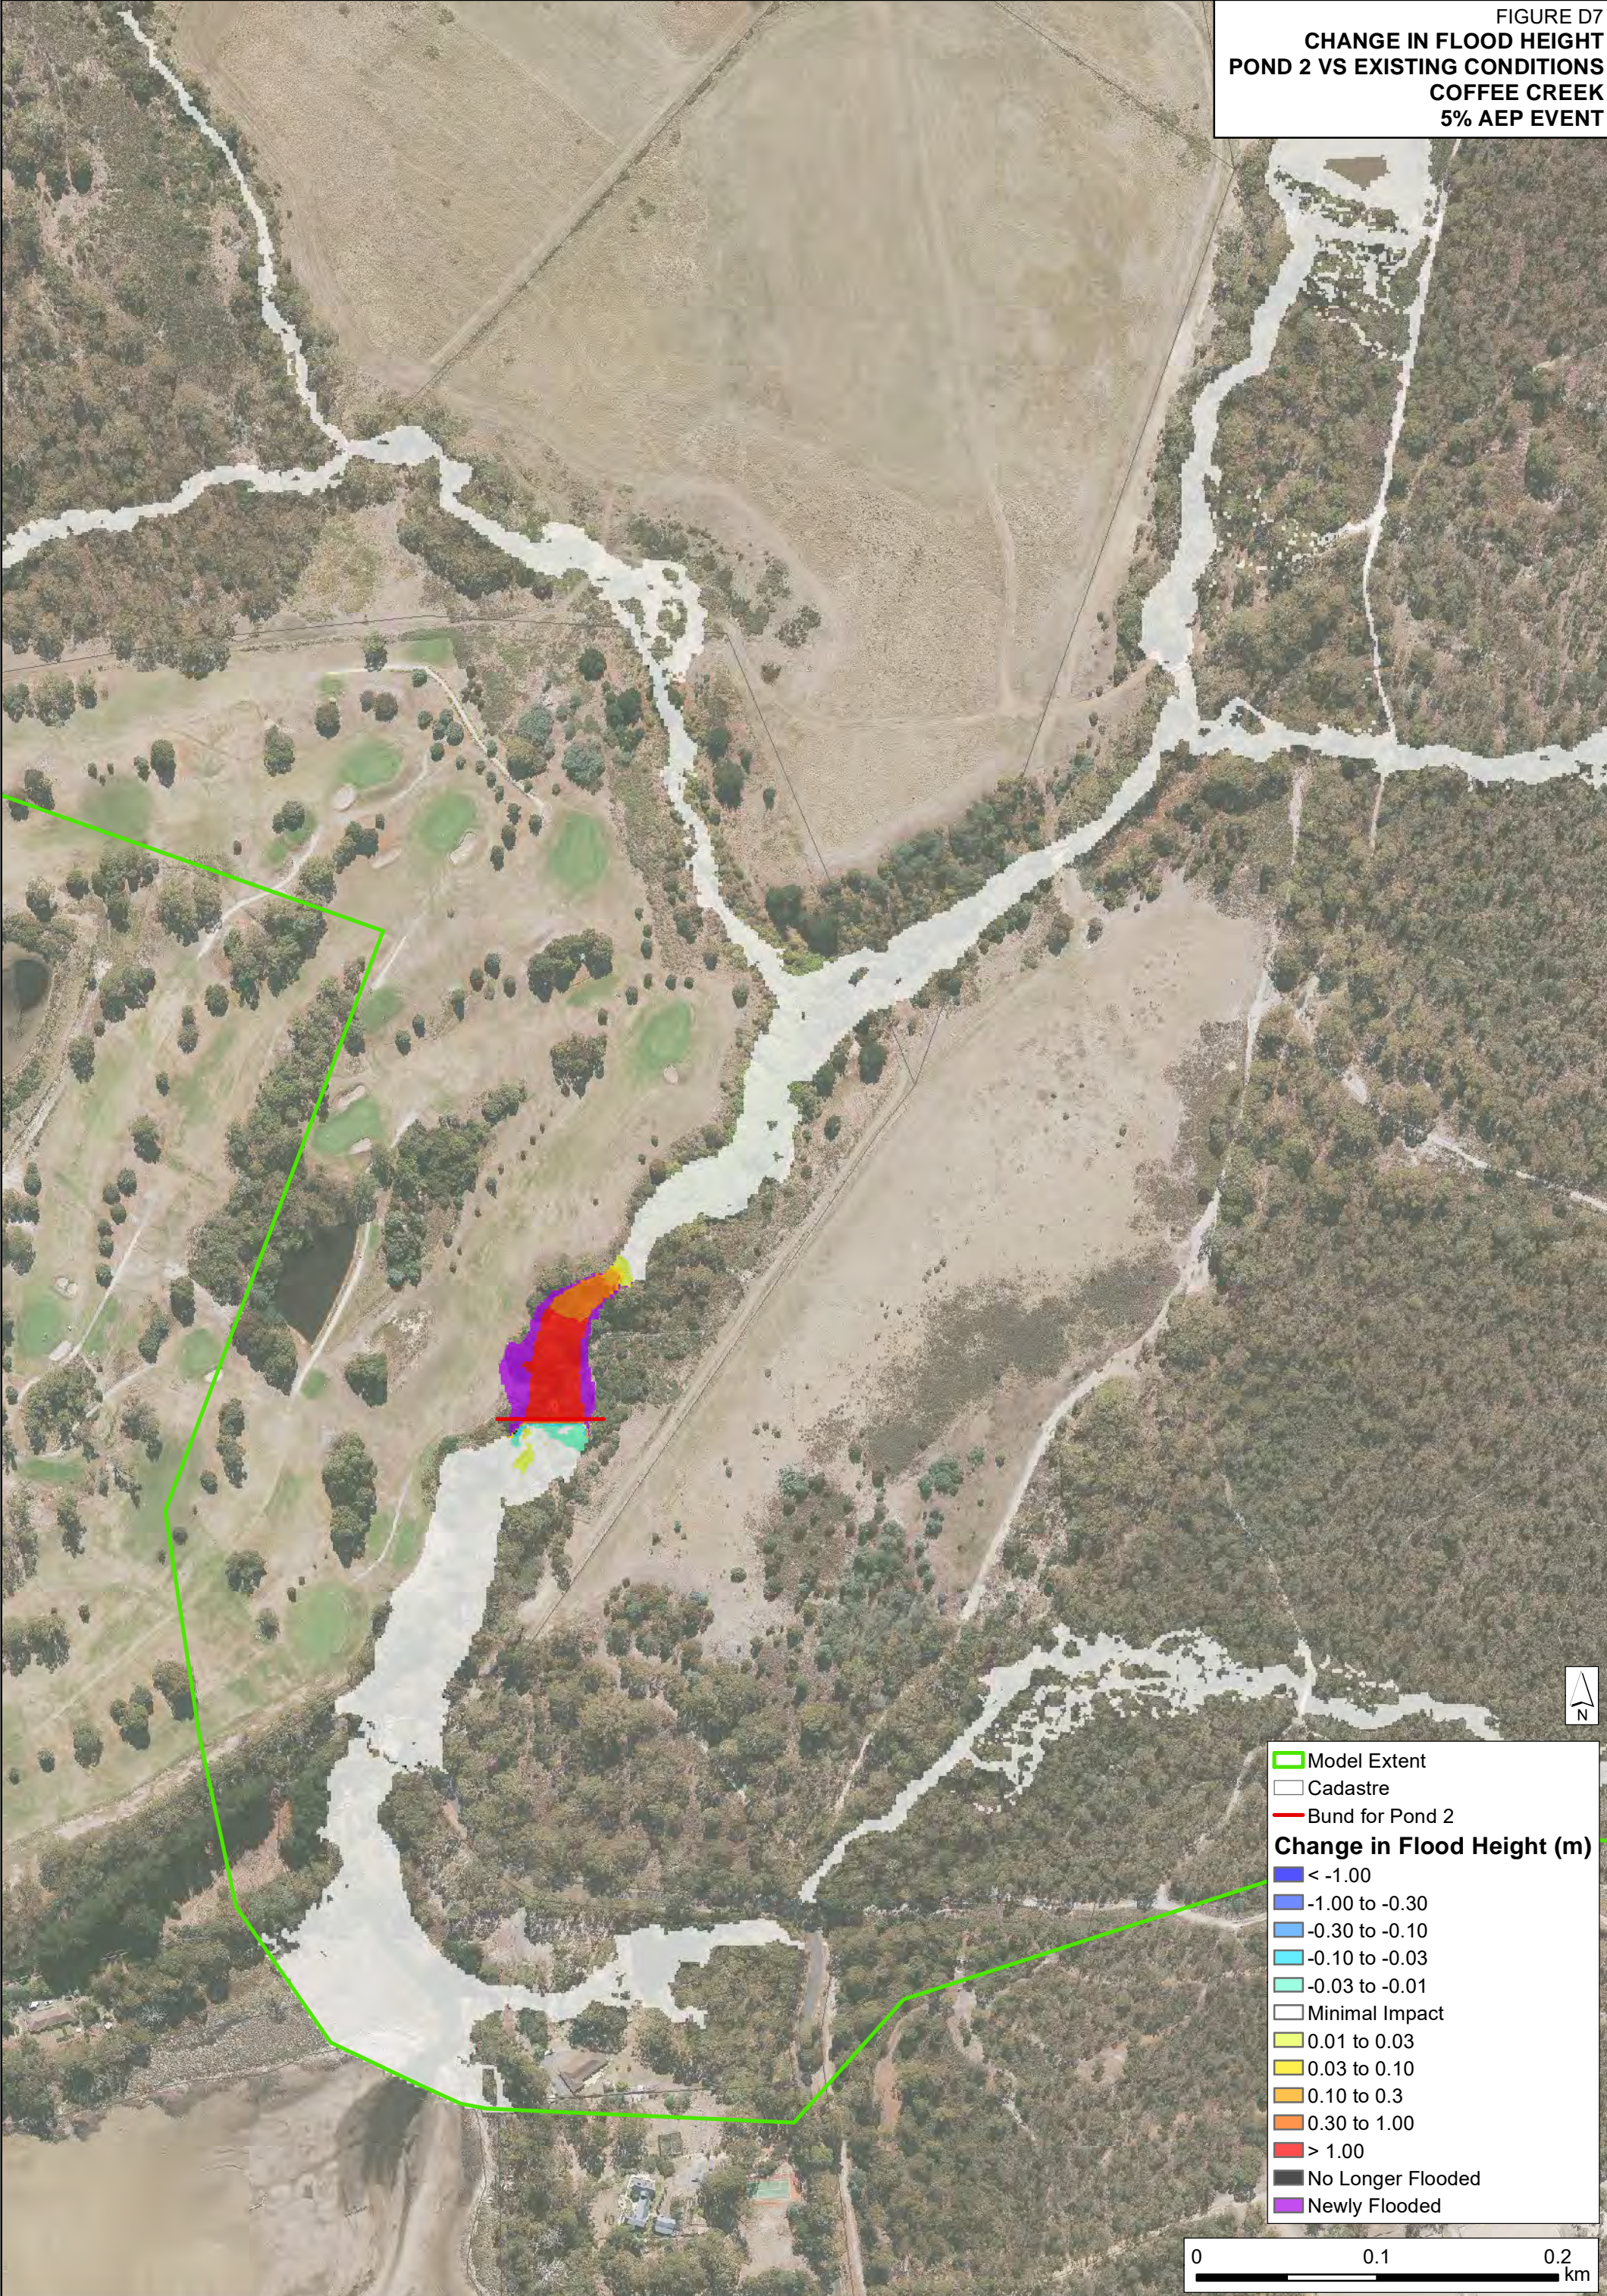
FIGURE D7
CHANGE IN FLOOD HEIGHT
POND 2 VS EXISTING CONDITIONS
COFFEE CREEK
5% AEP EVENT

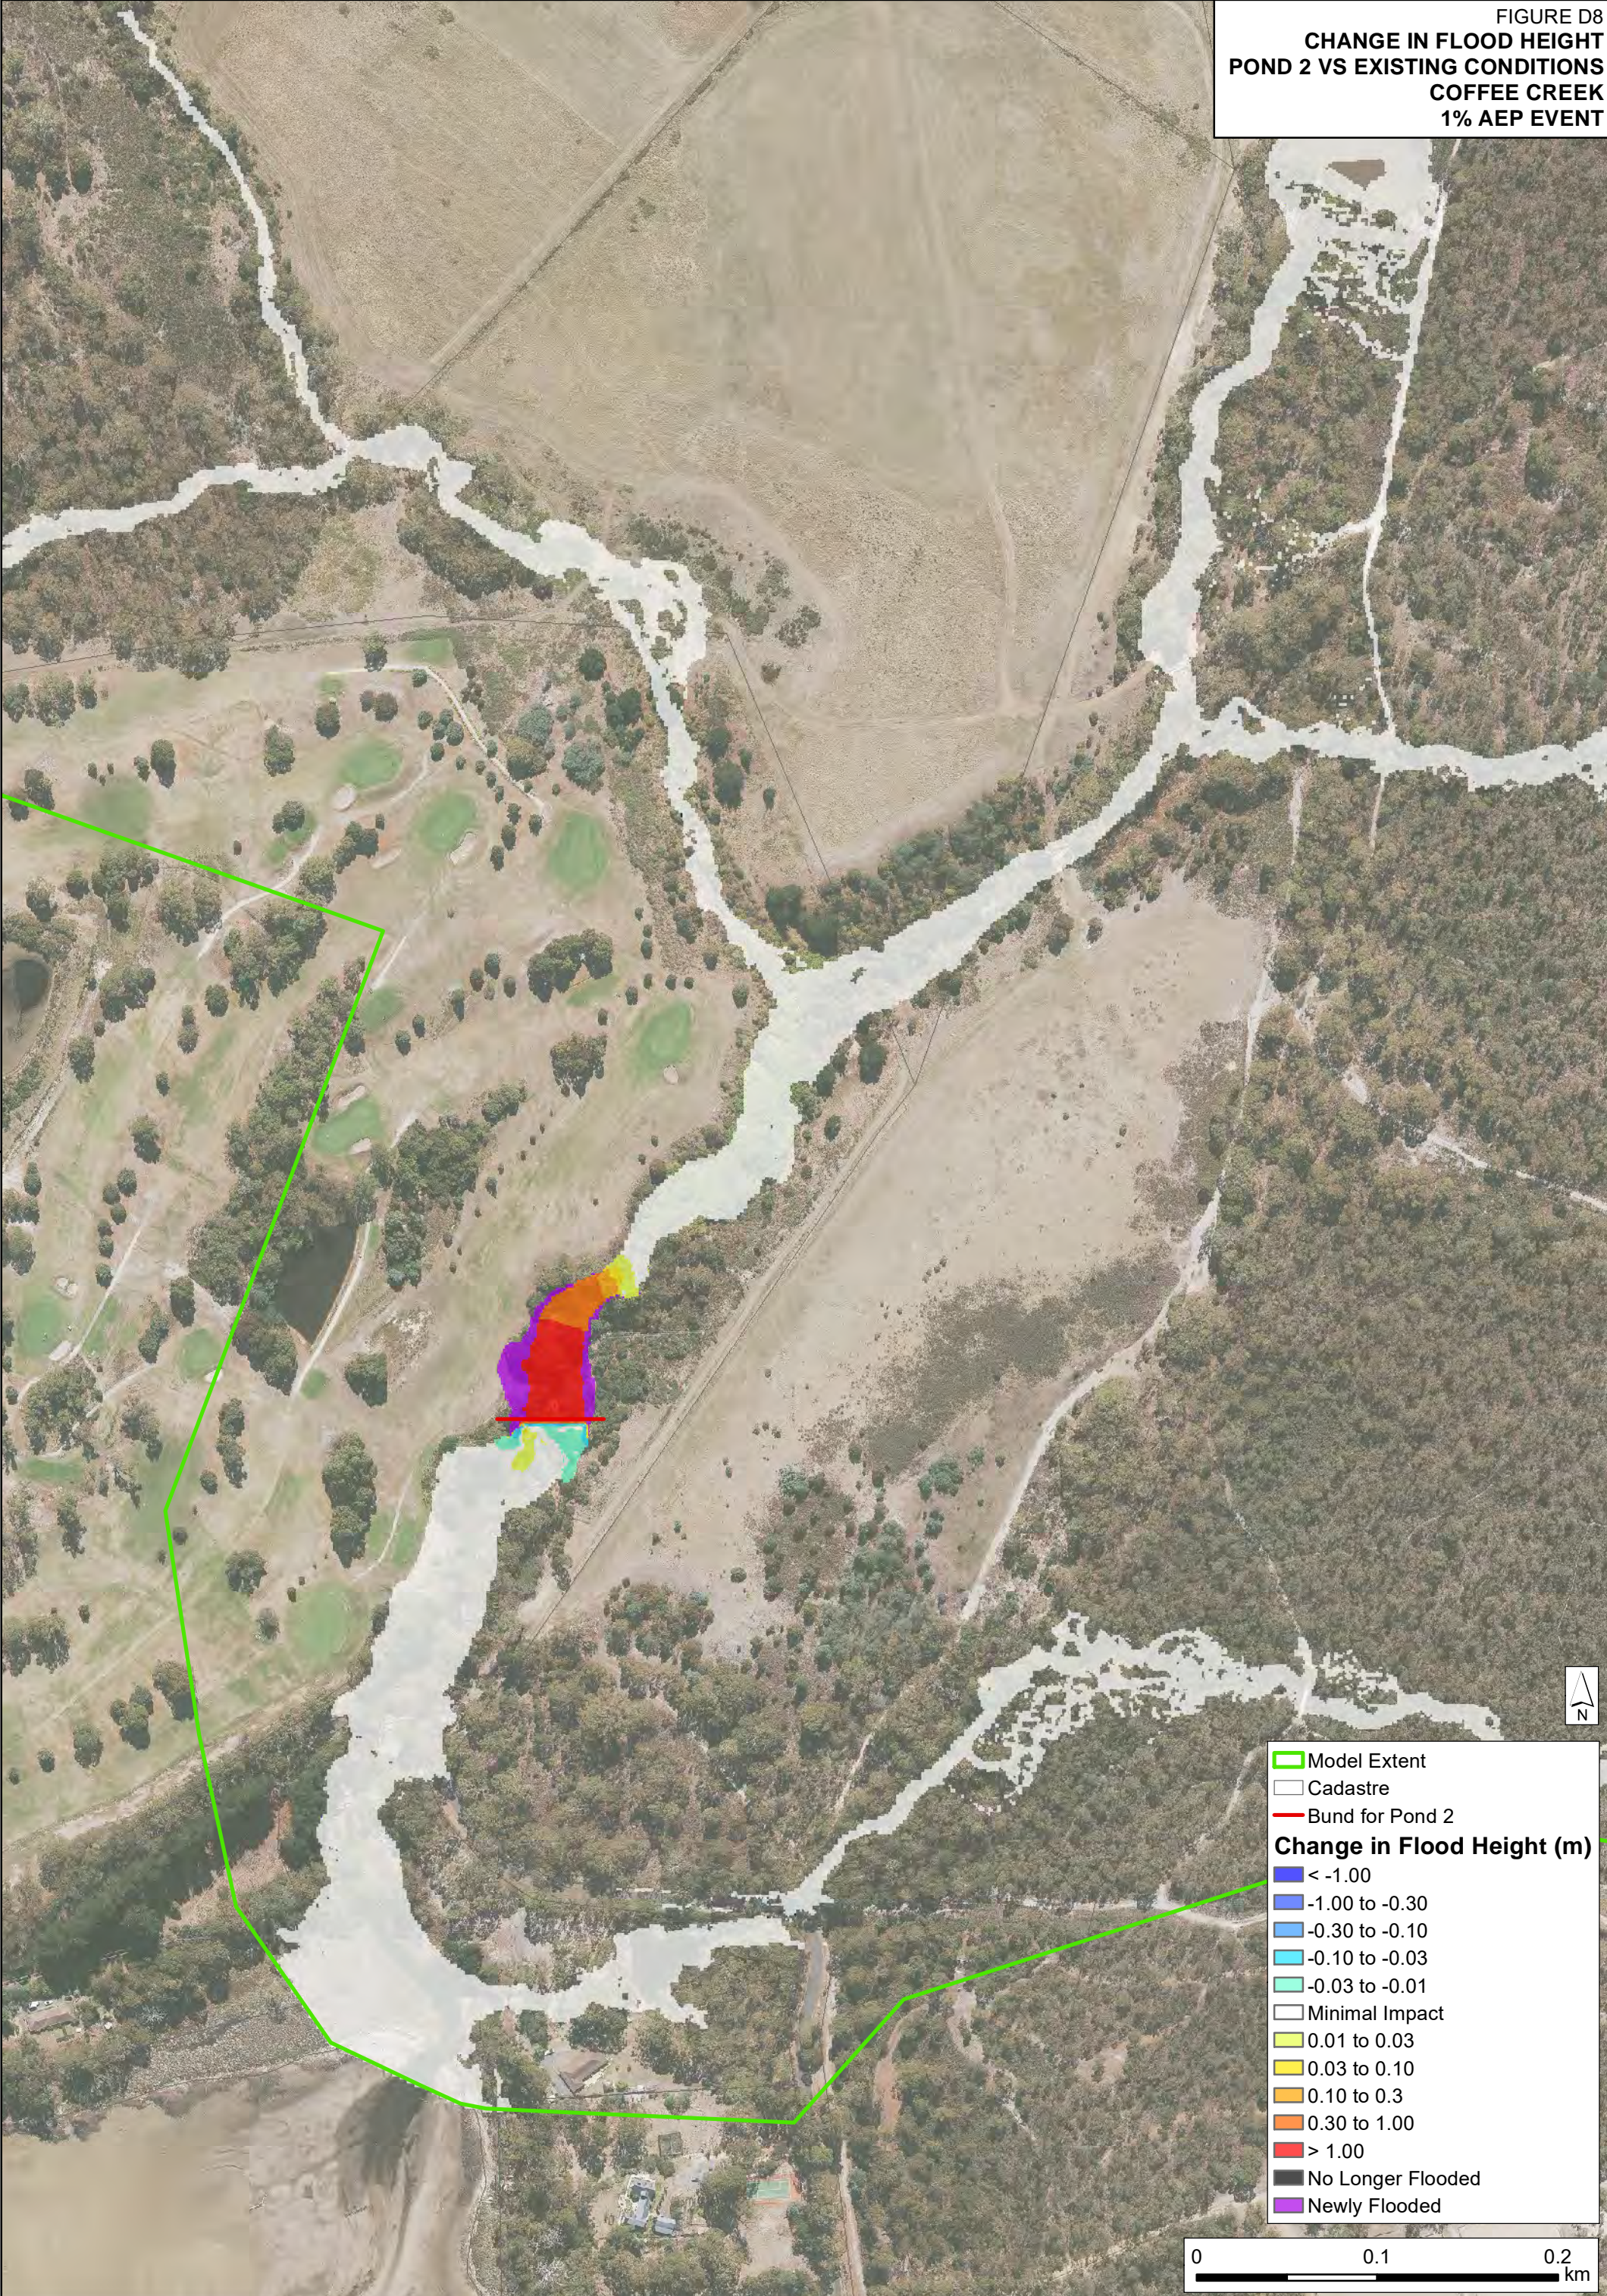
FIGURE D8
CHANGE IN FLOOD HEIGHT
POND 2 VS EXISTING CONDITIONS
COFFEE CREEK
1% AEP EVENT
