APPENDIX A. GLOSSARY

Appendix B

APPENDIX C. SENSITIVITY FLOOD MAPPING

APPENDIX D. FLOOD IMPACT MAPPING

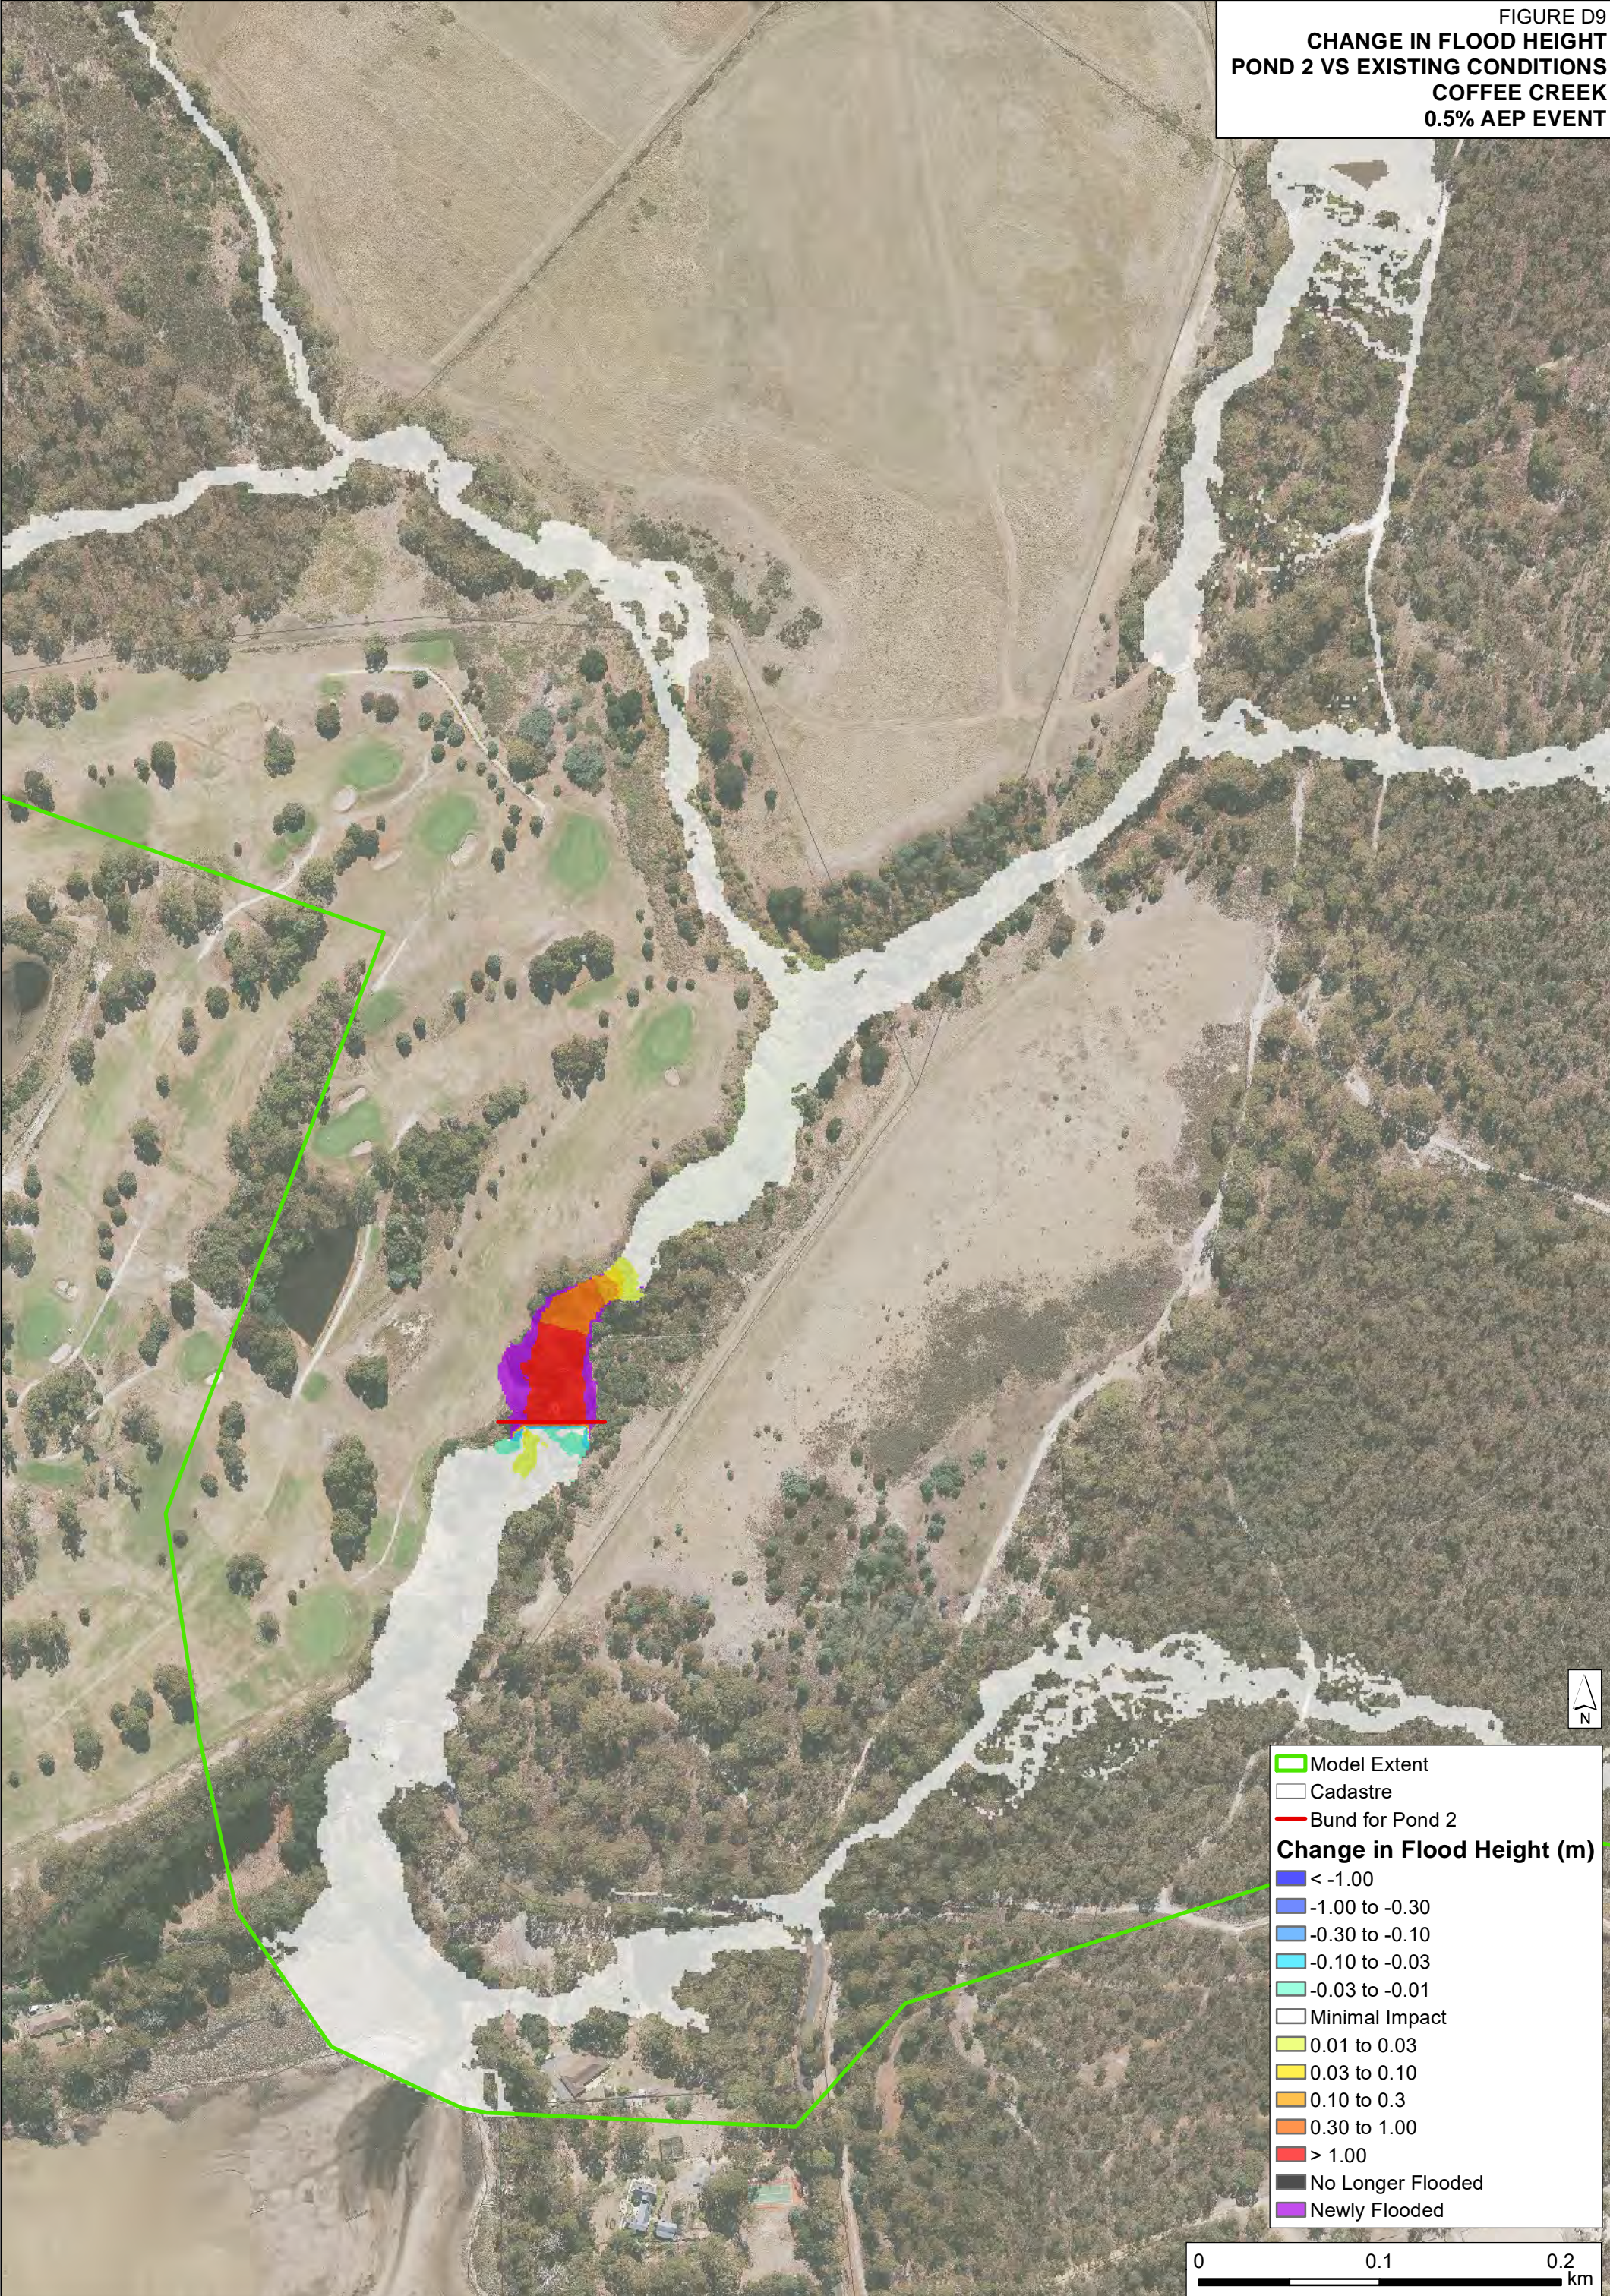
FIGURE D9
CHANGE IN FLOOD HEIGHT
POND 2 VS EXISTING CONDITIONS
COFFEE CREEK
0.5% AEP EVENT

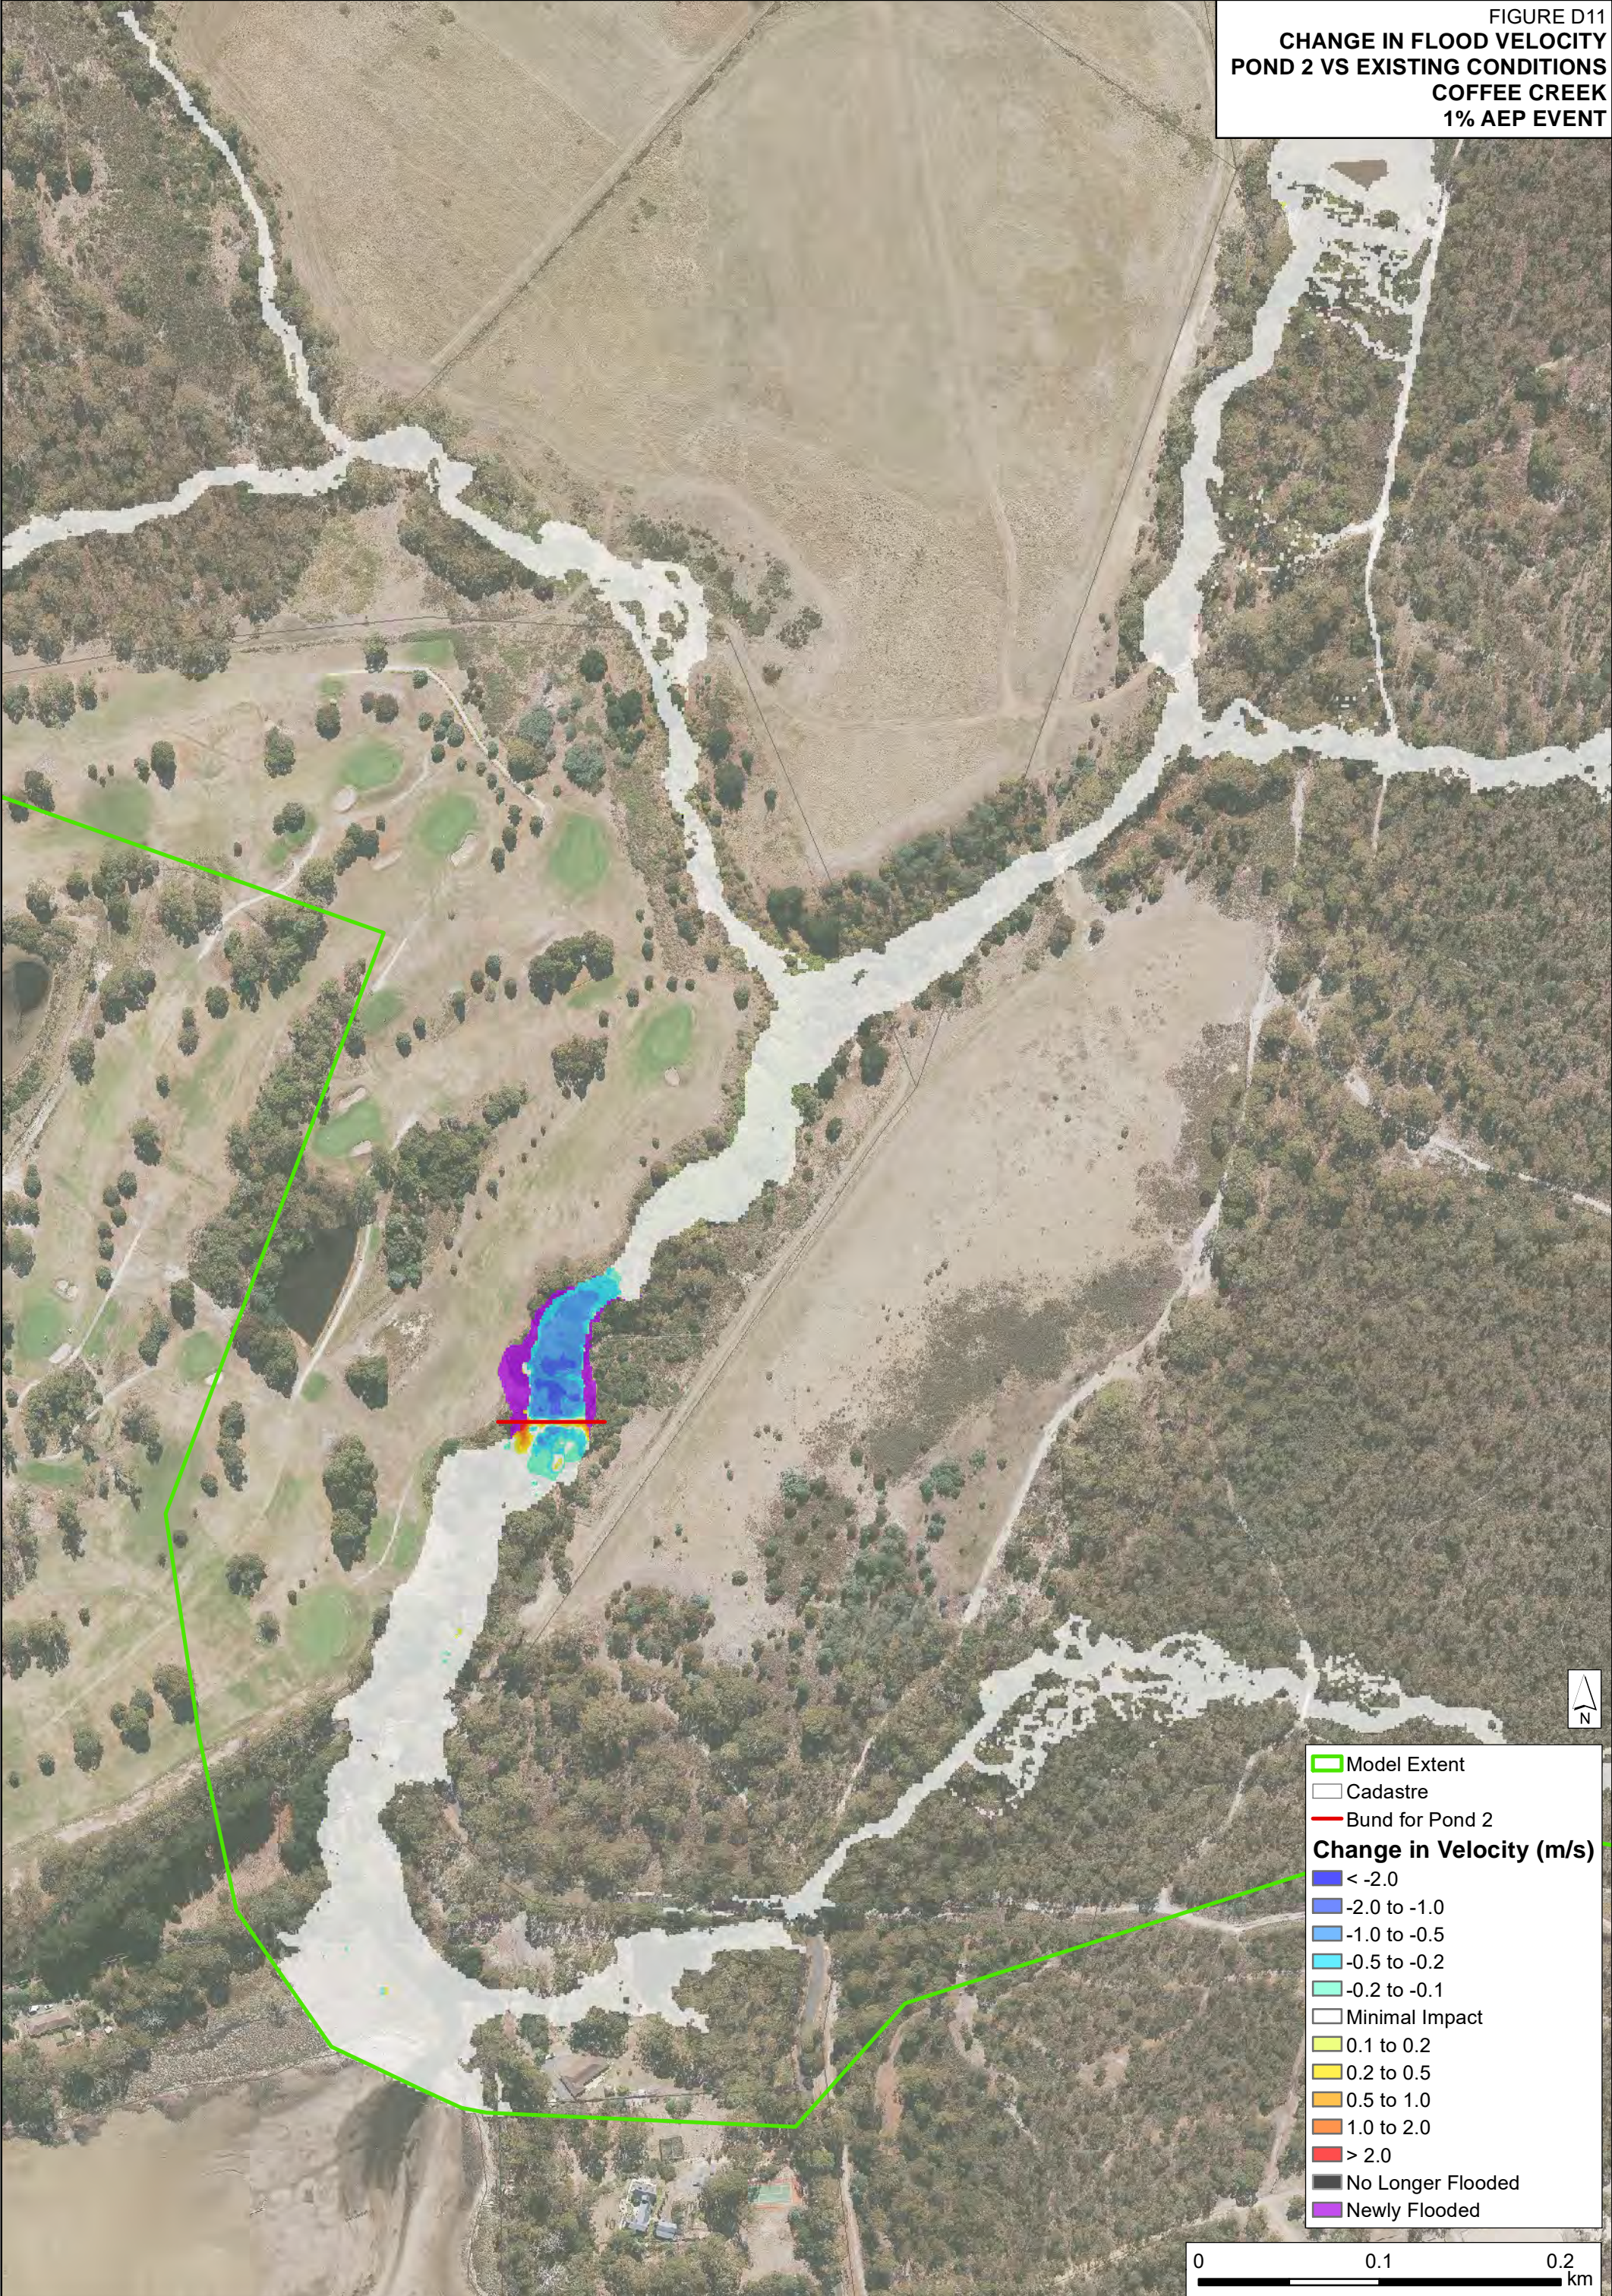
FIGURE D11
CHANGE IN FLOOD VELOCITY
POND 2 VS EXISTING CONDITIONS
COFFEE CREEK
1% AEP EVENT

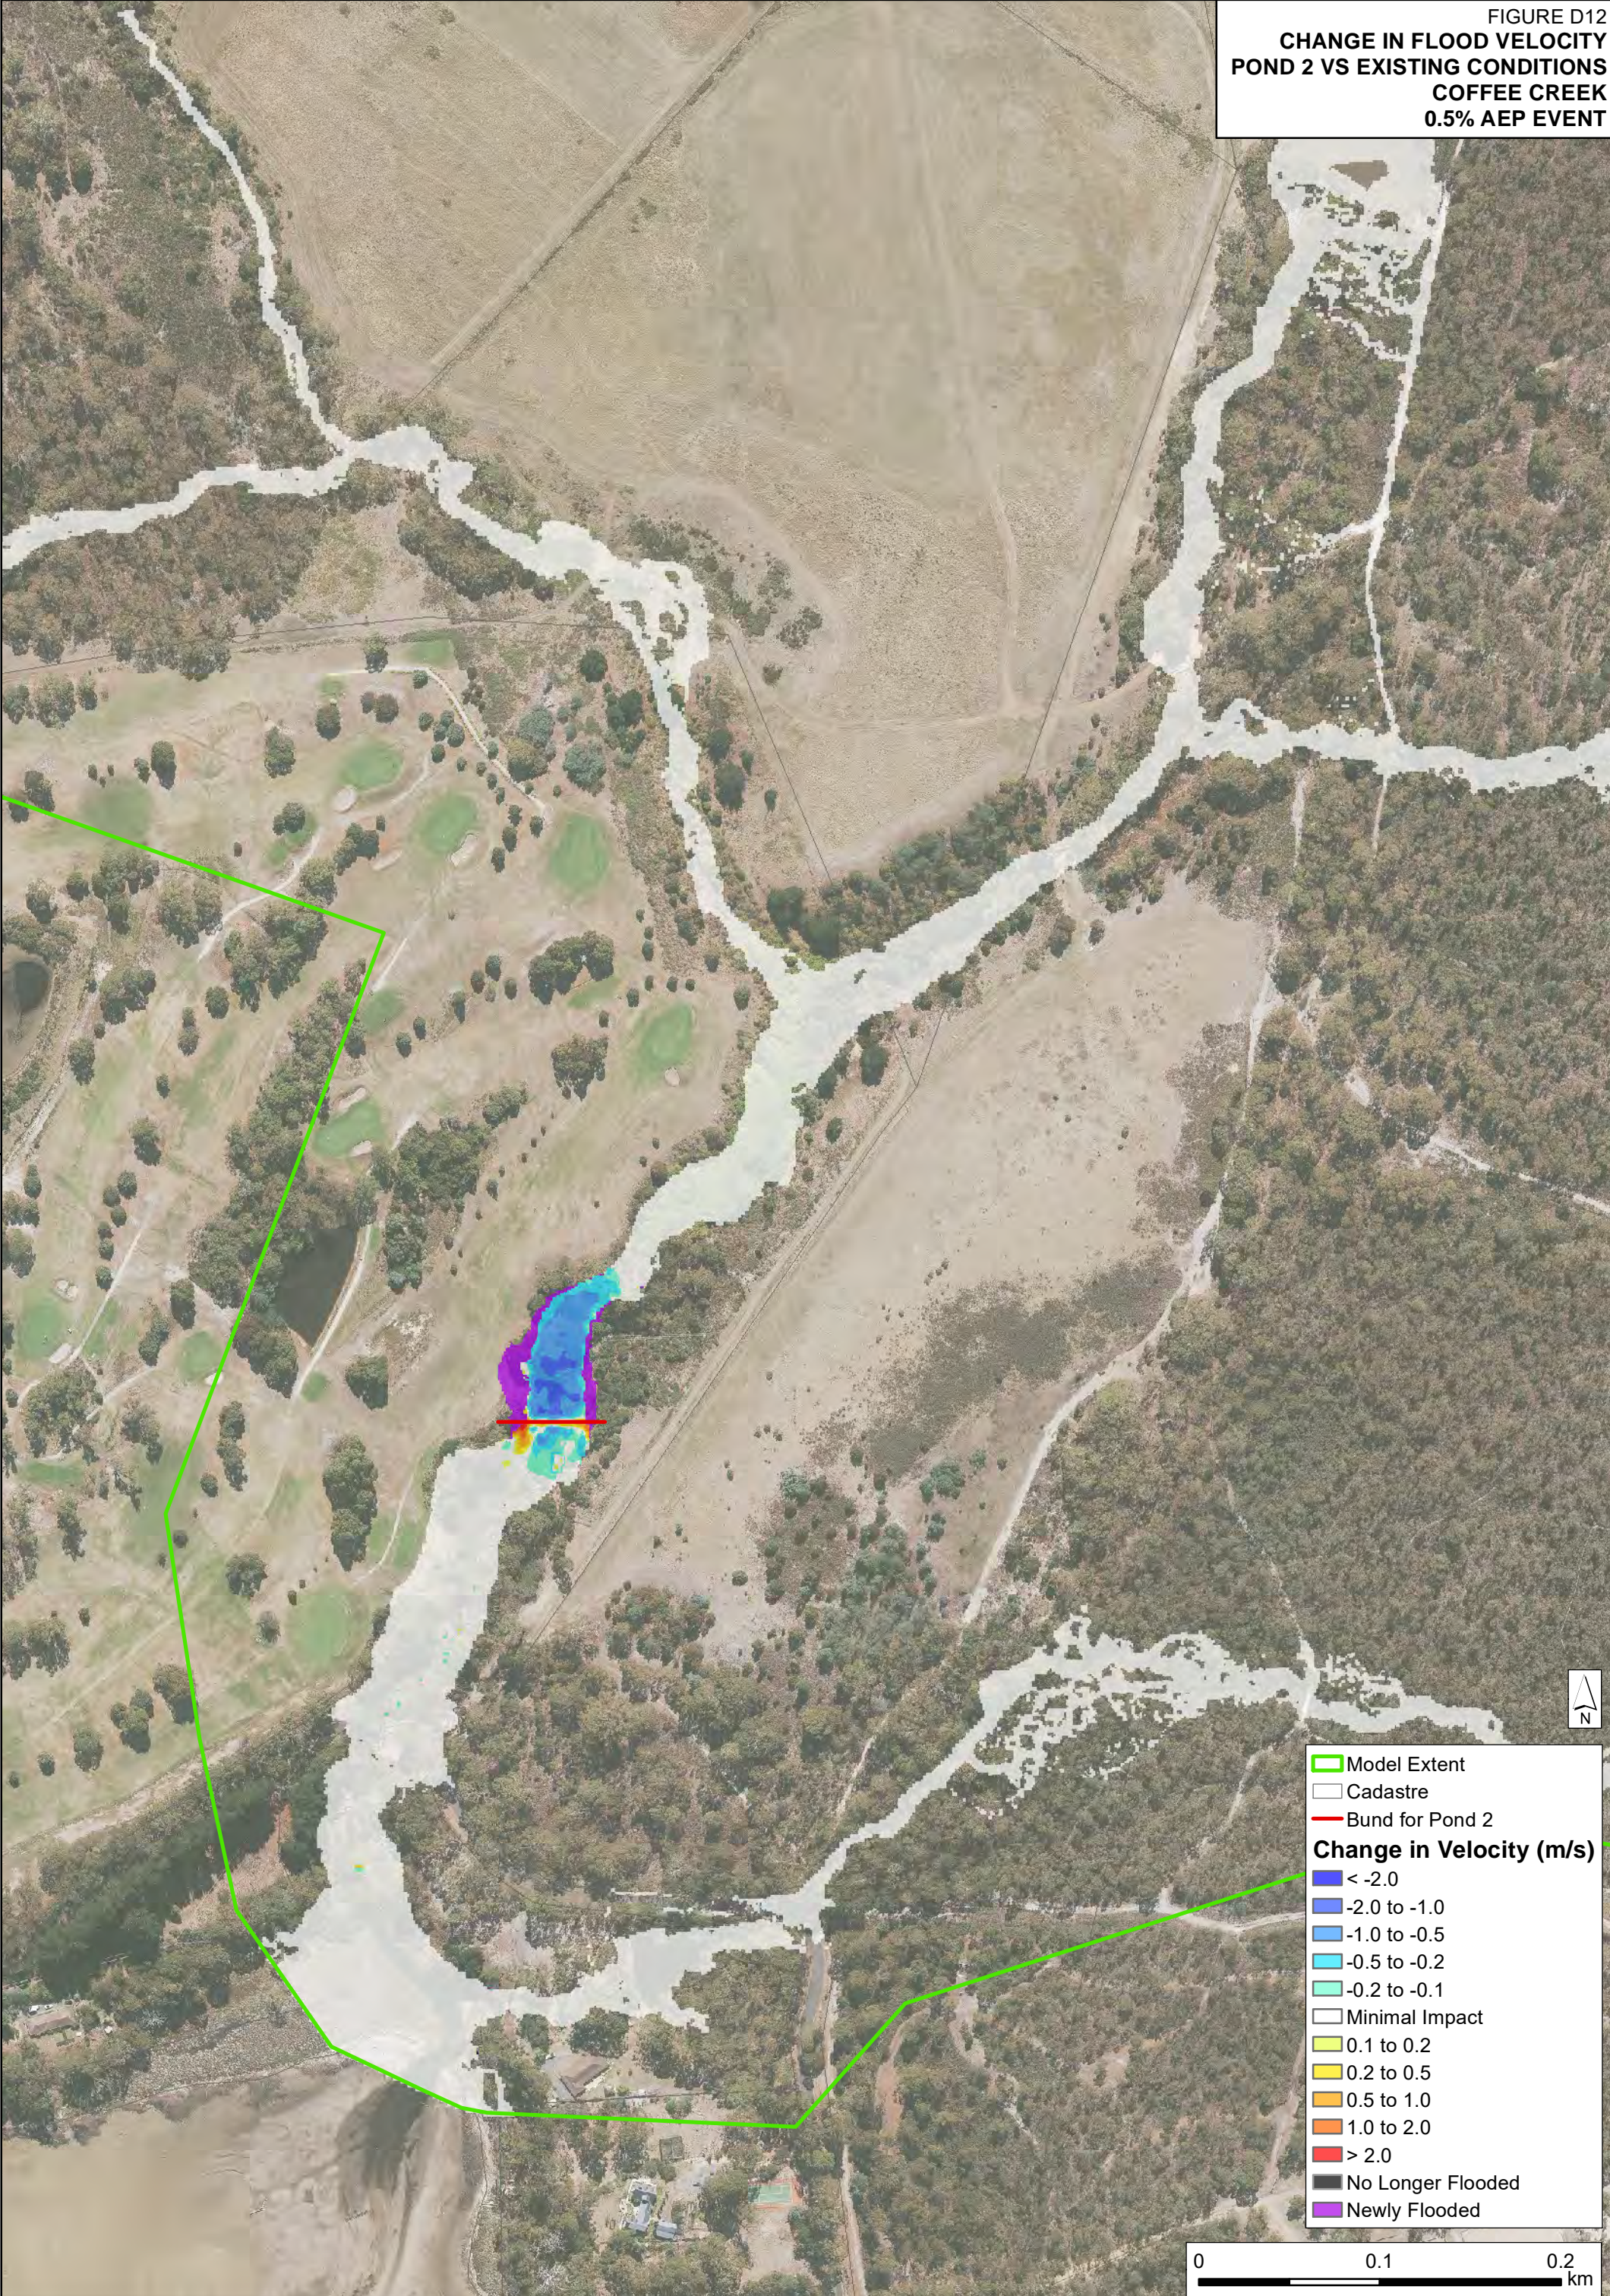
FIGURE D12
CHANGE IN FLOOD VELOCITY
POND 2 VS EXISTING CONDITIONS
COFFEE CREEK
0.5% AEP EVENT

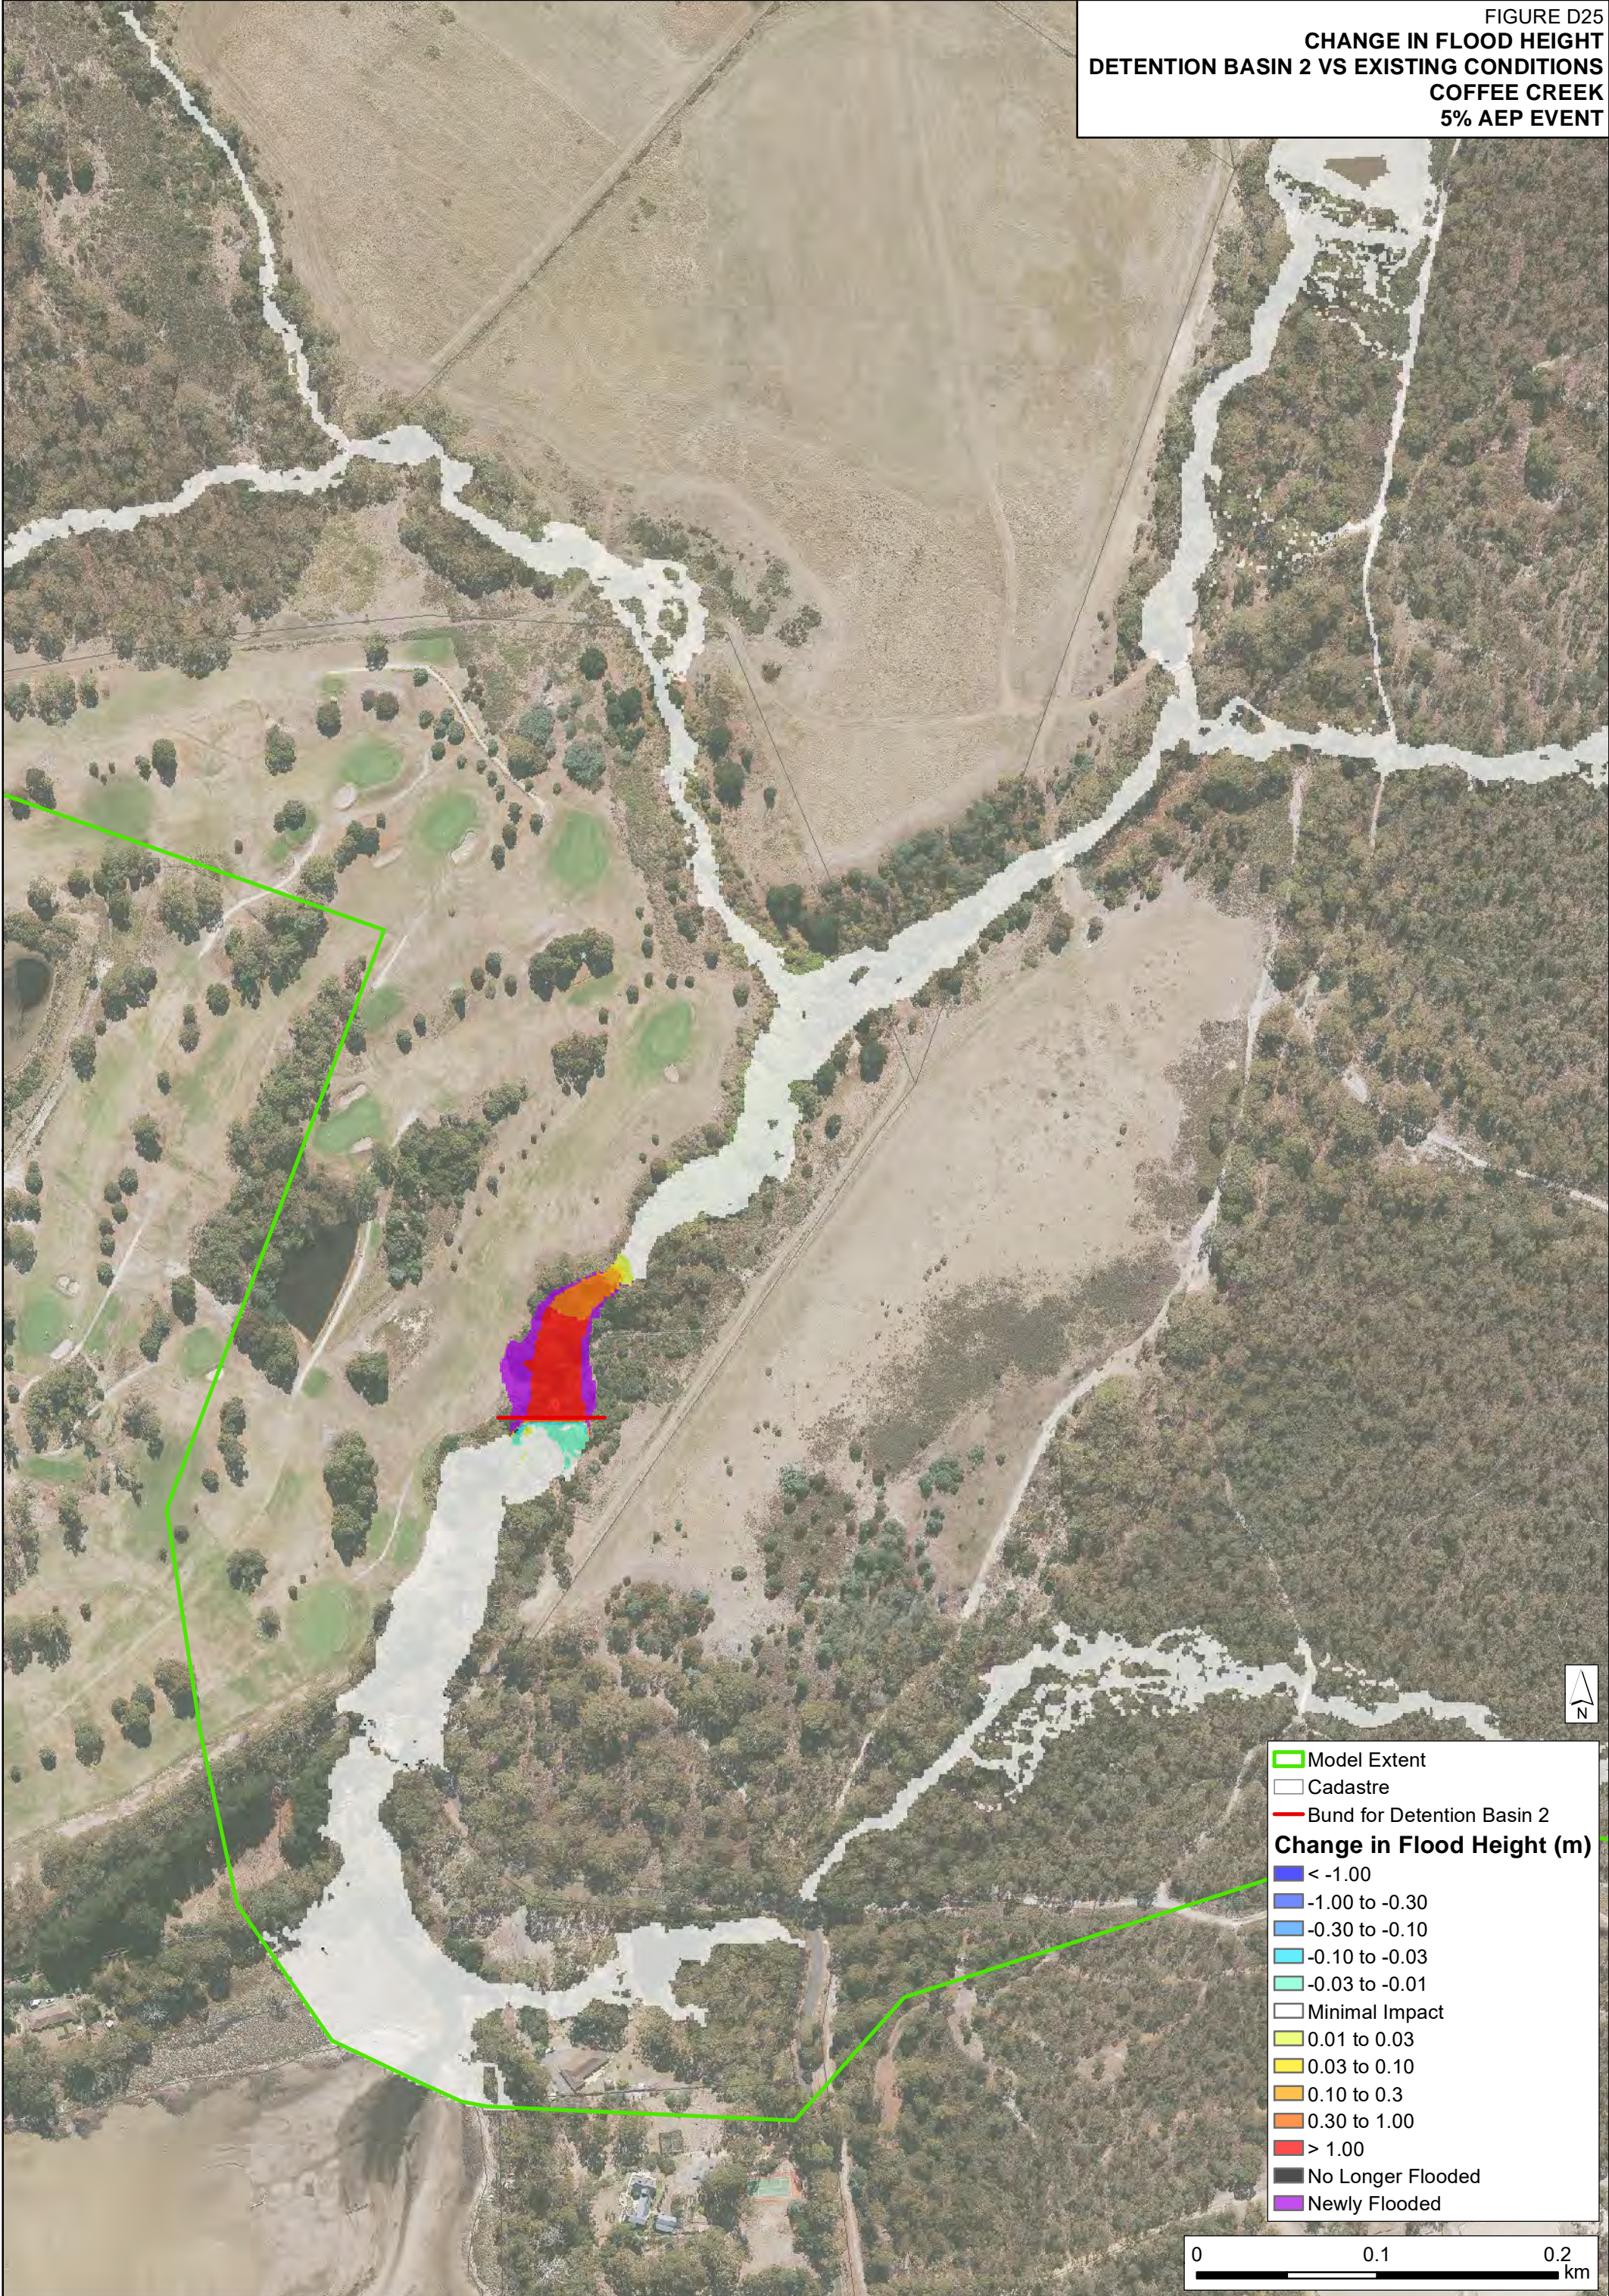
FIGURE D25
CHANGE IN FLOOD HEIGHT
DETENTION BASIN 2 VS EXISTING CONDITIONS
COFFEE CREEK
5% AEP EVENT

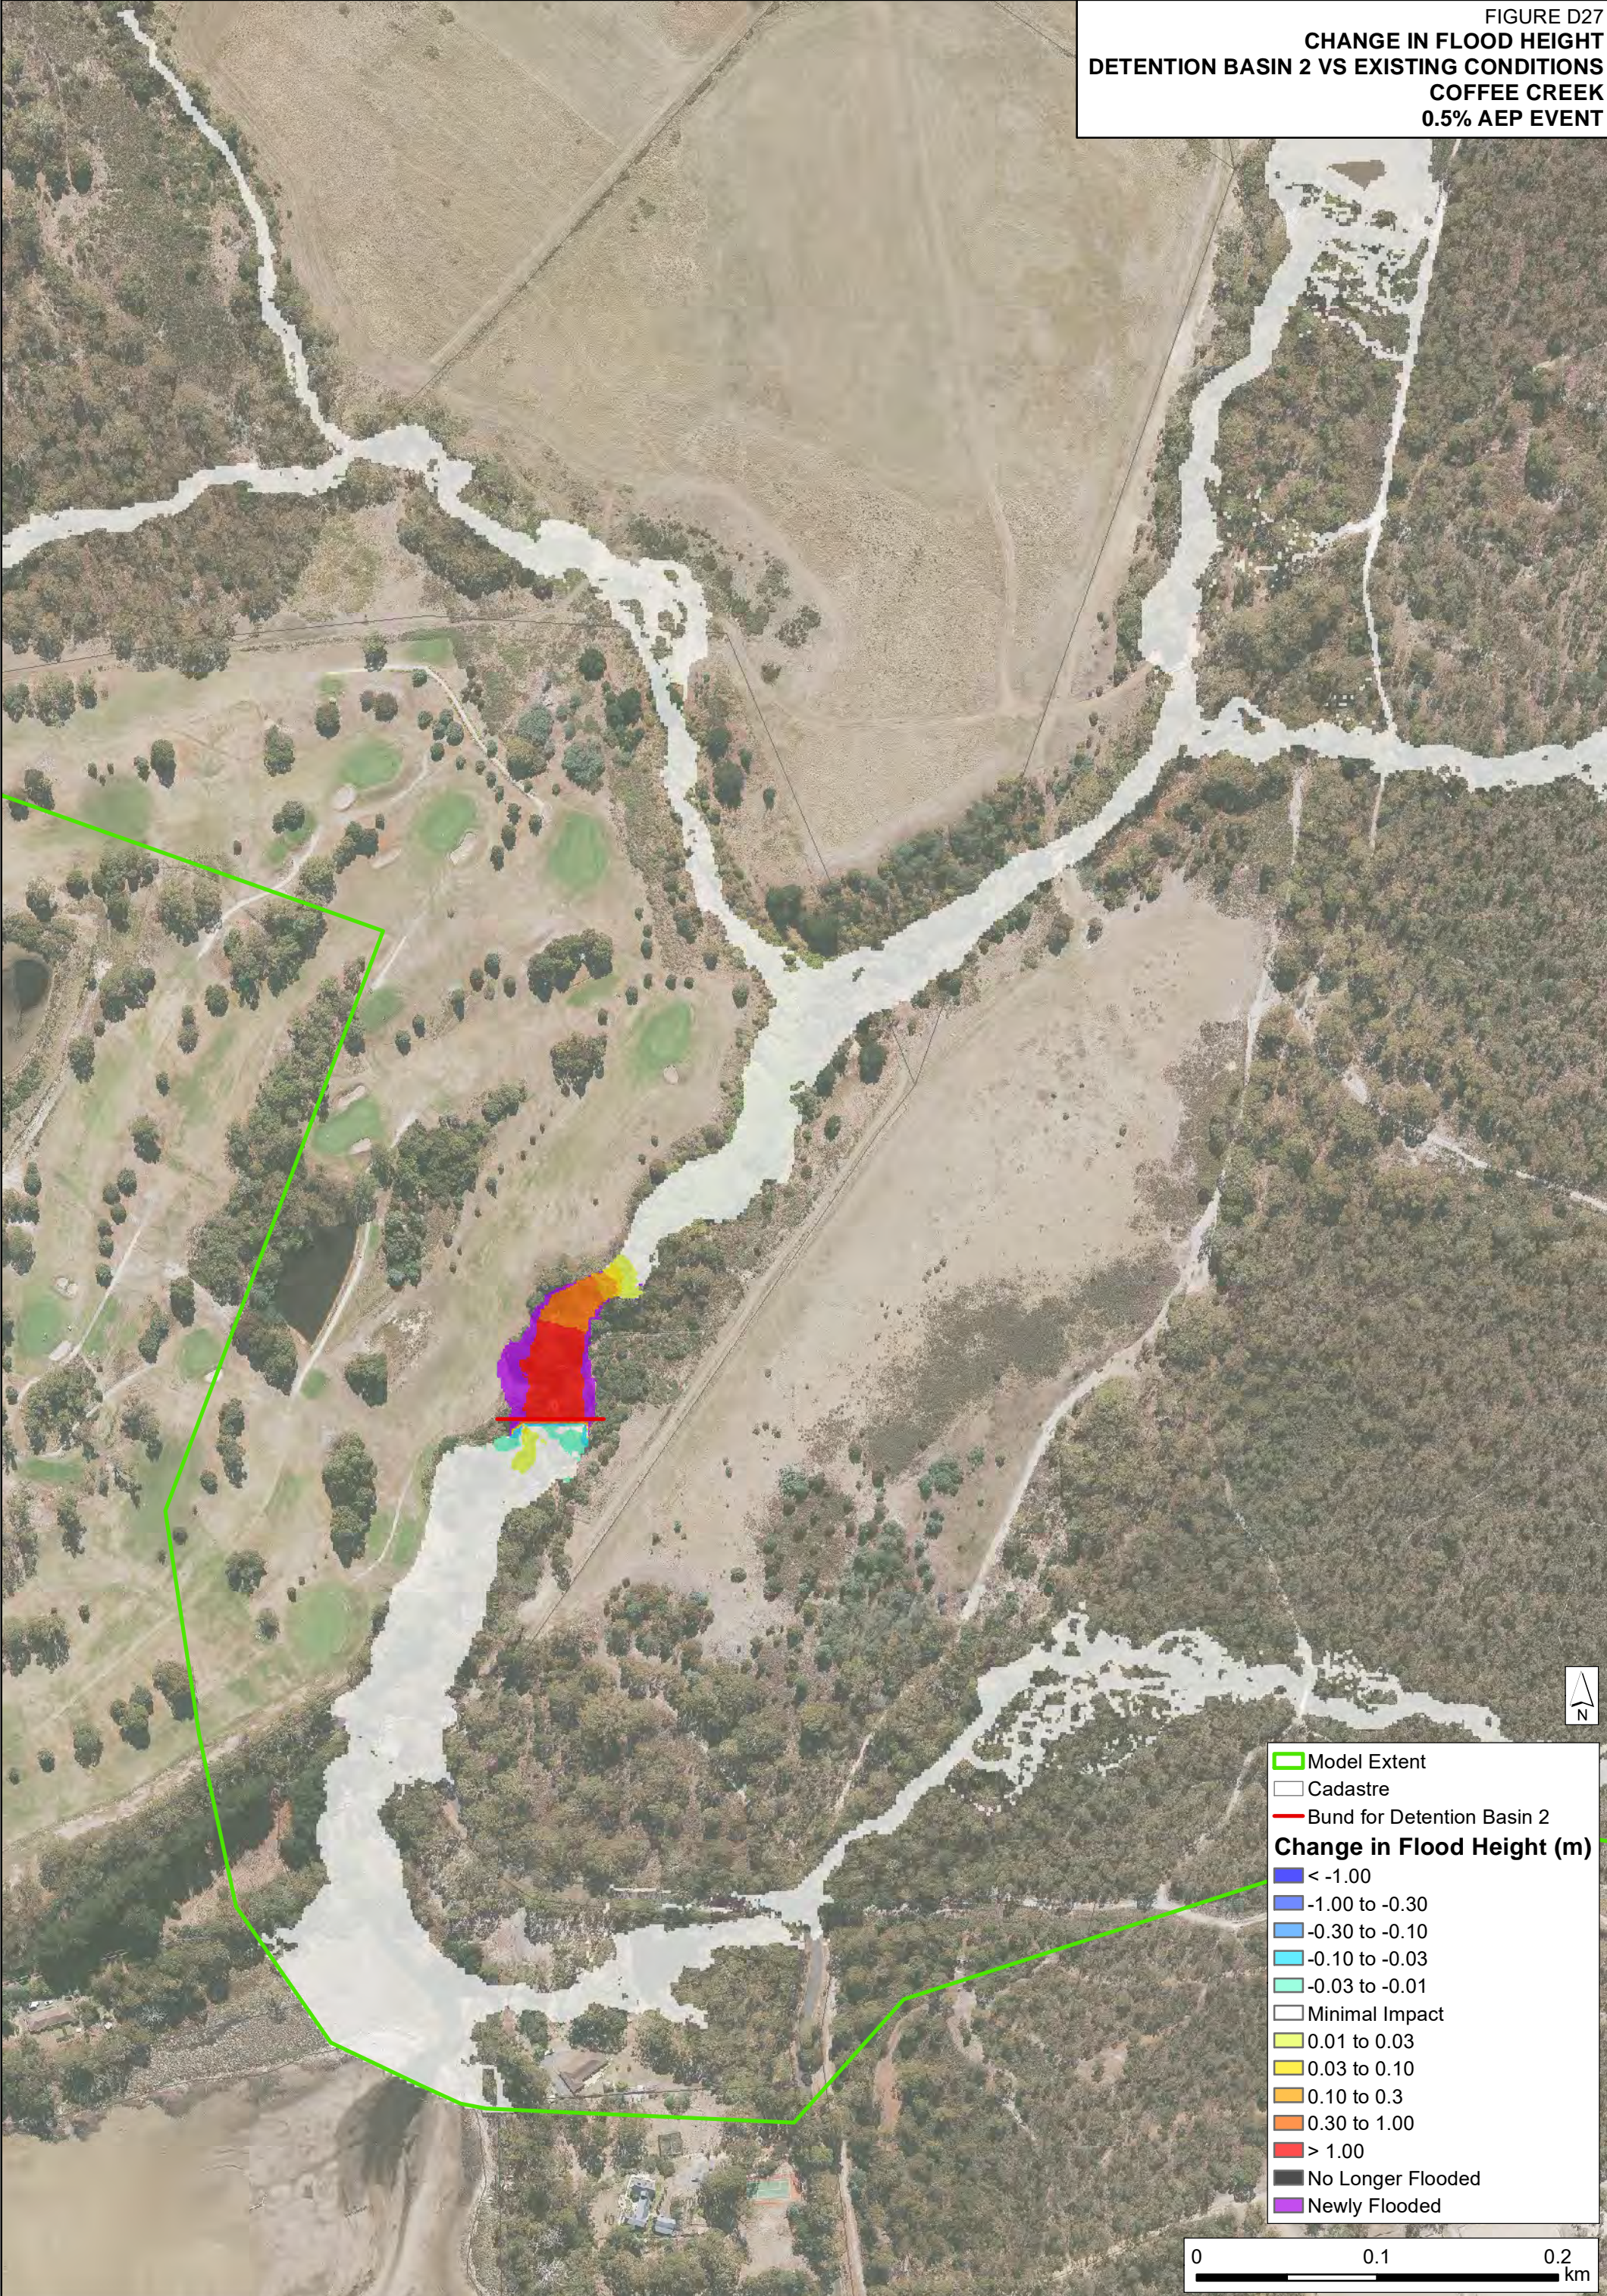
FIGURE D27
CHANGE IN FLOOD HEIGHT
DETENTION BASIN 2 VS EXISTING CONDITIONS
COFFEE CREEK
0.5% AEP EVENT

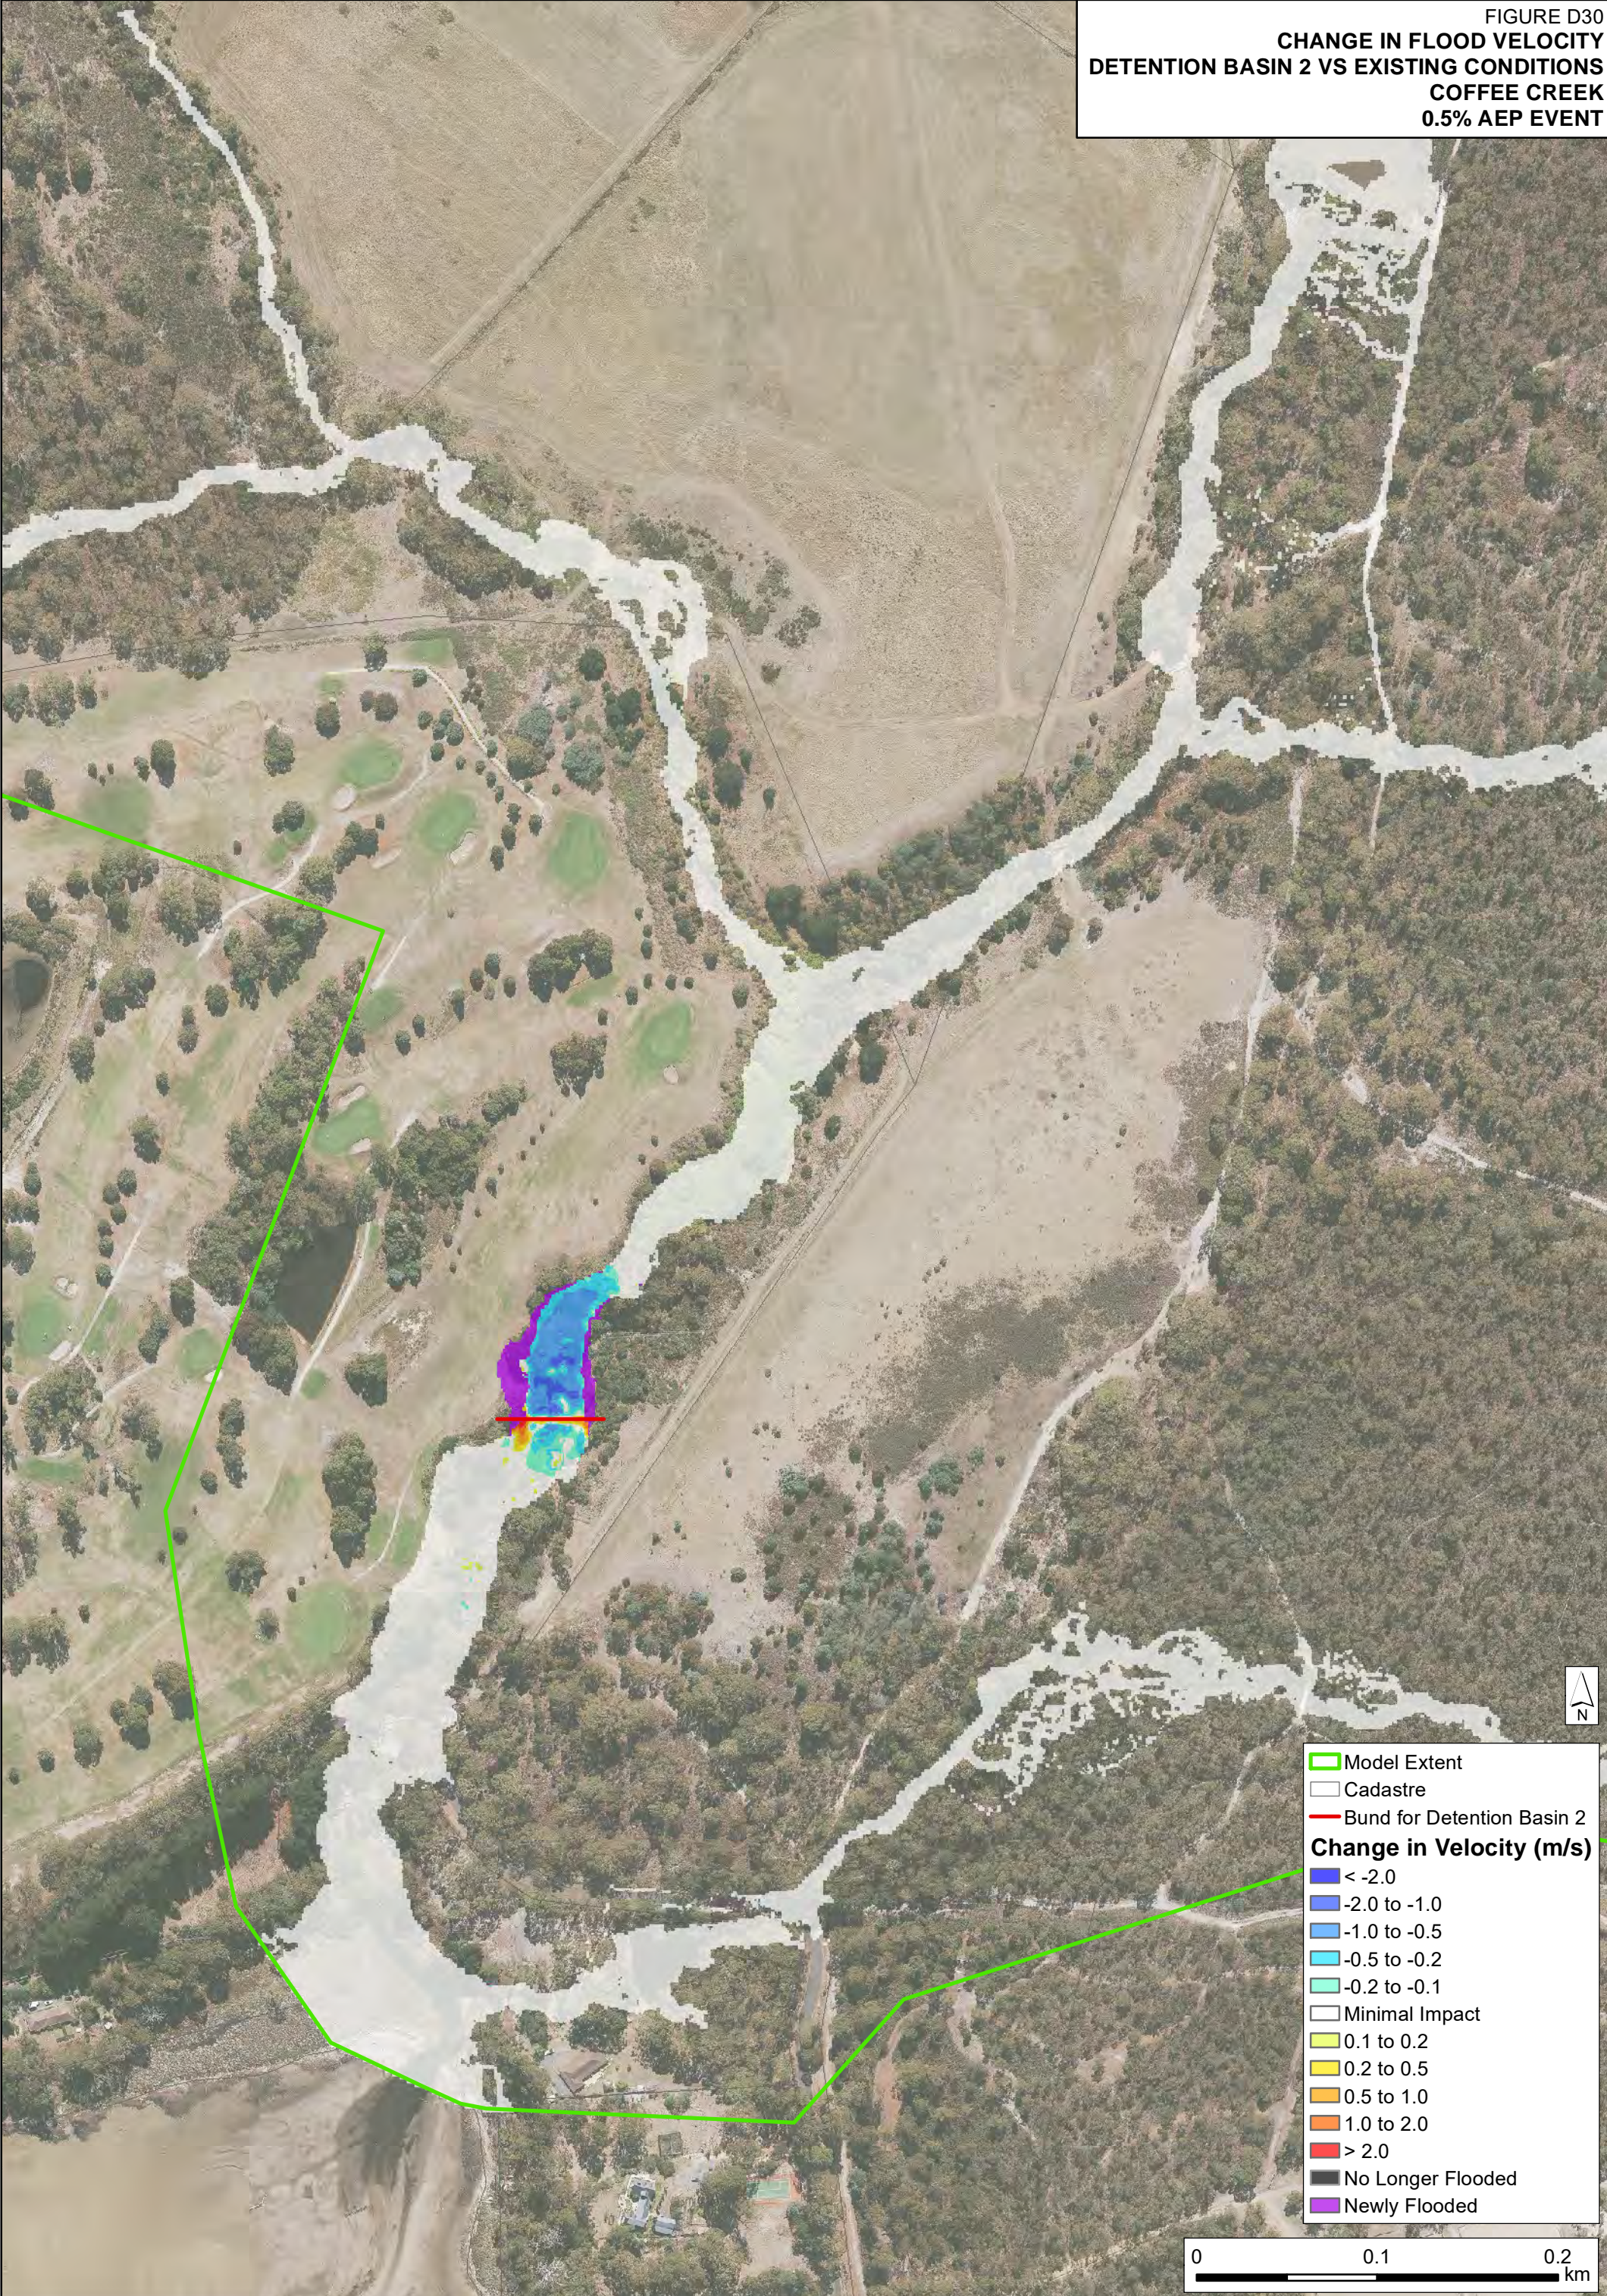
FIGURE D30
CHANGE IN FLOOD VELOCITY
DETENTION BASIN 2 VS EXISTING CONDITIONS
COFFEE CREEK
0.5% AEP EVENT
