APPENDIX A. GLOSSARY

Appendix B

APPENDIX C. SENSITIVITY FLOOD MAPPING

APPENDIX D. FLOOD IMPACT MAPPING

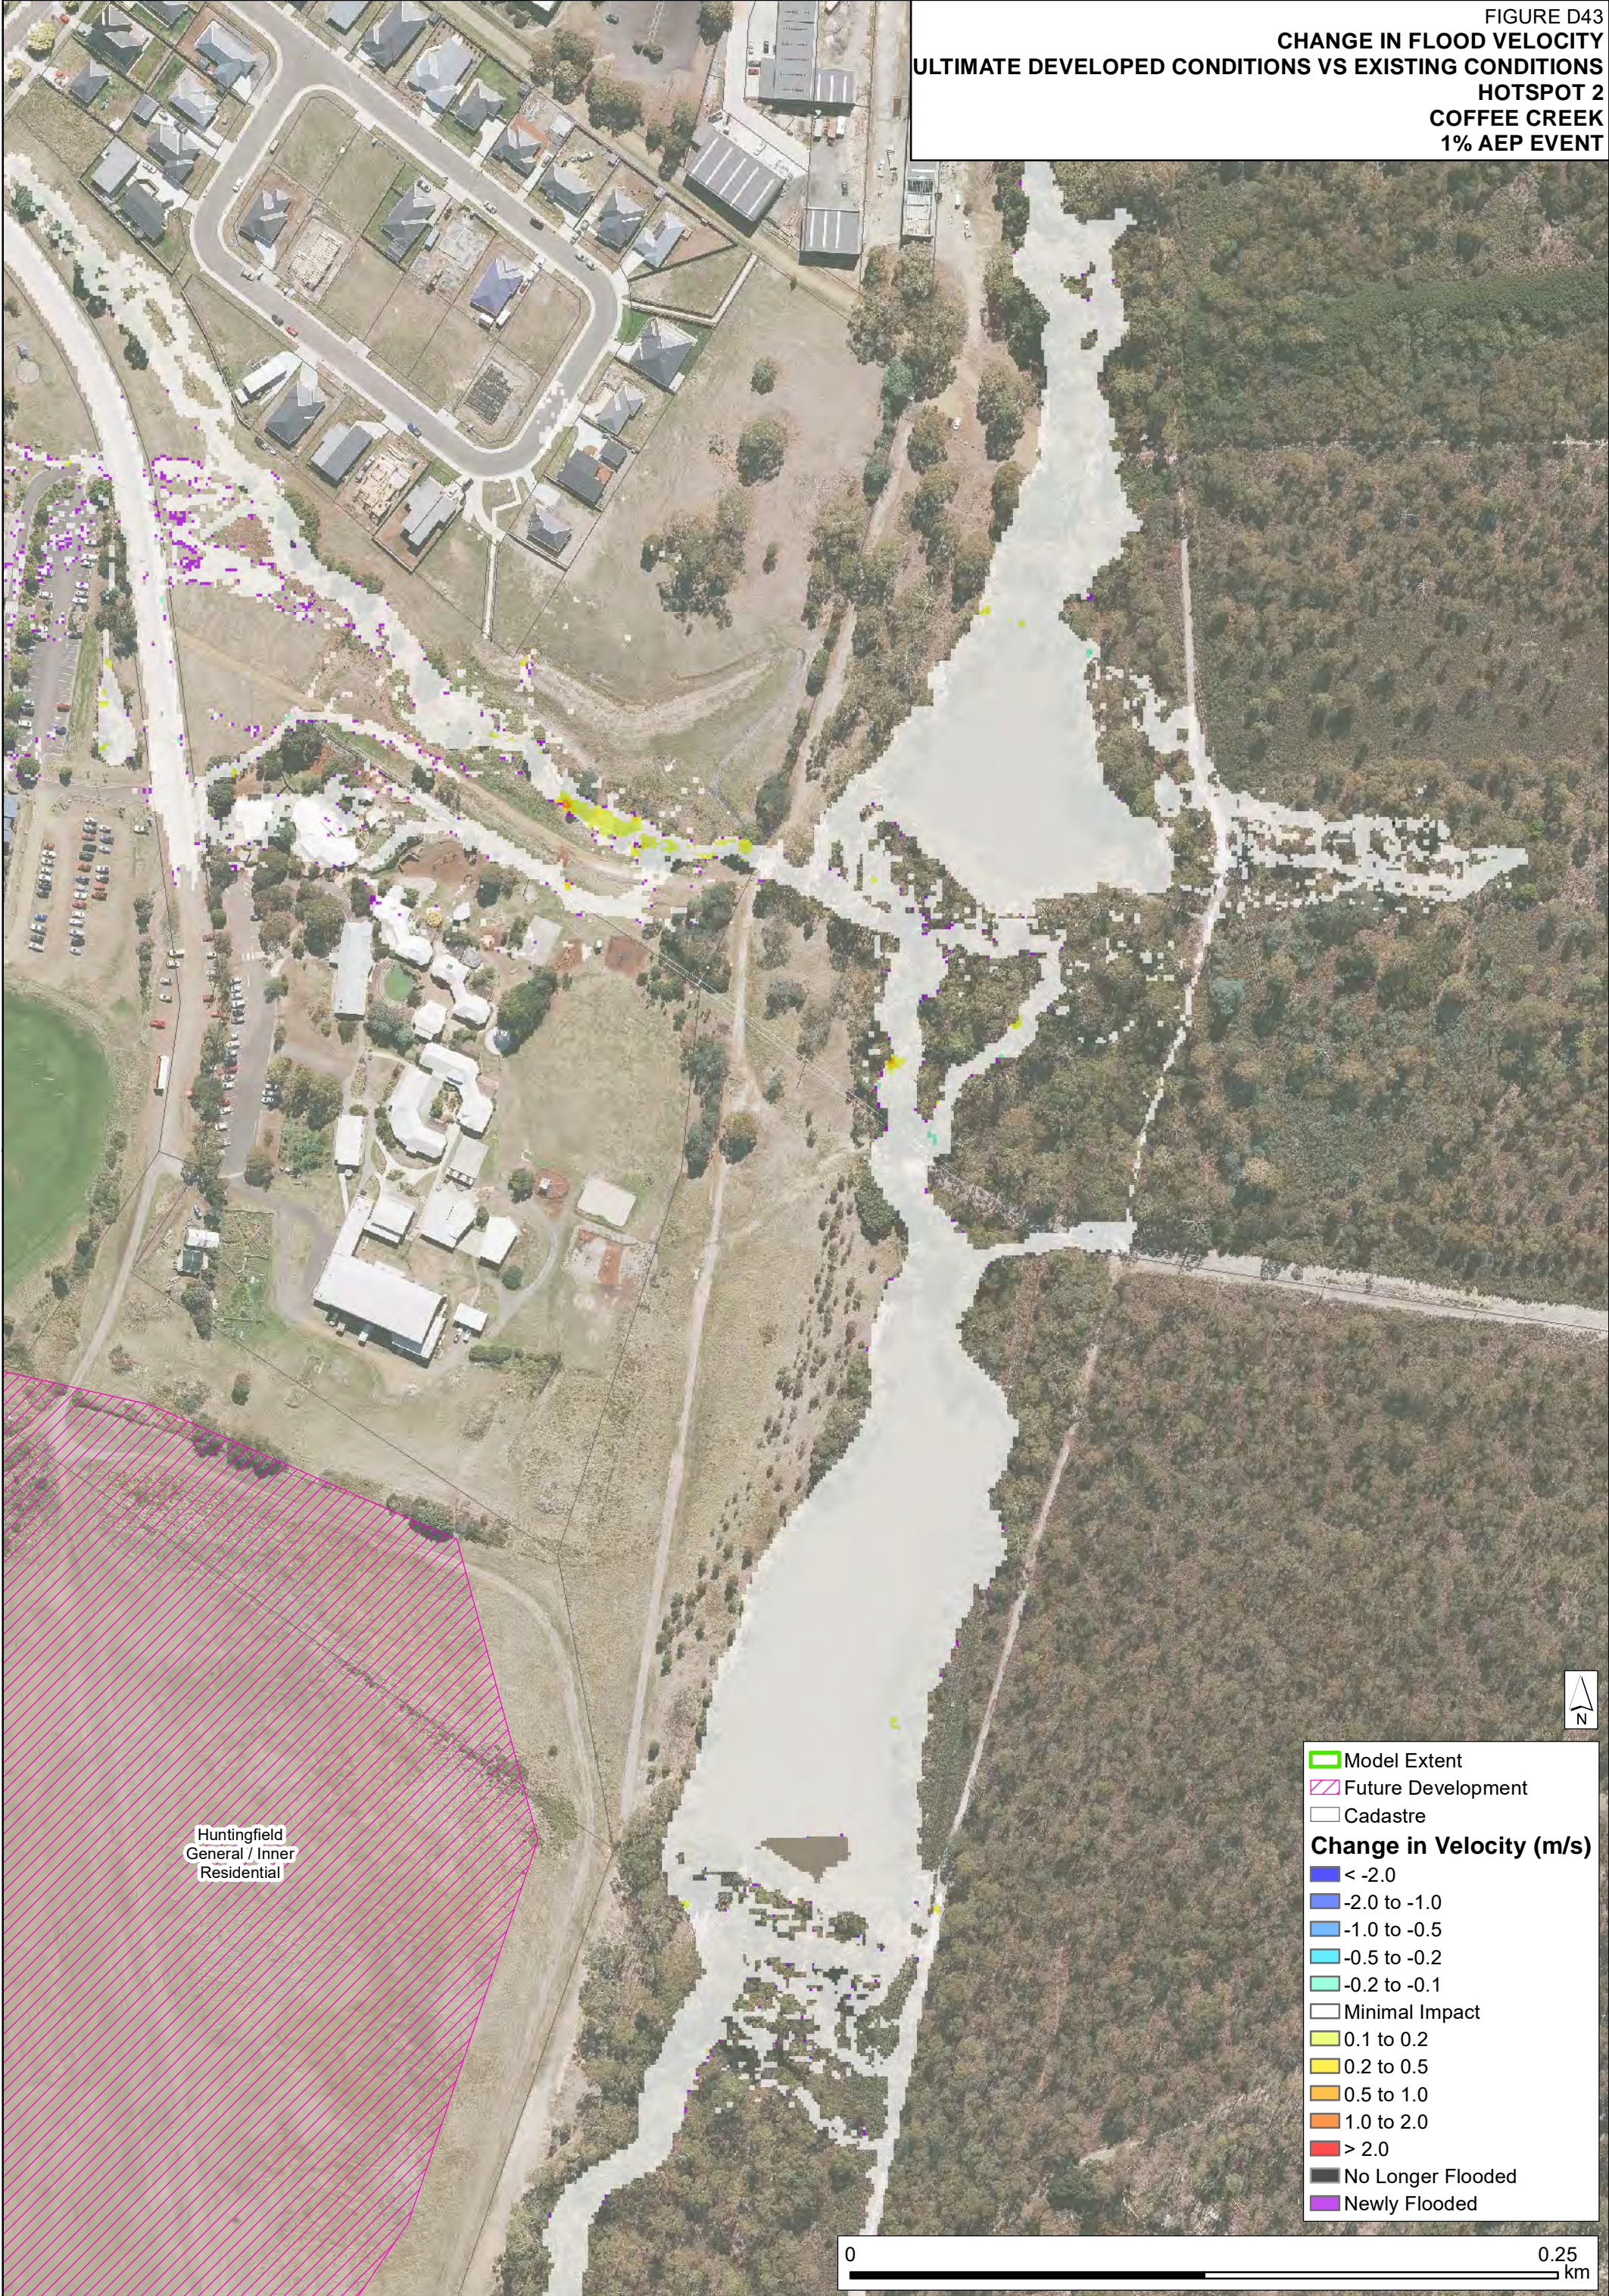
FIGURE D43
CHANGE IN FLOOD VELOCITY
ULTIMATE DEVELOPED CONDITIONS VS EXISTING CONDITIONS
HOTSPOT 2
COFFEE CREEK
1% AEP EVENT

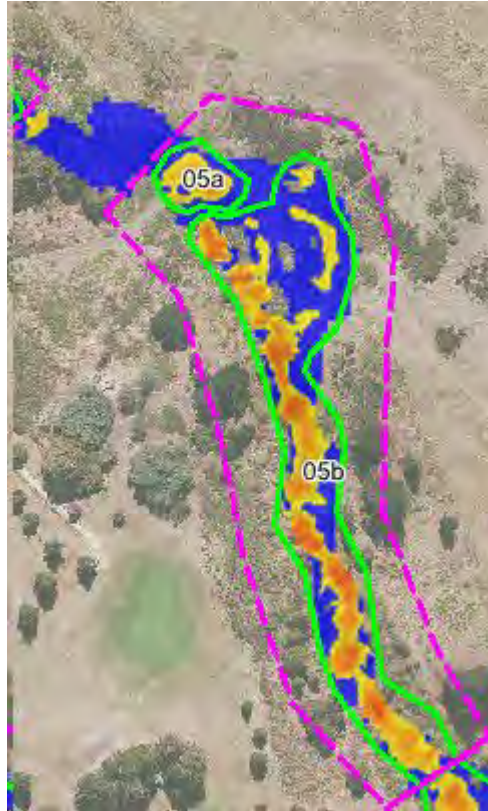
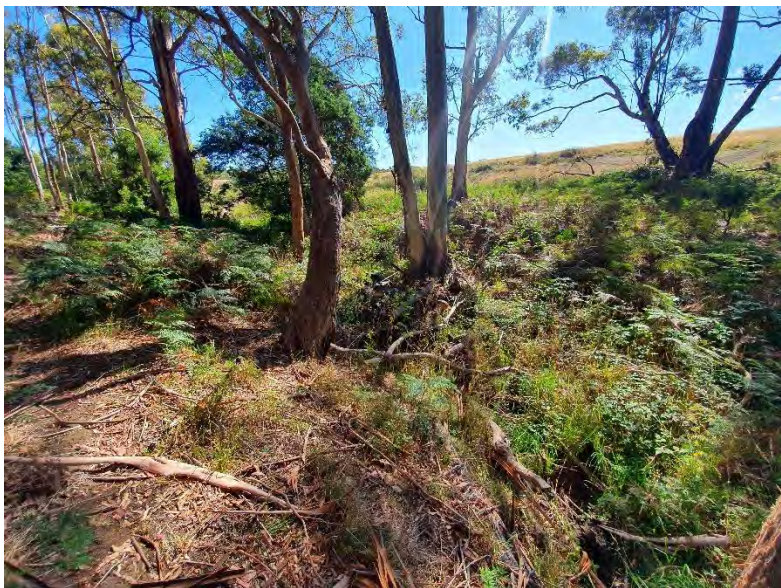
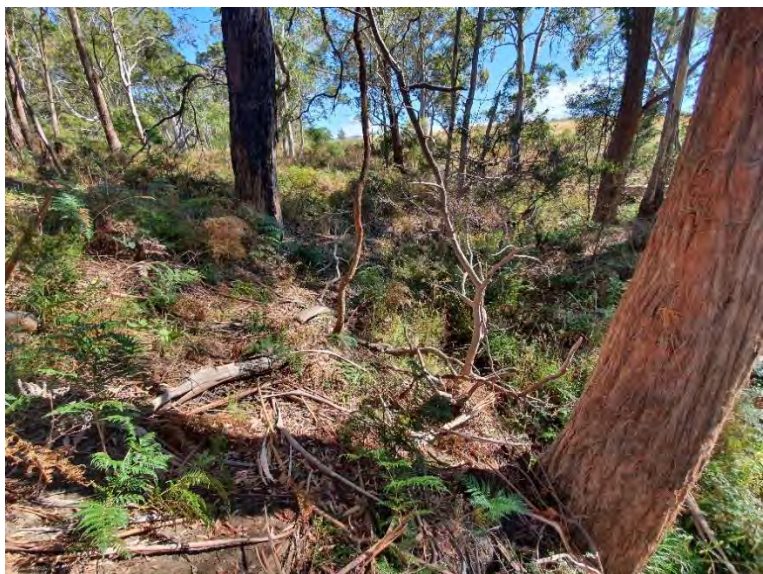
Location 5

Grasses ferns and blackberries cover a large portion of the banks.
Well established mature trees spread throughout

- Blackberries made access to the majority of the creek inaccessible.
- Small section of creek able to access showed little evidence of erosion.
- Disposed car parts found in creek
- On the edge of proposed development and golf course.

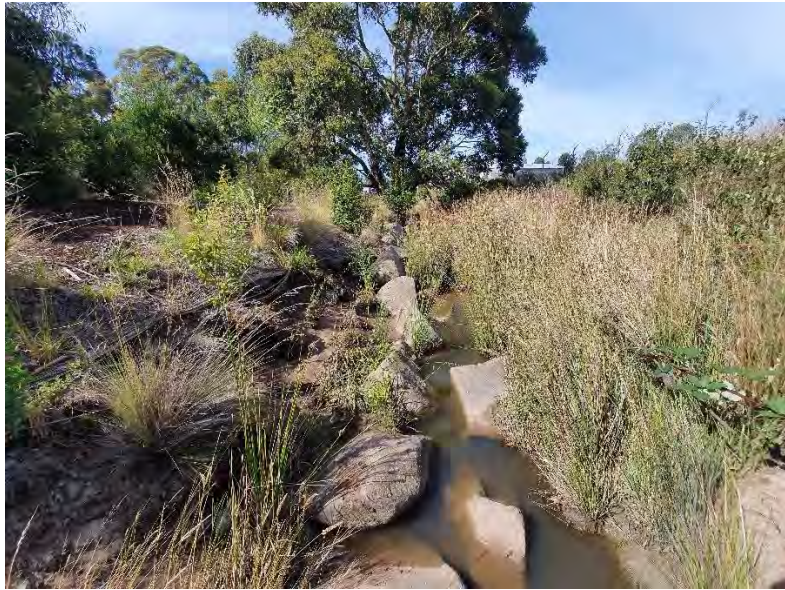
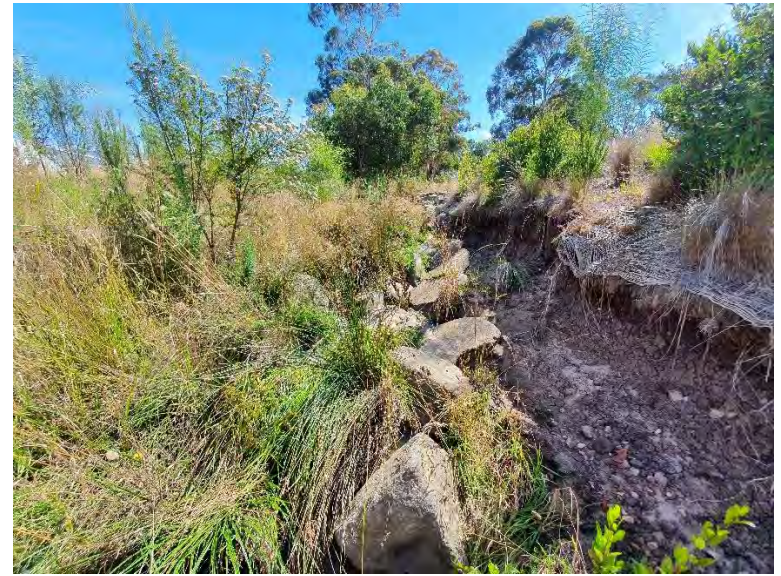
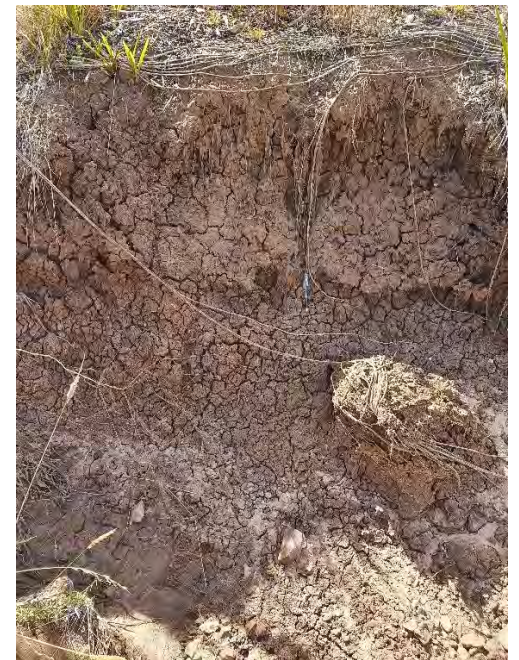
Location 8

Various Grasses and trees planted between 8a to 8e (not established yet)

From 8e onwards natural grasses and ferns present mostly on top of banks little to no vegetation in invert or on banks.

- Extensive erosion throughout the entire length, largely bank undercutting/erosion.
- Multiple and extensive attempts to mitigate against erosion including:
 - Large sandstone bolder placement (single layer on banks)
 - Geomesh placement on banks to assist plant growth
 - Rock weirs placed down channel
 - Smaller bluestone placement on bends
- Majority of mitigation attempts failed, rock placement moved, geomesh destroyed etc.
- Large industrial area large impervious area on both sides of rivulet.
- Gradual slope getting steeper as you traverse down the creek

| Cause of Erosion | | Location 8 | | | | | | |
|---|--|---|--|---|--|---|--|---|
| Runoff and base flow | Located immediately below Huntingfield Dam. Contribution from Huntingfield industrial area, location 9 and Huntingfield Dam overflow. | ACTIVE | COMMENT: large industrial area along both sides of the bank. Various mitigation method utilised; rock weirs, bluestone placement, geomesh and sandstone bolder placement. The rocks used have displaced. | UNSTABLE | COMMENT: Vegetation has not established. Sparsely found on banks. Loose sands present. | ERODING | COMMENT: Extensive erosion and undercutting. Scouring visible along banks. | CLASS 1 |
