ARBORICULTURAL IMPACT ASSESSMENT

NEW PRIVATE SEWER CONNECTION & LINE

87 KINGSTON VIEW DRIVE
KINGSTON 7050

OCTOBER 2024

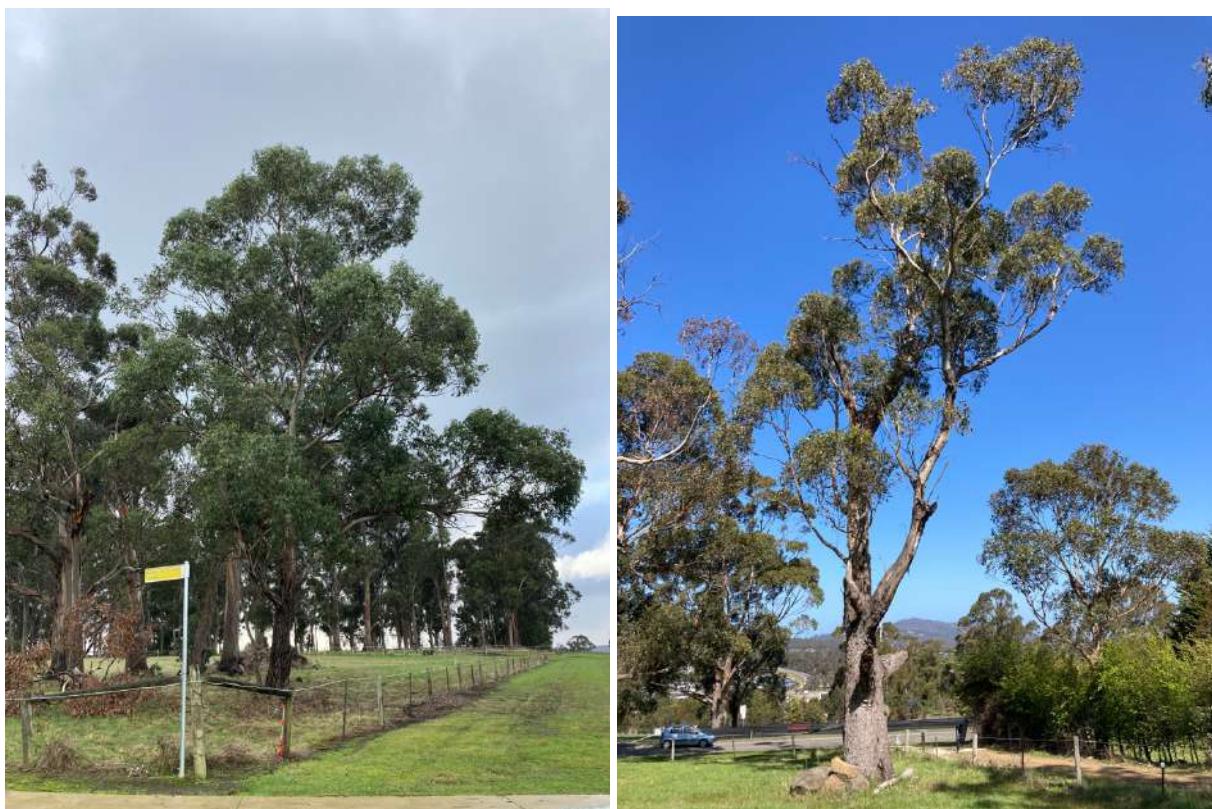
Figure 2: Subject trees 3 (left) & 4 (right) located within the subject property

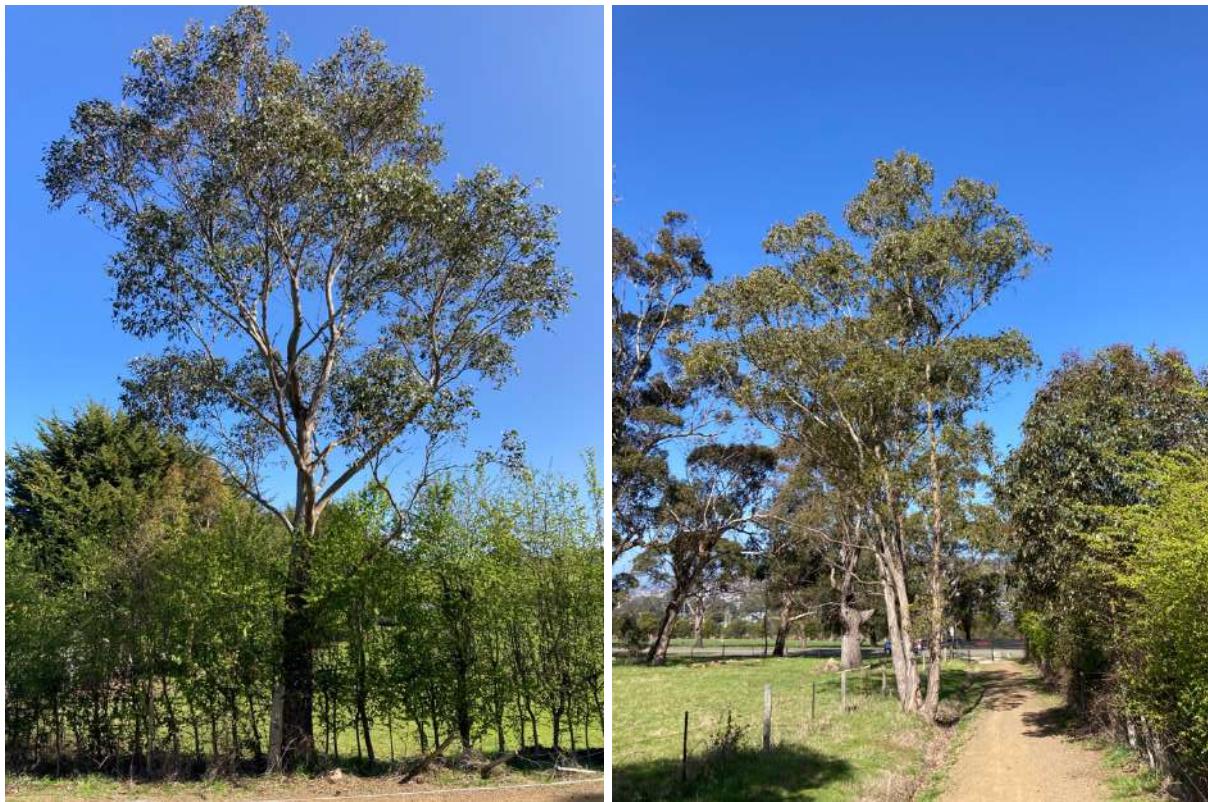
3.1.1 Tree 6, being located within the Council pathway is under the ownership & management of Kingborough Council. It is regarded as an infrastructure asset that is required to be retained & protected during the proposed works.

Figure 3: Subject tree 5 (left) located within 89 Kingston View Rd & tree 6 (right) located within the Council pathway

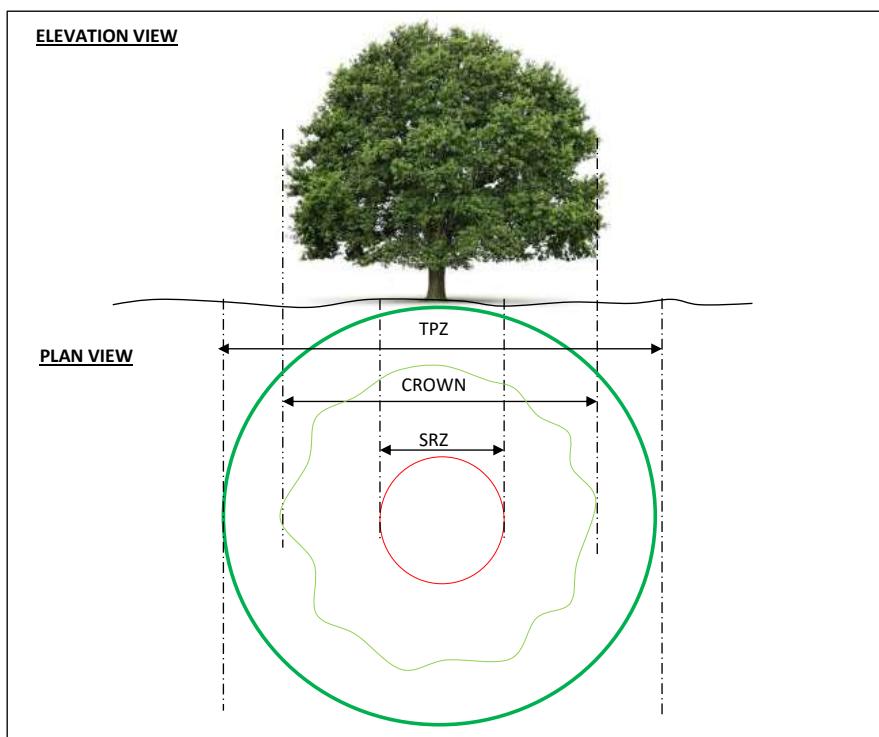
4.1.4 In addition to the TPZ, AS-4970 provides calculations to determine a tree's **Structural Root Zone** (SRZ). The SRZ is described in AS-4970 as "*the area around the base of a tree required for the tree's stability in the ground. This zone considers a tree's structural stability only, not the root zone required to maintain the trees vigour and long-term viability, which will usually be a much larger area*". Severance of structural roots (>25mm Ø) within the SRZ is not recommended as it may lead to the destabilisation and/or decline of the tree.

Figure 4: Indicative Tree Protection Zone and Structural Root Zone (AS-4970)

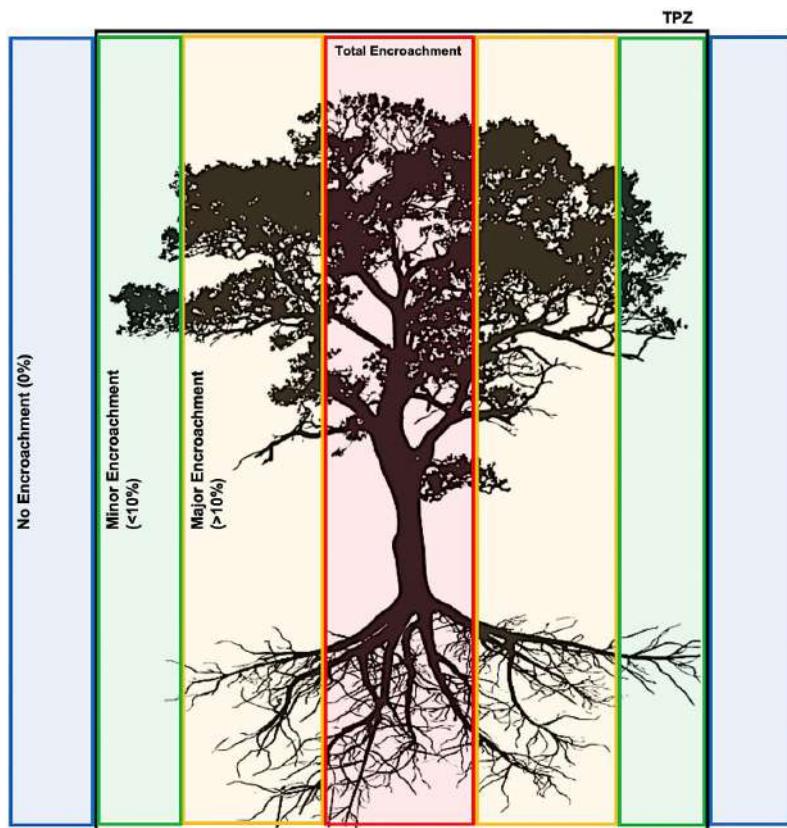
4.2.1 Where encroachment to the TPZ is unavoidable, an incursion to the TPZ of not exceeding 10% of the area of the TPZ and outside the SRZ can be acceptable. Greater incursions to the TPZ may result in an adverse impact on the tree. Indicative levels of root zone encroachment are shown in figure 3 below. Various examples of acceptable incursions are also shown in **Appendix 3**.

Figure 5: Indicative levels of root zone encroachment

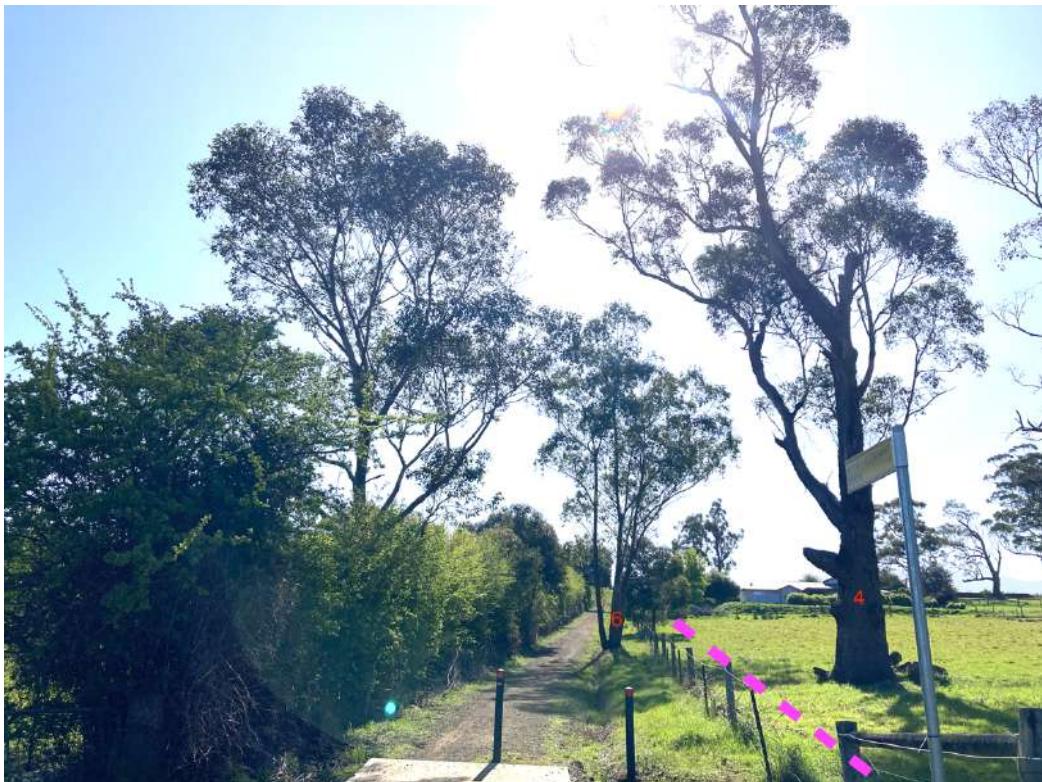
5.2.2.1 Open trenching for the new sewer line installation will result in **unacceptable** encroachments on the TPZ area of **tree 4** (34%) & **tree 6** (23%). The works will also occur within the SRZ of tree 4. Conventional mechanical open trenching along the proposed alignment will likely sever damage significant roots of these trees leading to an adverse impact, especially on tree 4 which already has a reduced overall vitality. The adverse impact on both trees will also be compounded due to the southwestern root zone of both trees likely being restricted by the presence of the existing council pathway. In addition, the trenching will likely sever significant woody structural roots of tree 4 potentially leading to its compromised stability.

Figure 6: The proposed sewer service alignment (pink dashed line) between trees 4 & 6

5.2.2.2 In order to avoid adverse impacts on trees 4 & 6 the new sewer line should be installed in accordance with **Items 6.4 & 6.6** of the Tree Protection Specification in **Section 6**. Specifically, non-destructive exploratory excavation should be conducted along the proposed service alignment within the tree TPZs to determine the presence of significant roots (>40mm diameter). Where significant roots are encountered they should be retained intact & undamaged by conducting non-destructive tunnelling beneath the roots and feeding the new pipe under the roots in the space created. Sections with no significant roots may be able to be trenched by hand. Where this is not practical and root pruning is the only alternative, proposed root pruning should be assessed by the Project Arborist to evaluate the potential impact on the health and stability of the subject trees.

5.3.2 Install the new sewer service line within the TPZ of trees 4 & 6 using non-destructive techniques in accordance with Items 6.4 & 6.6 of the Tree Protection Specification In Section 6.

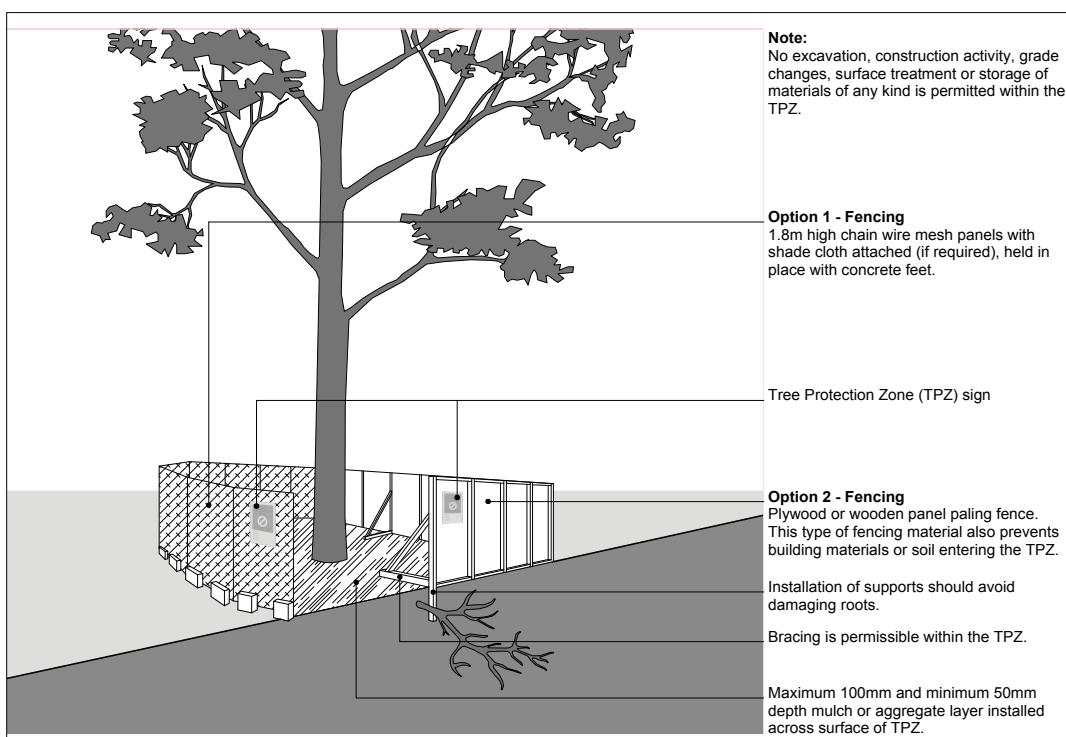
6.3.2 Tree Protection Fencing: Protective fencing shall be installed at the locations shown on the Tree Protection Plan in **Appendix 1** by a blue line. Where Tree Protection Zones merge a single fence encompassing the area is deemed to be adequate. The actual form of the fencing can vary, provided it is fit for purpose in that it **effectively physically restricts access and damaging activities within the TPZ/SRZ that it encloses for the duration of the proposed works** (see figures 4 & 5 below) and it is approved by the Project Arborist. **For the proposed works it would be appropriate to construct the fencing from medium duty (160 gsm minimum) barrier mesh attached to star pickets (droppers) at 5m minimum spacing.** In order to maintain tension 2mm fencing wire should be run through the top of the barrier mesh & droppers (see figure 5 below).

Figure 7- Tree Protection Fencing

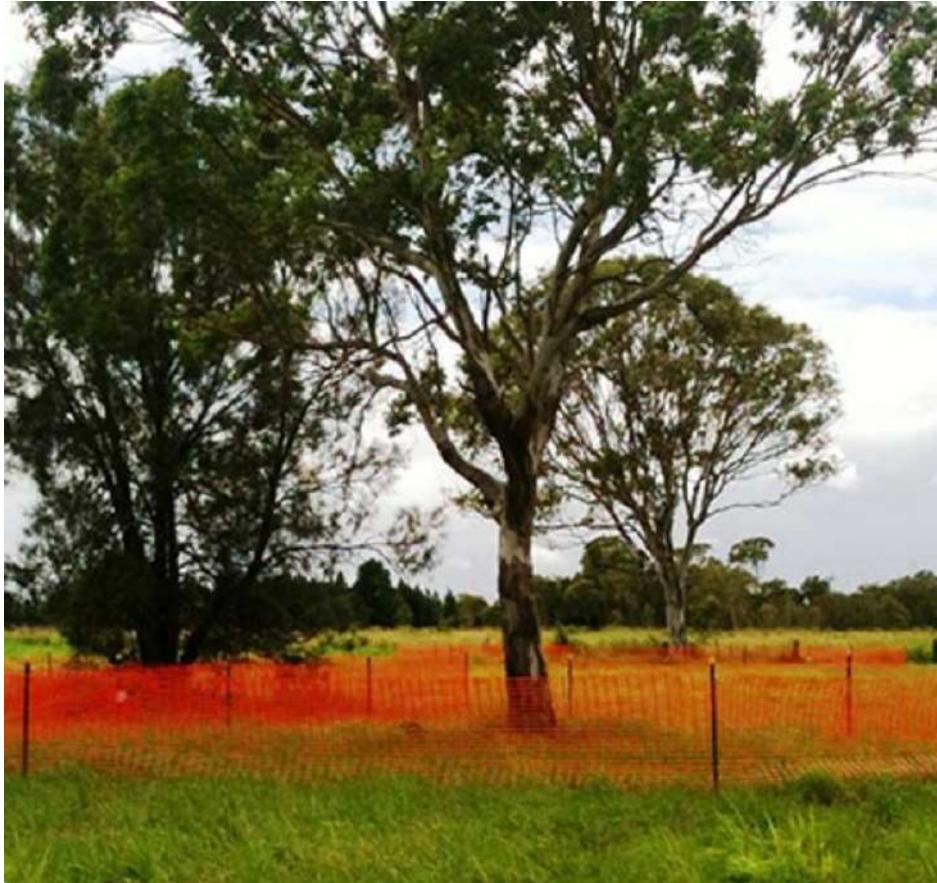
Figure 8- Tree Protection Fencing constructed with barrier mesh.

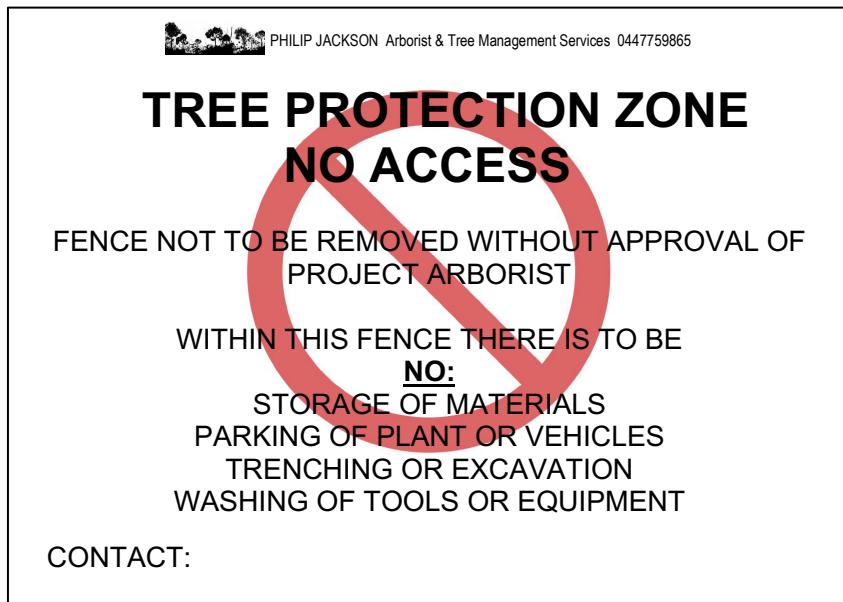
6.3.3 Tree Signage: Appropriate signage shall be installed on the fencing to prevent unauthorised movement & or storage of plant and equipment or entry to the TPZ/SRZ (see figure 6 below). A sample Tree Protection Zone sign is attached to the back of this document.

Figure 9- Appropriate Tree Protection Zone Signage

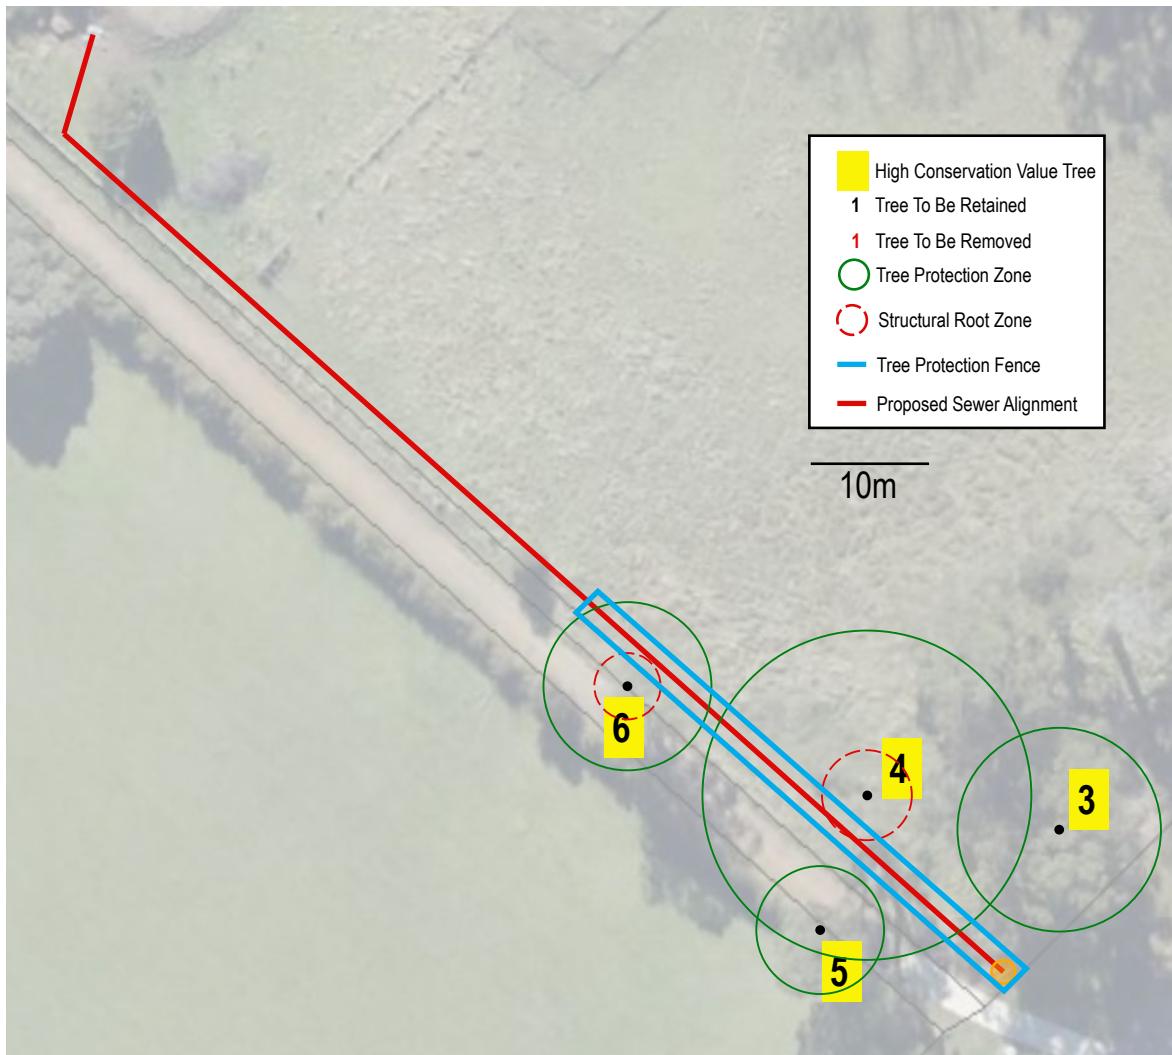
TREE PROTECTION PLAN:
87 KINGSTON VIEW DRIVE
KINGSTON

NOTE: TREE LOCATIONS ARE APPROXIMATE

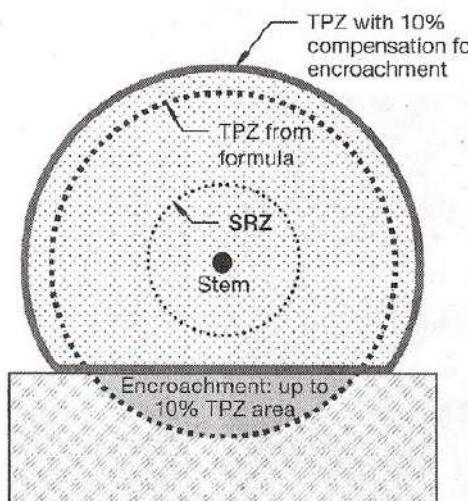
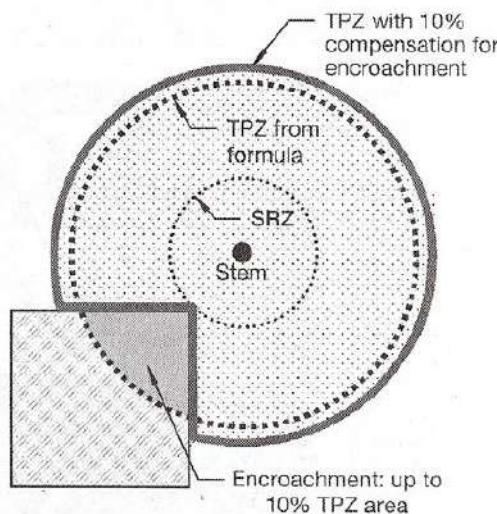
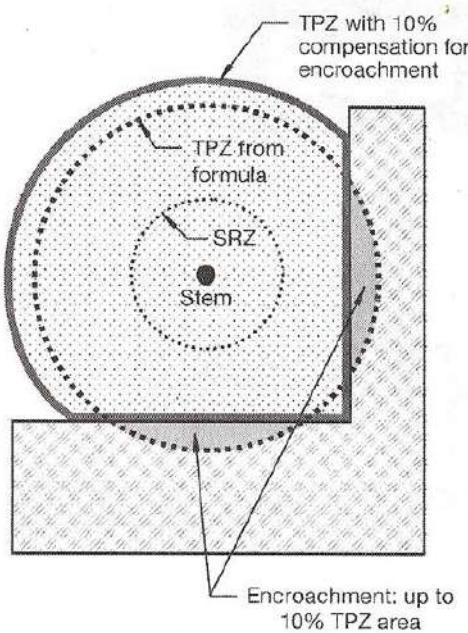
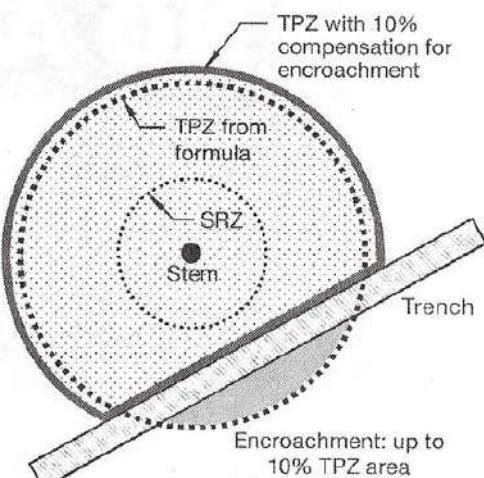
APPENDIX 3 - ACCEPTABLE INCURSIONS TO THE TREE PROTECTION ZONE (TPZ)

NOTE: Less than 10% TPZ area and outside SRZ. Any loss of TPZ compensated for elsewhere.
