LANDSLIDE RISK ASSESSMENT

Proposed Additions/Alterations

17 Roslyn Avenue
Kingston Beach,
TAS
7050

DOCUMENT CONTROL		
Report Title:	17 Roslyn Avenue, Kingston Beach TAS 7050	
Project Type:	Landslide Risk Assessment	
Client:	Kat McGuire & Michael Middleton	
Project Job Number:	12381	
Revision Version:	V01	
Date:	16/01/2026	
Approved By:	V.Gupta	
	Signature:	Date

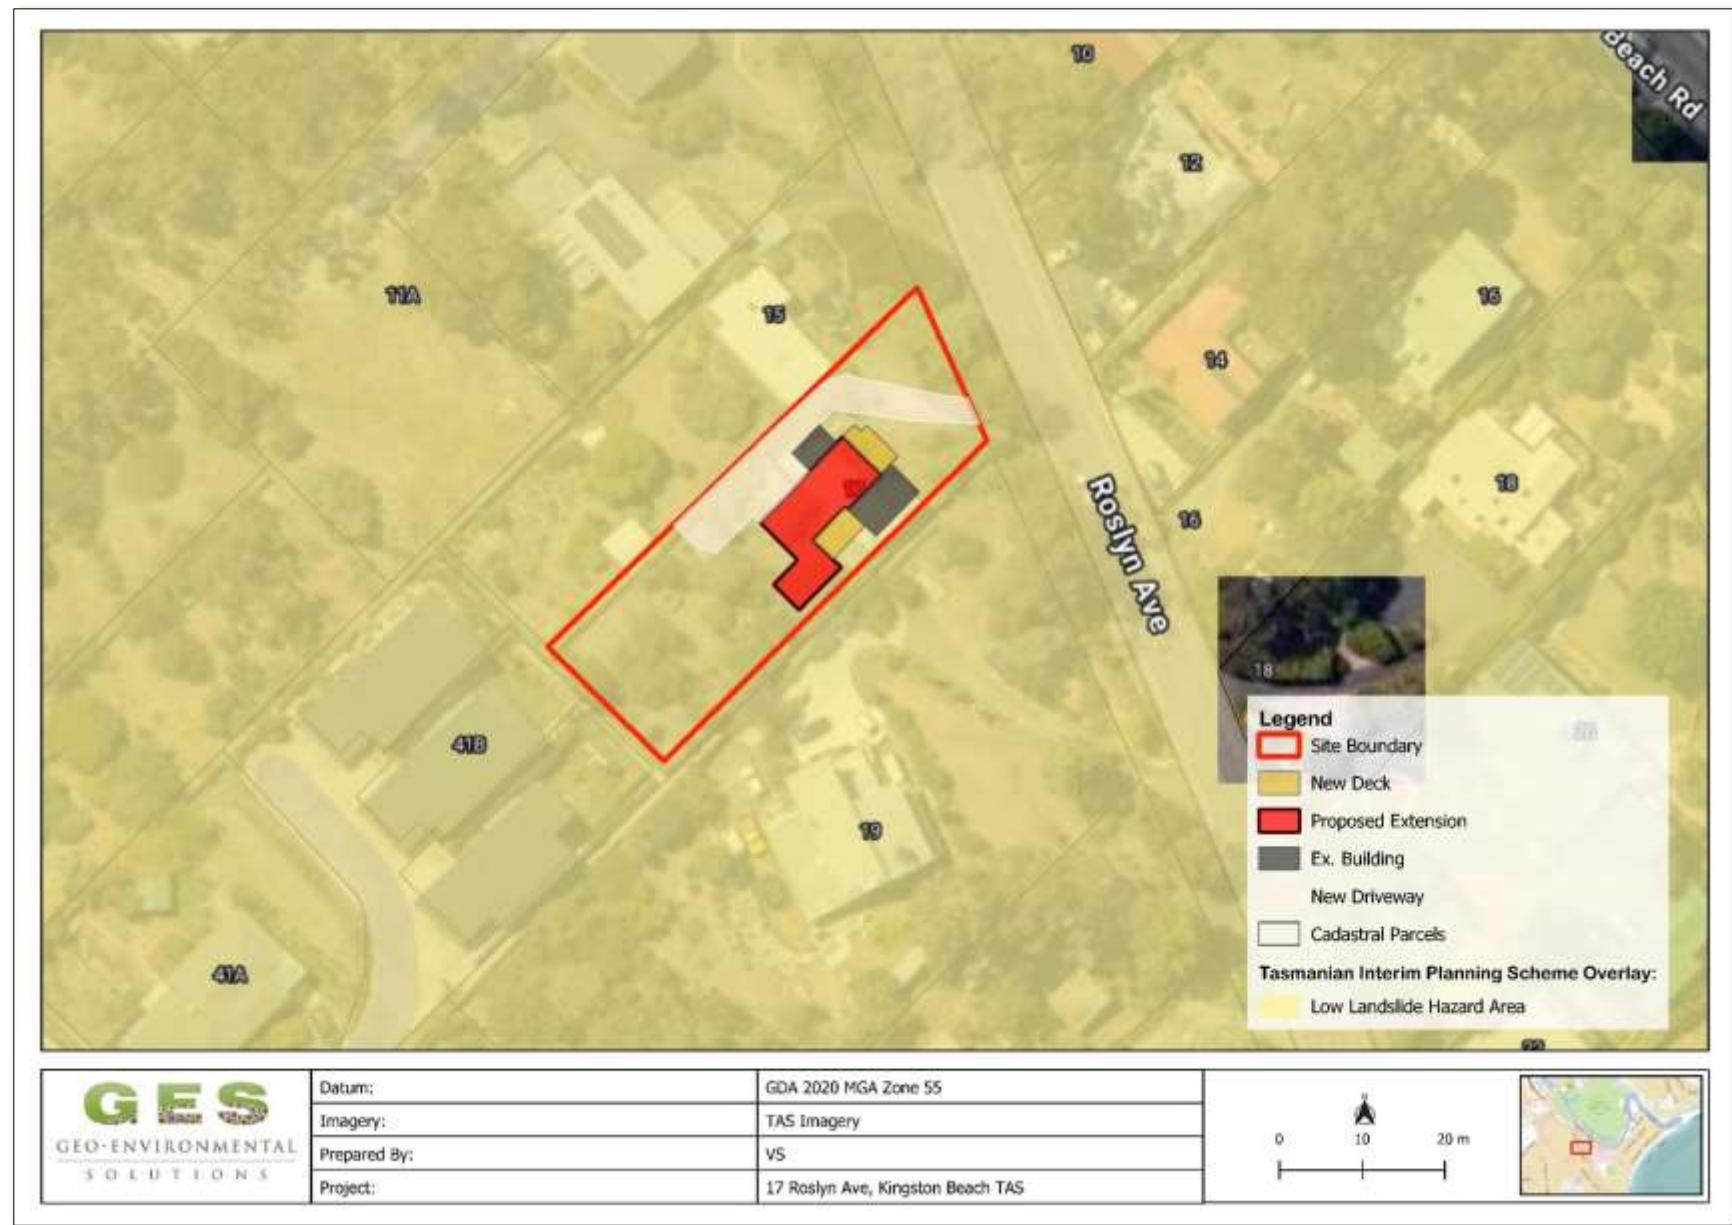
Figure 2 – Landslide Overlay near the Site (The List)

The site is within the low landslide overlay due the slopes of 11-20 degrees (Figure 2).

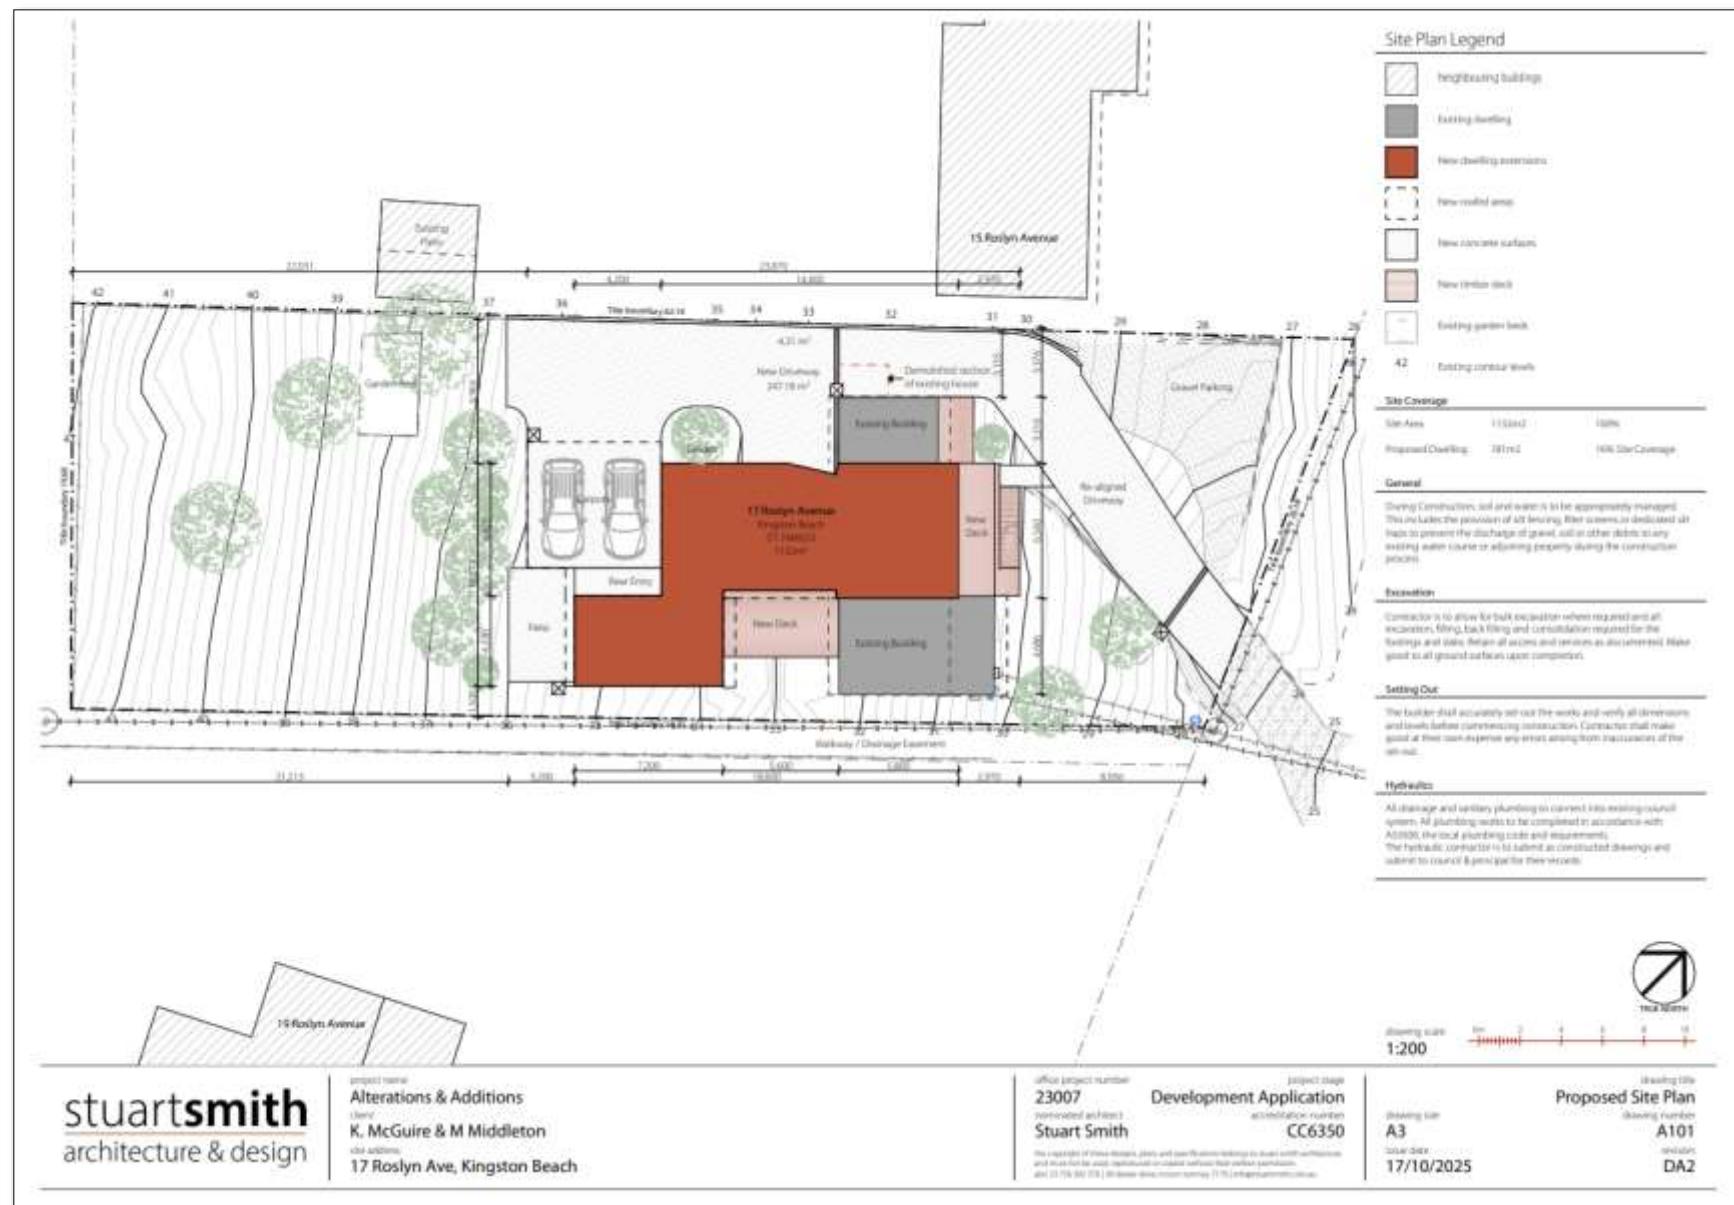
Figure 3 - Site Plan showing proposed works.

The proposed works involve additions and alterations to the existing dwelling. The extensions will be located on the southwest side of the site. To accommodate the new construction, cut and fill works will be required on the sloping terrain, and the proposed cuts will be supported by retaining walls. The existing driveway will be resurfaced and reconstructed on the northeast side of the site, with access from Roslyn Avenue.

Plans have been provided to GES from Stuart Smith Architecture & Design (Project Number: 23007, Dated: 17 October 2025). The plans are presented in Figure 3.

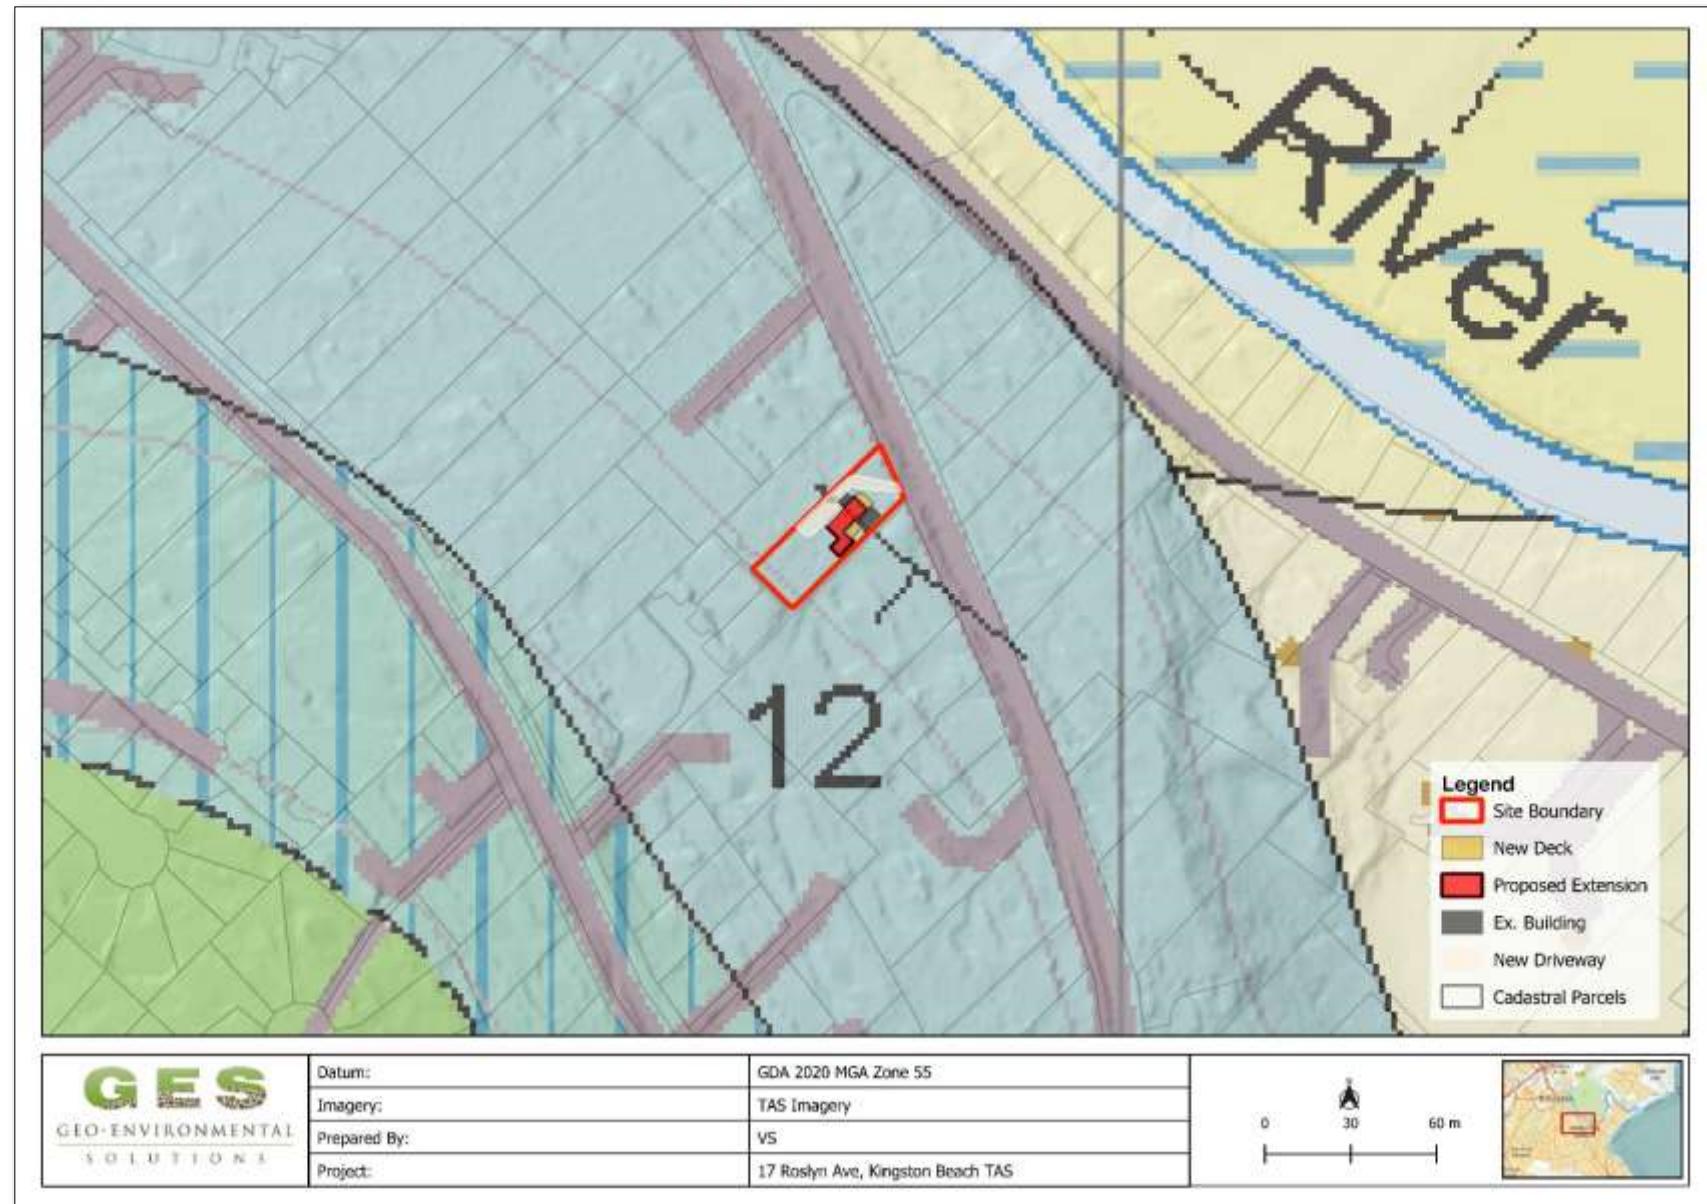
Figure 4 - Mapped Geology (Source: MRT 1:25,000)

The geological map for the site has been presented in Figure 4. Based on the MRT 1:25,000 Mineral Resources Tasmania (MRT) Geology of Tasmania (Map Sheet: Taroona), the site geology comprises of the following geological units:

- **(Map Unit – Pua):** Generally unfossiliferous glaciomarine interbedded non-fissile and fissile siltstone and silty sandstone, with common bioturbation and limestones, rare pebbly beds and fossiliferous beds; top beds of laminated grey to brown siltstone with thin beds of well sorted sandstone (Abels Bay Formation).

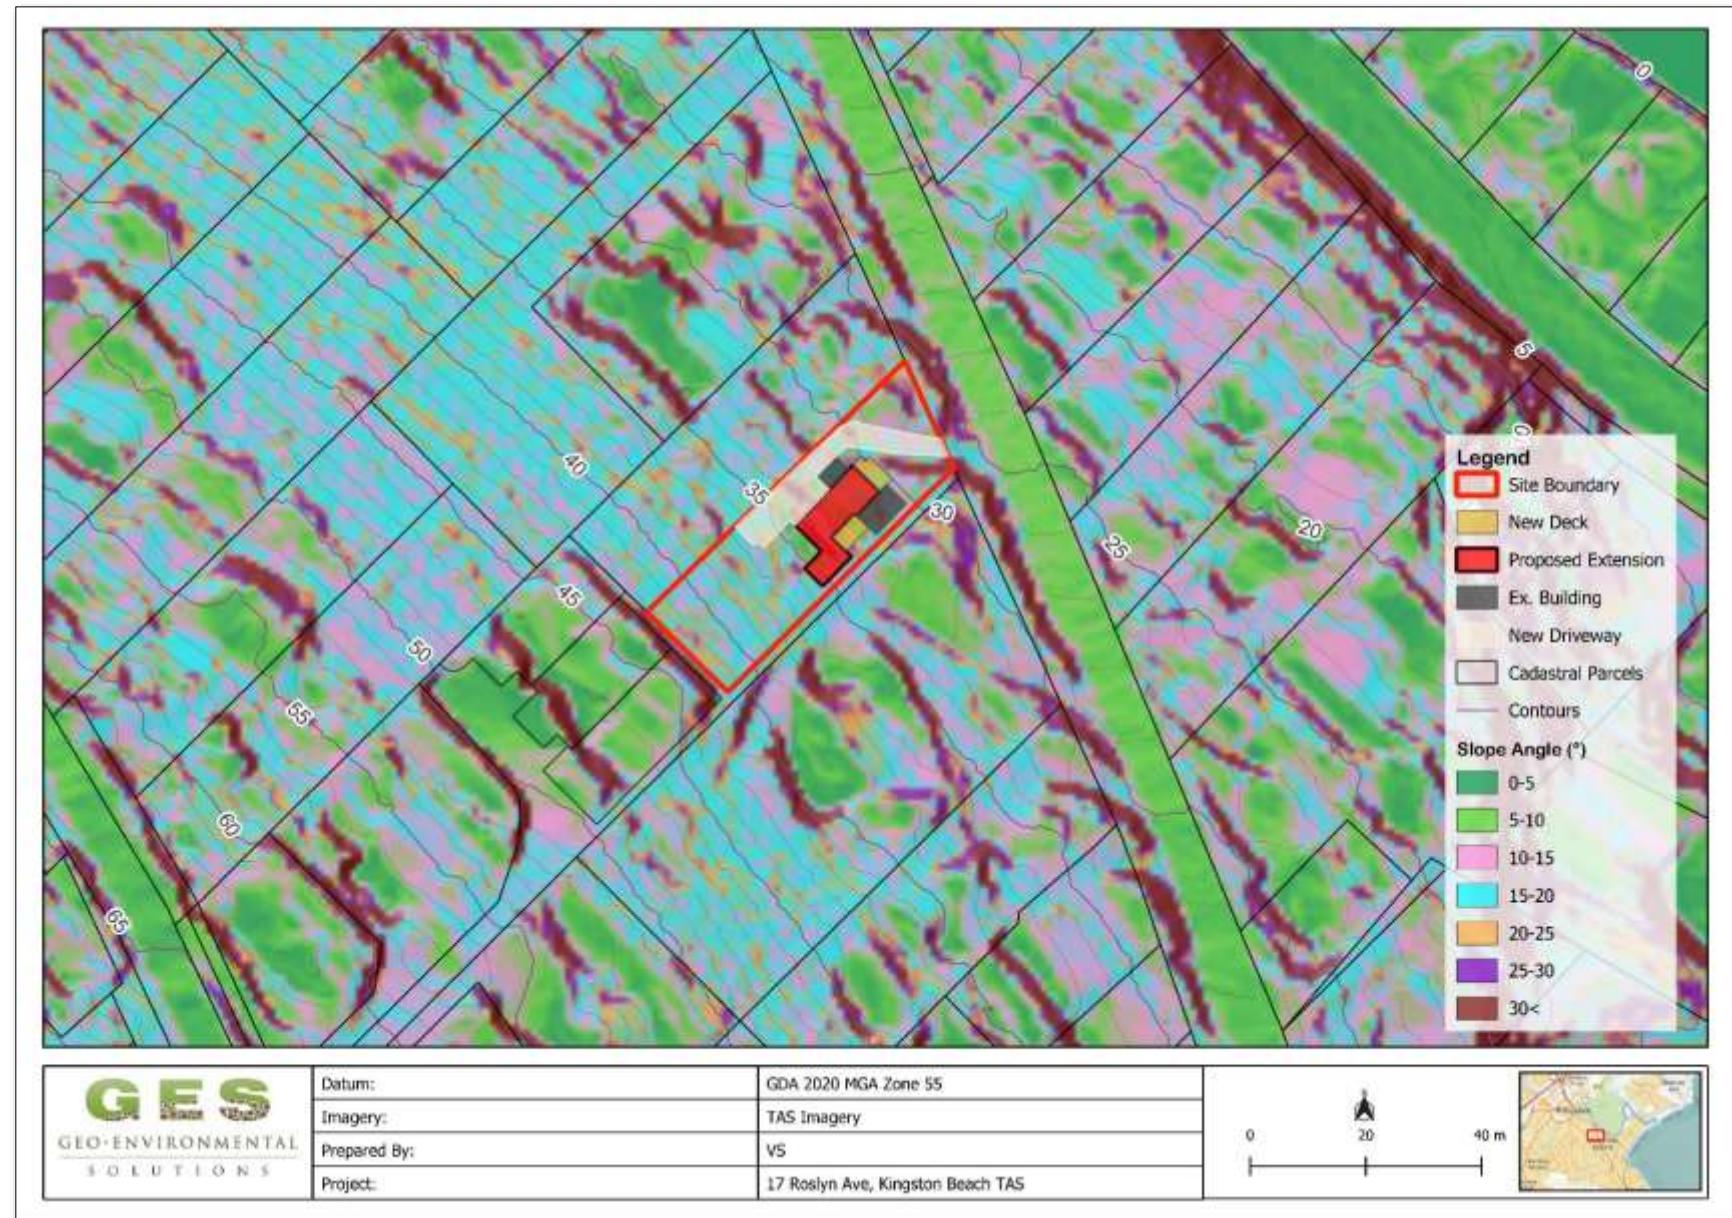
Figure 5 Slope angle model developed from Kingborough 2022 LiDAR data.

The site is located on the northeastern extent of Boronia Hill. The natural slopes across the site range from gentle to moderately steep. Slope angles and aspects in the area of the proposed development vary but are typically between 5° and 20° toward the northeast. The slope steepens to more than 30° along the eastern side of the site.

The site has an elevation of approximately 44 m AHD along the southwest boundary, which decreases to around 33 m AHD along the northeast boundary. To provide a visual representation of the on-site slope conditions, a slope angle map was produced using QGIS software, based on the Kingborough 2022 LiDAR dataset. Refer to Figure 5 for a detailed depiction of the slope angles observed on the site.

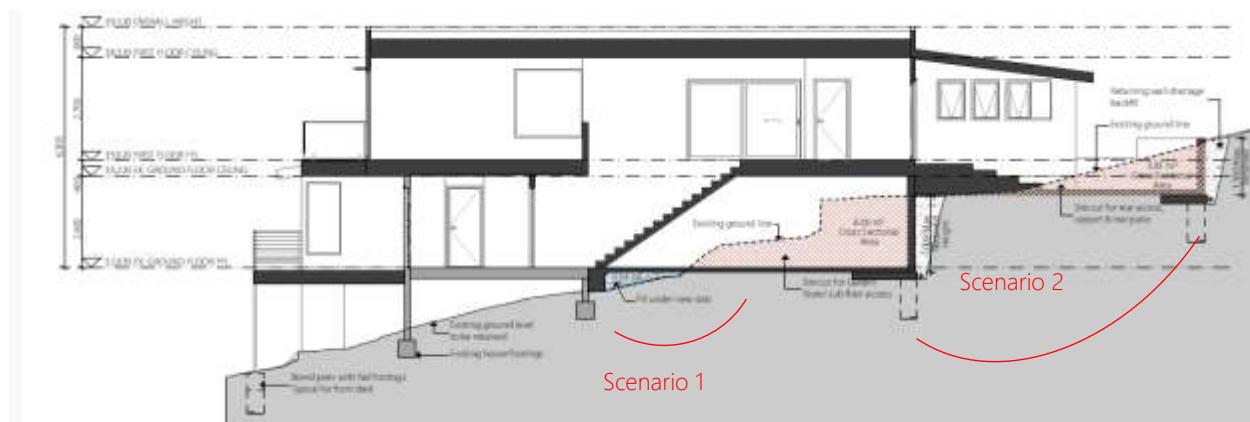
Figure 6 – Possible scenarios of landslip

- **Scenario 1** – Shallow slide failure in fill batters immediately below the proposed dwelling with potential regression; and
- **Scenario 2** – Shallow translational slide within shallow residual soils in cuttings above the proposed dwelling, caused by oversteepening of natural soil slopes, with no allowance for drainage.

The Societal Risk Graph plot presented in Figure 7. showing the estimated individual risks for scenarios 1 and 2 as presented in Figure 6 (outlined in the AGS 'Landslide Risk Management Concepts and Guidelines', 2000). The risks are estimated based on people in the structure spending up to 12 hours per day in internal areas the property.

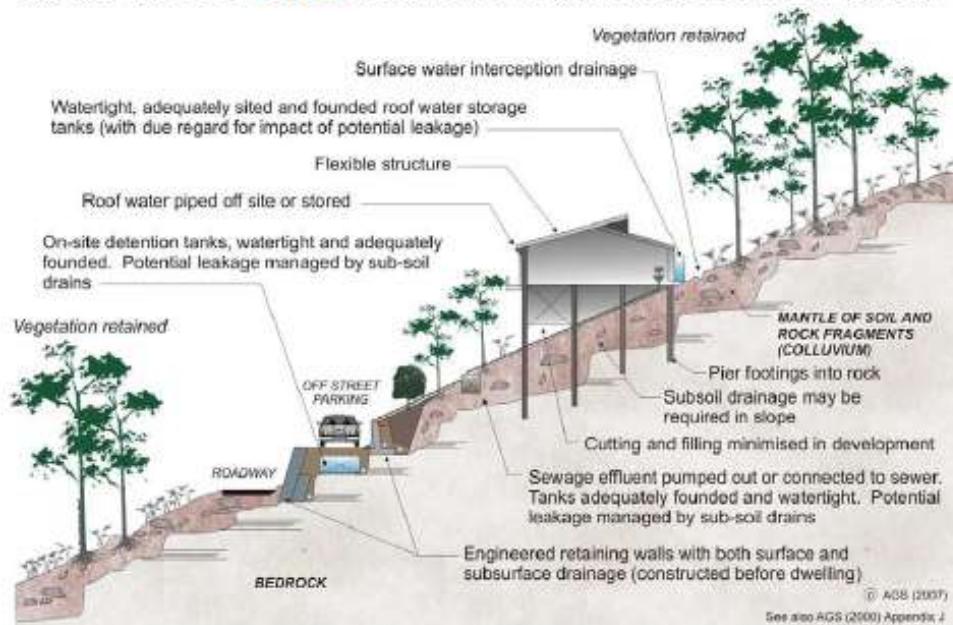
EXAMPLES OF GOOD HILLSIDE CONSTRUCTION PRACTICE

Roadways and parking areas - are paved and incorporate kerbs which prevent water discharging straight into the hillside (GeoGuide LR6).

Sewage - whether treated or not is either taken away in pipes or contained in properly founded tanks so it cannot soak into the ground.

Surface water - from roofs and other hard surfaces is piped away to a suitable discharge point rather than being allowed to infiltrate into the ground. Preferably, the discharge point will be in a natural creek where ground water exits, rather than enters, the ground. Shallow, lined, drains on the surface can fulfil the same purpose (GeoGuide LR5).

Surface loads - are minimised. No fill embankments have been built. The house is a lightweight structure. Foundation loads have been taken down below the level at which a landslide is likely to occur and, preferably, to rock. This sort of construction is probably not applicable to soil slopes (GeoGuide LR3). If you are uncertain whether your site has rock near the surface, or is essentially a soil slope, you should engage a geotechnical practitioner to find out.

Vegetation clearance - on soil slopes has been kept to a reasonable minimum. Trees, and to a lesser extent smaller vegetation, take large quantities of water out of the ground every day. This lowers the ground water table, which in turn helps to maintain the stability of the slope. Large scale clearing can result in a rise in water table with a consequent increase in the likelihood of a landslide (GeoGuide LR5). An exception may have to be made to this rule on steep rock slopes where trees have little effect on the water table, but their roots pose a landslide hazard by dislodging boulders.

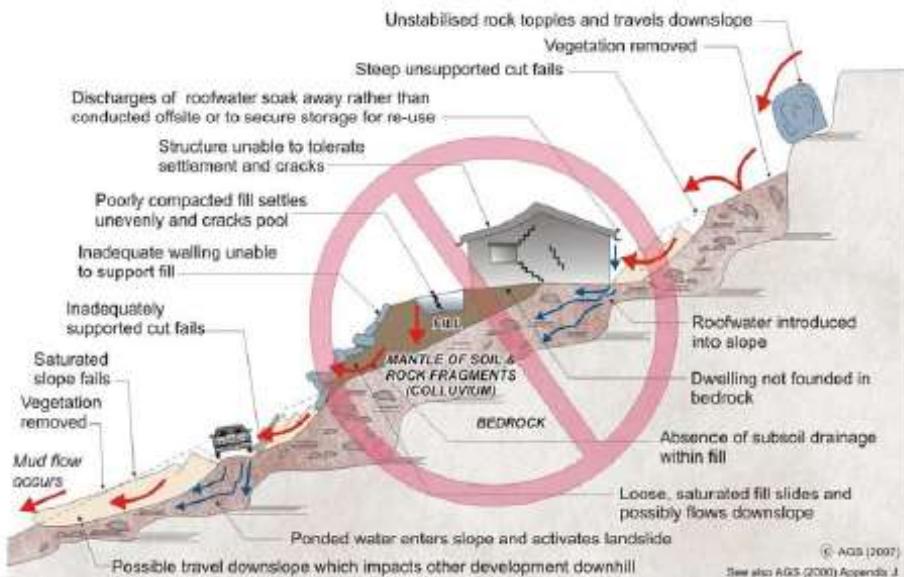
EXAMPLES OF POOR HILLSIDE CONSTRUCTION PRACTICE

Roadways and parking areas - are unsurfaced and lack proper table drains (gutters) causing surface water to pond and soak into the ground.

Cut and fill - has been used to balance earthworks quantities and level the site leaving unstable cut faces and added large surface loads to the ground. Failure to compact the fill properly has led to settlement, which will probably continue for several years after completion. The house and pool have been built on the fill and have settled with it and cracked. Leakage from the cracked pool and the applied surface loads from the fill have combined to cause landslides.

Retaining walls - have been avoided, to minimise cost, and hand placed rock walls used instead. Without applying engineering design principles, the walls have failed to provide the required support to the ground and have failed, creating a very dangerous situation.

A heavy, rigid, house - has been built on shallow, conventional, footings. Not only has the brickwork cracked because of the resulting ground movements, but it has also become involved in a man-made landslide.

Rock debris - from landslides higher up on the slope seems likely to pass through the site. Such locations are often referred to by geotechnical practitioners as "debris flow paths". Rock is normally even denser than ordinary fill, so even quite modest boulders are likely to weigh many tonnes and do a lot of damage once they start to roll. Boulders have been known to travel hundreds of metres downhill leaving behind a trail of destruction.

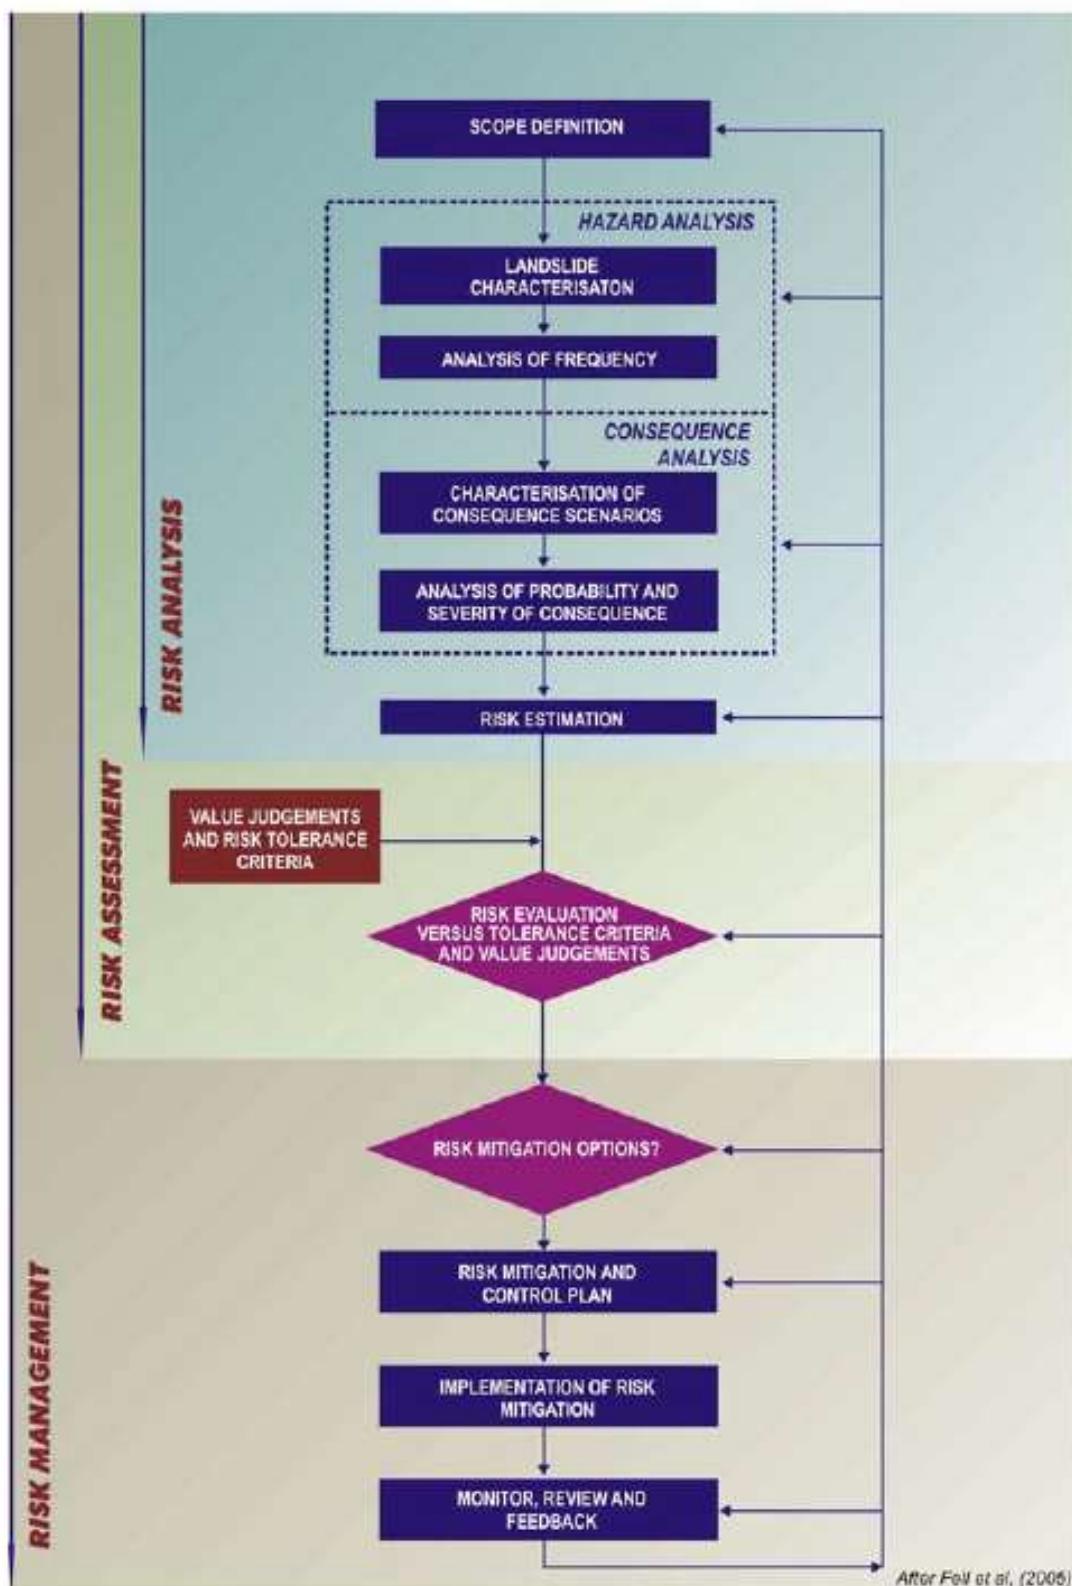
FRAMEWORK FOR LANDSLIDE RISK MANAGEMENT

After Fell et al. (2006)

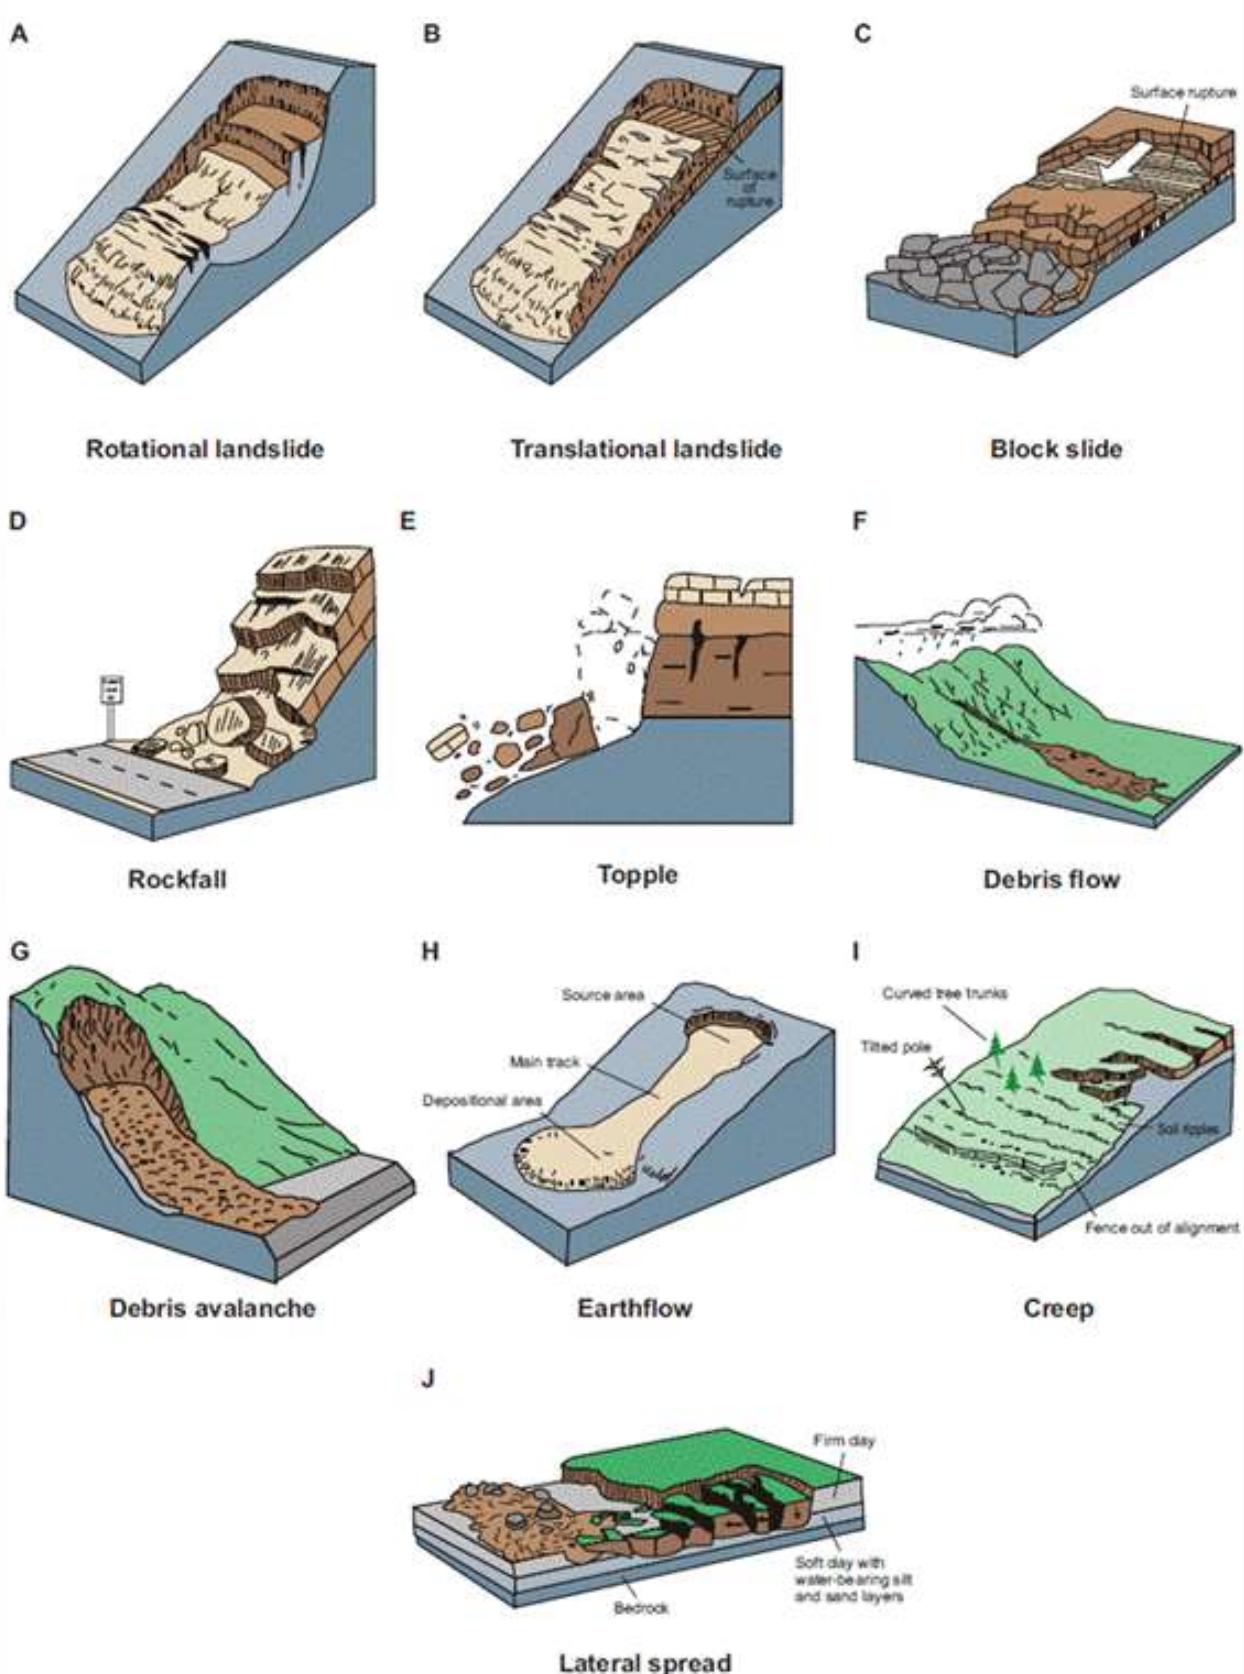
Figure B1 gives schematics to illustrate the major types of landslide movement. Further information and photographs of landslides are available on the USGS website at <http://landslides.usgs.gov>.
