# SUNCOAST HEADLAND TRACK BLACKMANS BAY

## GEOTECHNICAL REPORT

AUGUST 2020

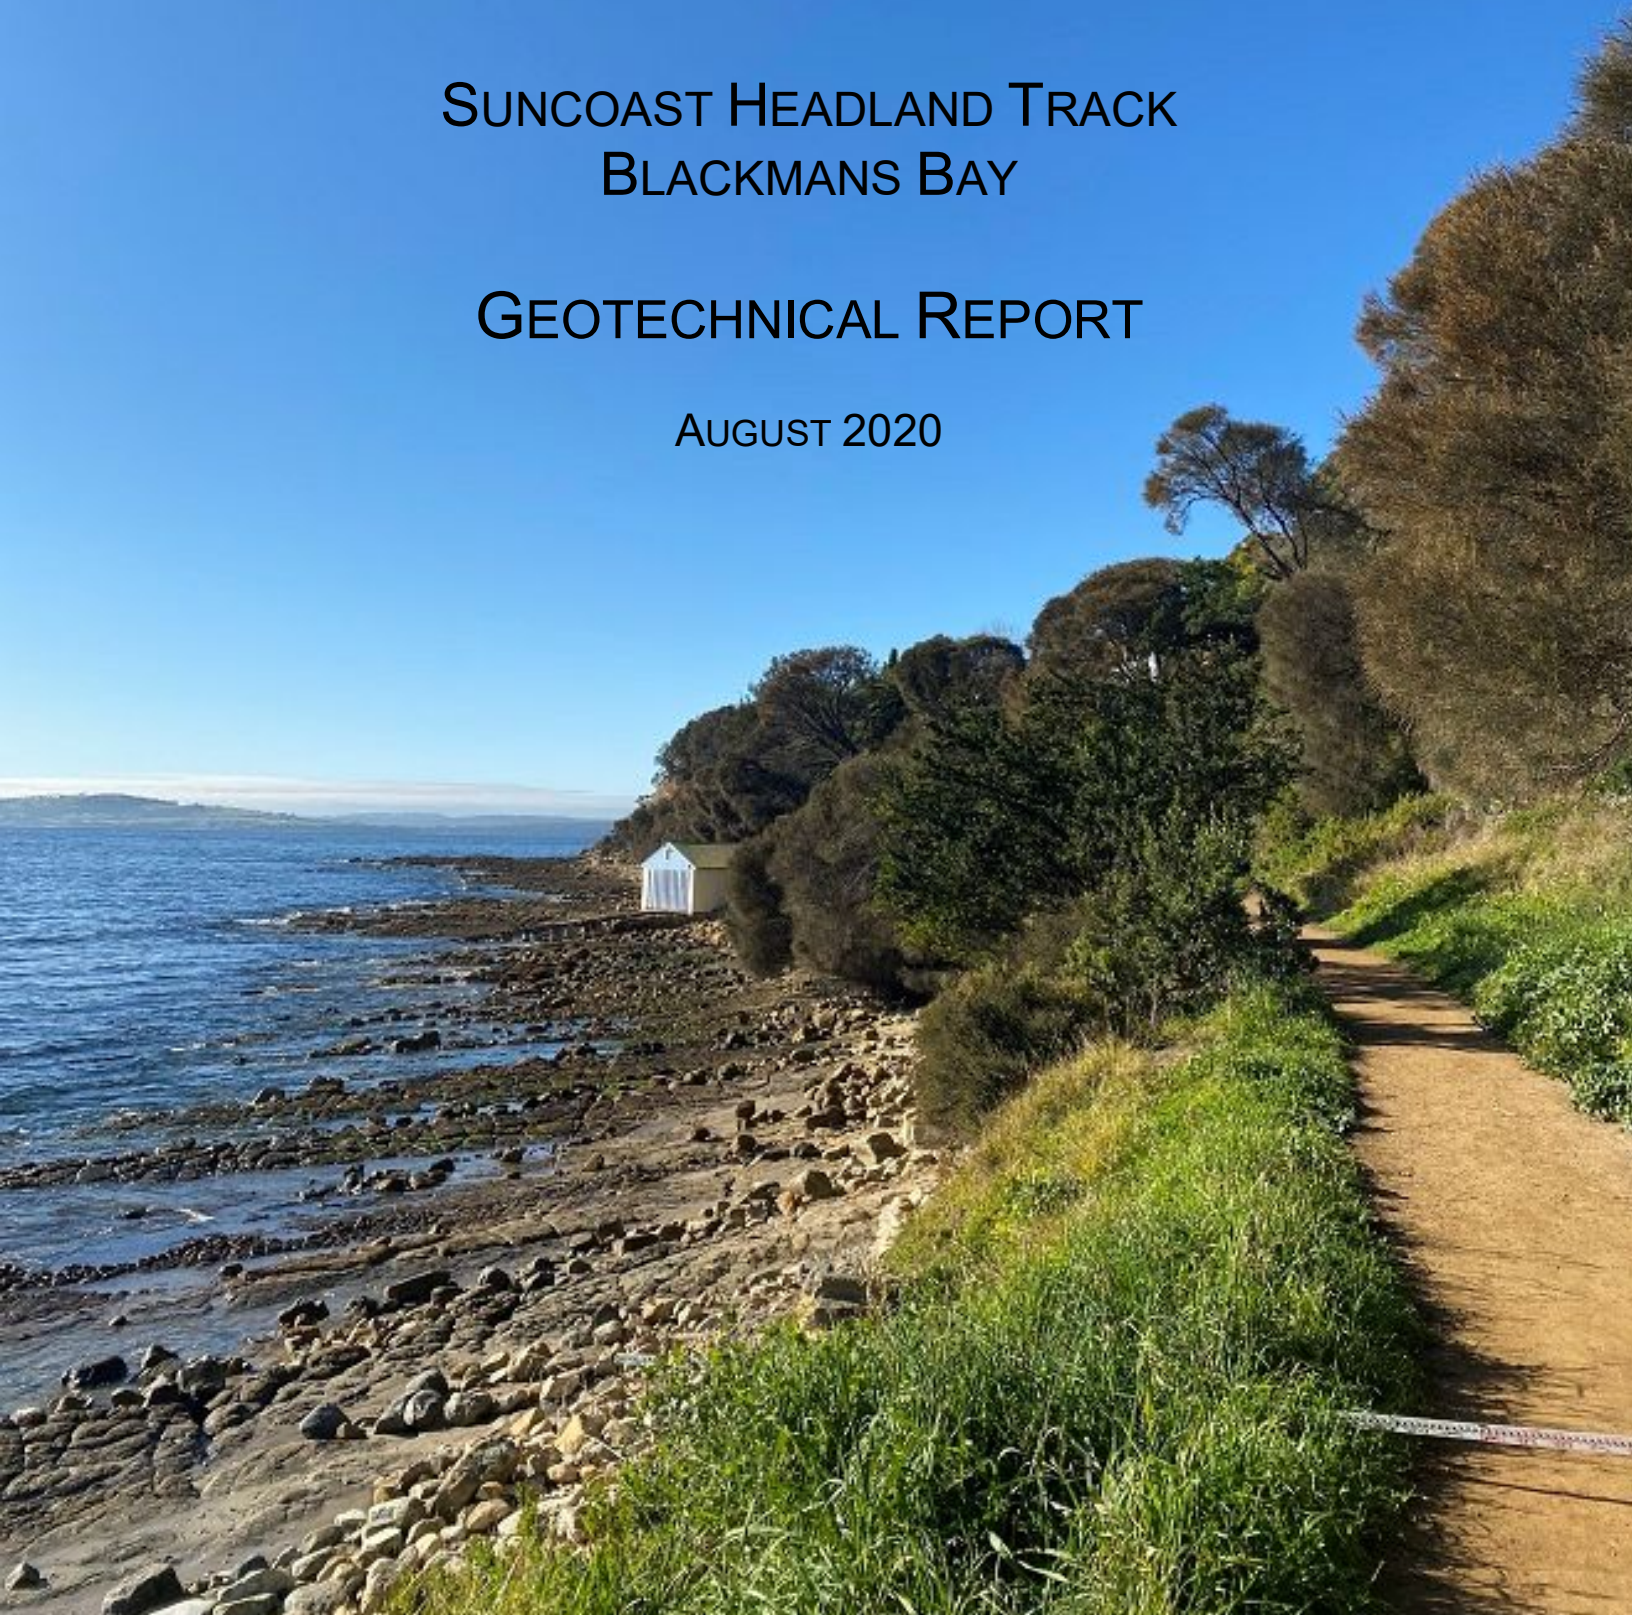
### Cover image

View looking east along part of the Suncoast Headland Track, which starts at the southern end of Blackmans Bay Beach. This report concerns geotechnical conditions along about 170m of track, from the end of the beach to the boat shed in the middle distance.

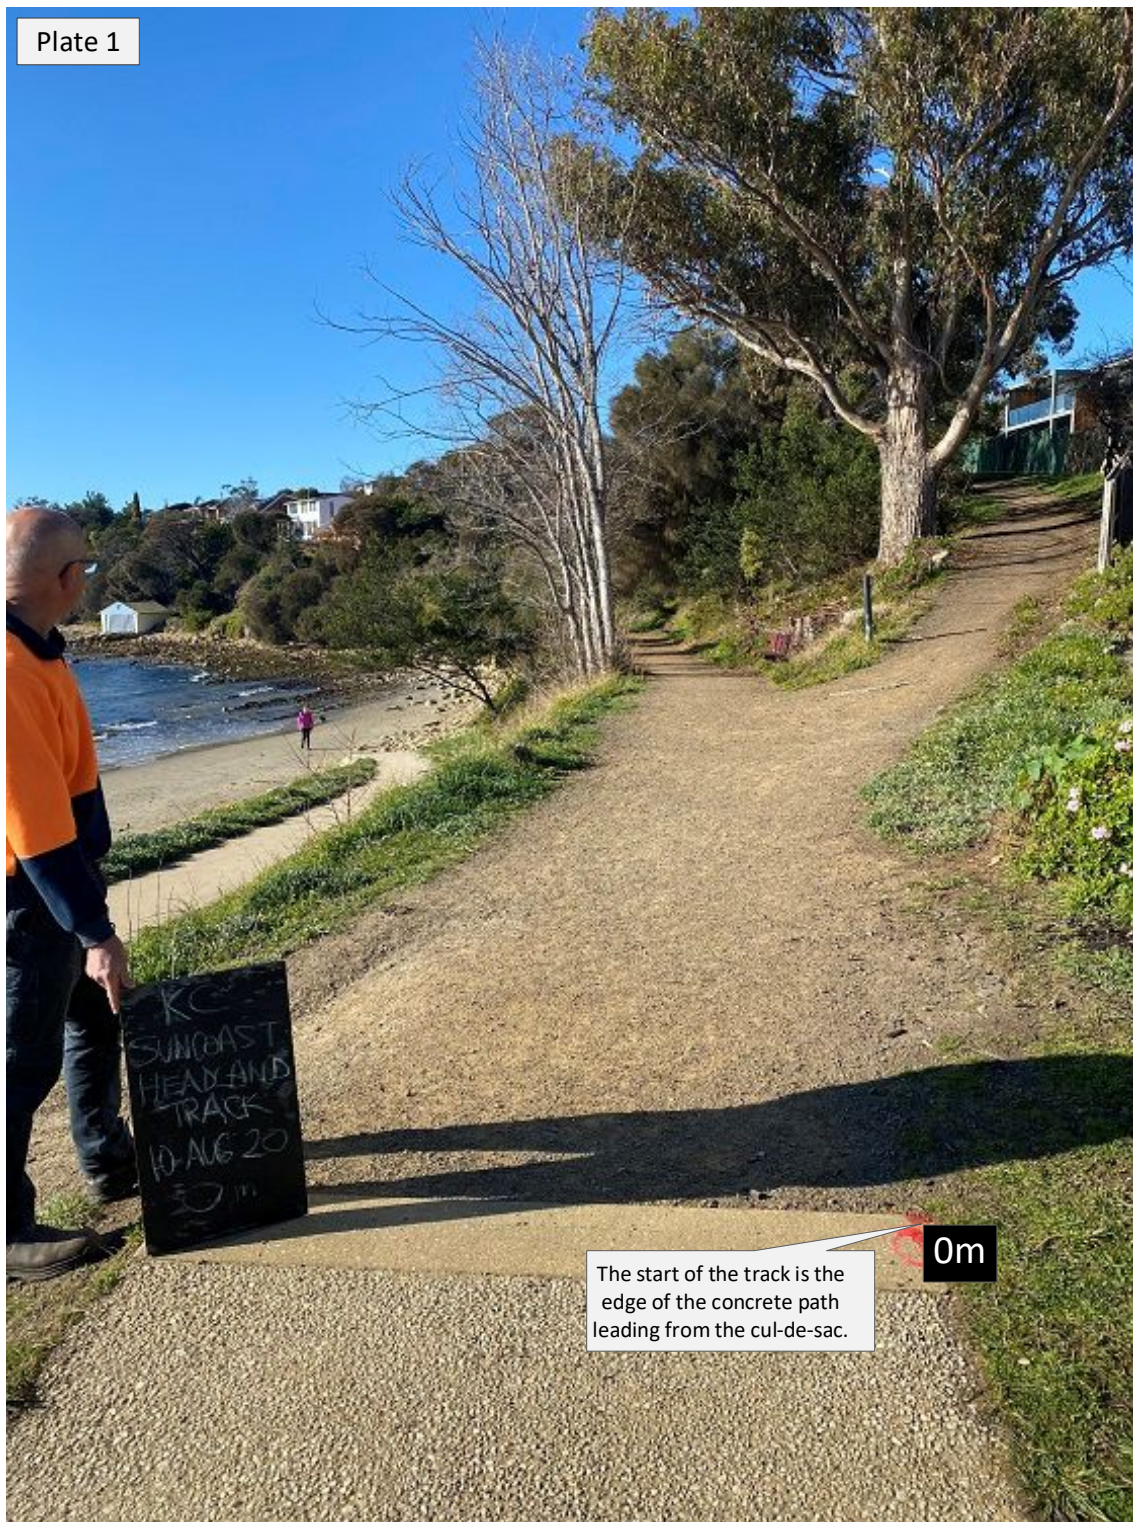
Plate 1

Text is kept to a minimum in this report. Results are mainly summarised in diagrams, and in the series of site photographs in Attachment 2 where distances (“chainages”) in metres along the track (in 10m increments up to 170m) are measured from the end of the concrete pathway off the cul-de-sac at the southern end of the beach (Plate 1 in Attachment 2).
