## **Geomorphological considerations in landscaping options for Tinderbox Beach and adjacent backshore**

Report to Kingborough Council

By Chris Sharples

December 2021

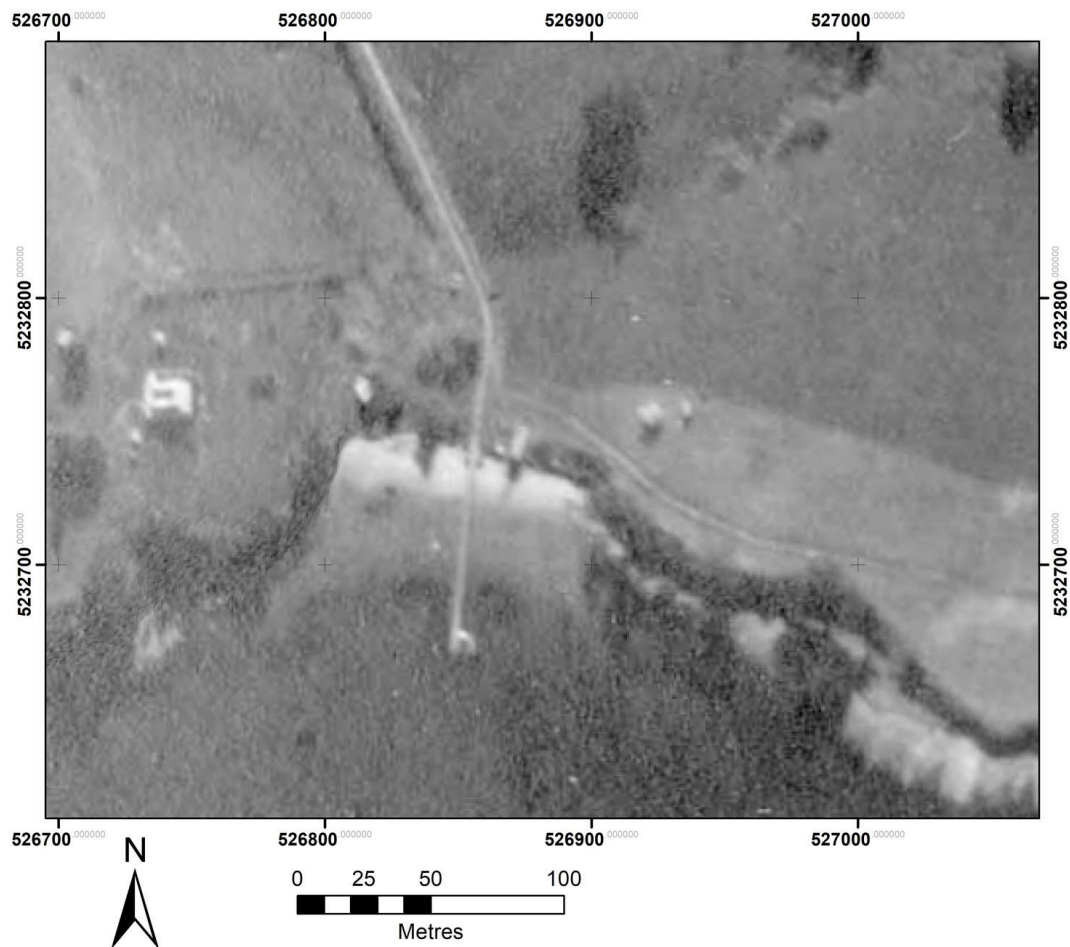
**Figure 2: Detail of an air photo dated 9<sup>th</sup> Jan. 1948, showing Tinderbox Beach at that time.** This is the oldest air photo available for Tinderbox Beach. The jetty seen in this photo extended 76 metres offshore from the back of the sandy beach but had been removed by 1965 (air photo evidence). The position of the soil (fill) margin at the back of the beach in this 1948 air photo is clearly evident and is indistinguishable from the position of the soil margin in a 2012 air photo (see discussion in section 2.3 below). Air photo © Land Information Services Tasmania (LIST). Metric map co-ordinates are based on Map Grid of Australia Zone 55 (MGA55), GDA94 datum.

Comparison of historic air photos (see 1948 air photo in Figure 2) provides evidence that the freshly active erosion of the soil margin shown in Figure 10 is a relatively recent phenomenon. Direct comparison of the earliest and the most recent air photos of Tinderbox Beach available to the writer (1948 and 2012) demonstrate that the soil margin at the back of the beach did not detectably recede over that period. That is, any movement of the margin was less than the 0.7 m pixel size of the scanned air photos (and also less than the  $\pm 2.3$  m mean ortho-rectification error margin for these photos)<sup>2</sup>. Comparison of ground photos between 2007 and 2013 (Figure 12) show an active mostly fresh erosion scarp behind the beach over that period, but not a major shoreline retreat as yet.
